FULL RESERVE STUDY

Grand Panama Beach Resort Condominium Association, Inc.

Panama City Beach, Florida

October 27, 2017

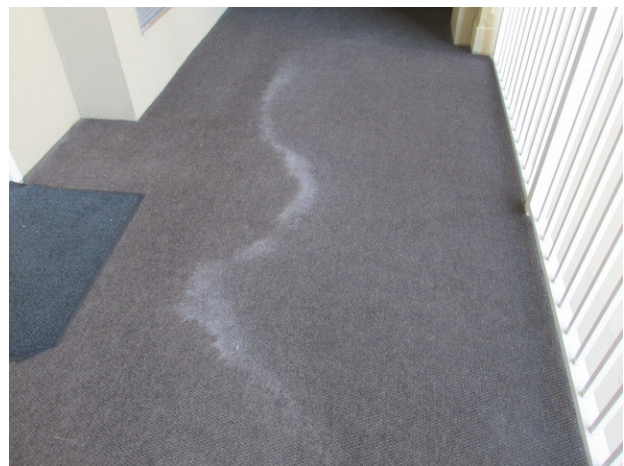
Condition: Good overall condition with isolated water stains evident

**Isolated water stains at carpet floor coverings
at breezeways**

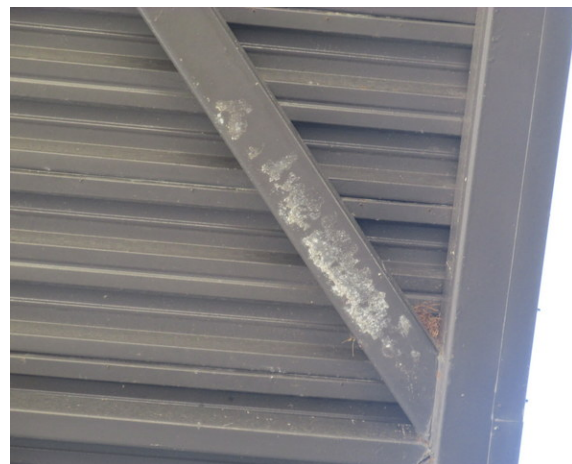
Condition: Good to fair overall with isolated finish deterioration evident.

Isolated deterioration of paint finishes at skywalk

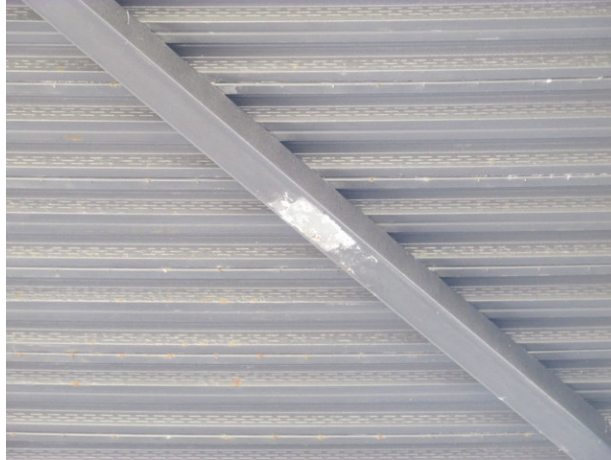
Isolated deterioration of paint finishes at
skywalk

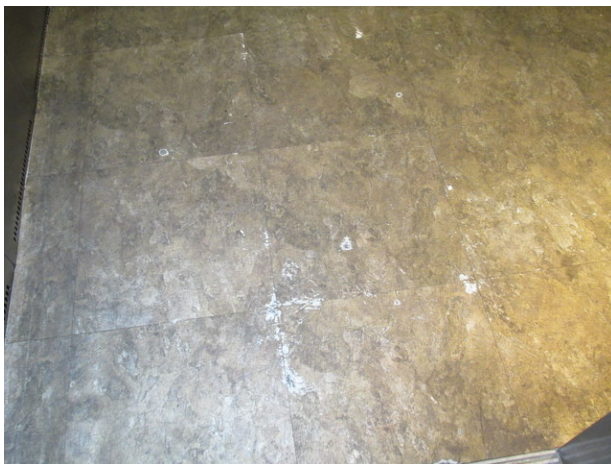
Condition: Good overall with the exception of the tile floor coverings. We note deterioration at the floor coverings. Management informs us that the Association plans to apply epoxy floor coverings at the cabs in 2018.

Deterioration at tile floor coverings at elevator cab

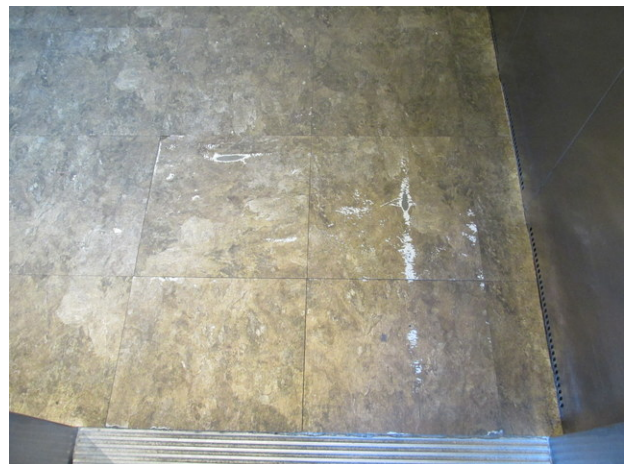
Deterioration at tile floor coverings at elevator cab

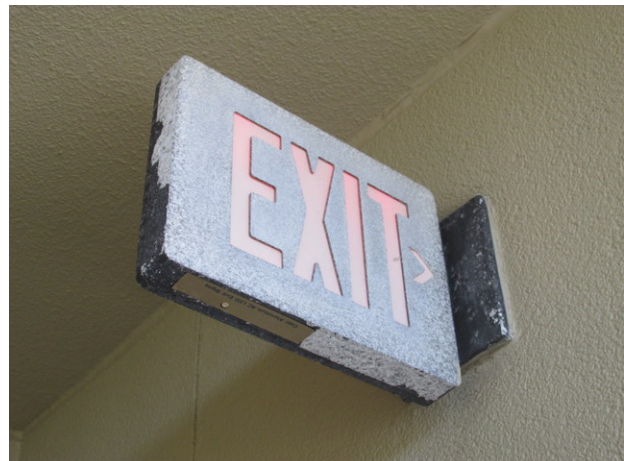
Conditions: Reported satisfactory. We note isolated emergency fixtures with deteriorated finishes. The Association should replace deteriorated fixtures as needed and fund this activity through the operating budget.

Deteriorated finishes at emergency device

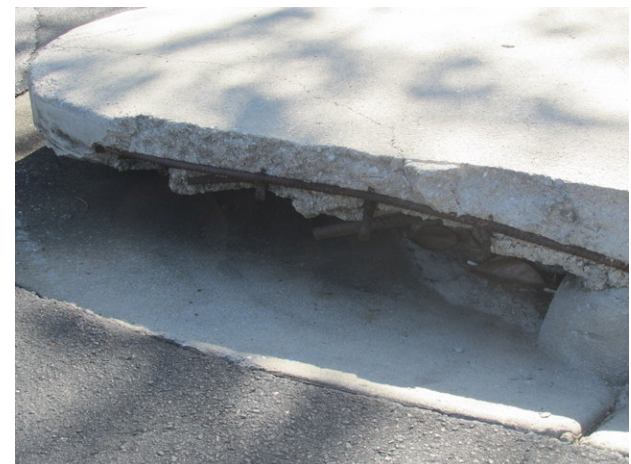
Condition: Good overall condition. We note isolated concrete deterioration and exposed rebar at a catch basin at the Tower 2 parking area.

Isolated severe spalling and exposed rebar at catch basin at Tower 2 parking area

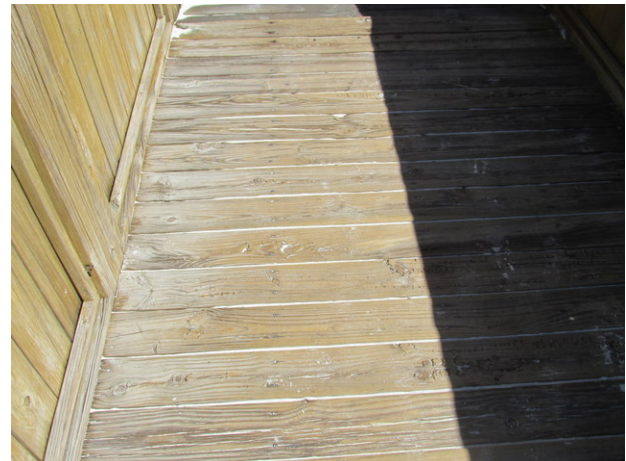
History: The components are primarily original. We note areas of replaced decking.

Area of replaced wood decking at dune walkover

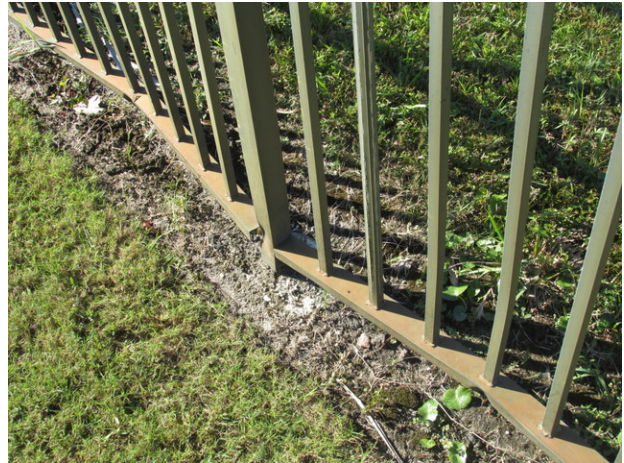
Condition: Good to fair overall. We note isolated damage and finish deterioration.

Isolated damage at aluminum fence adjacent to gate house

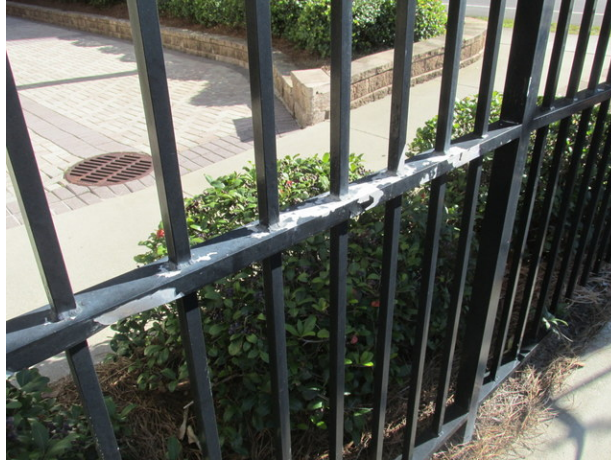
Isolated finish deterioration at aluminum fence
at Tower 2 parking area

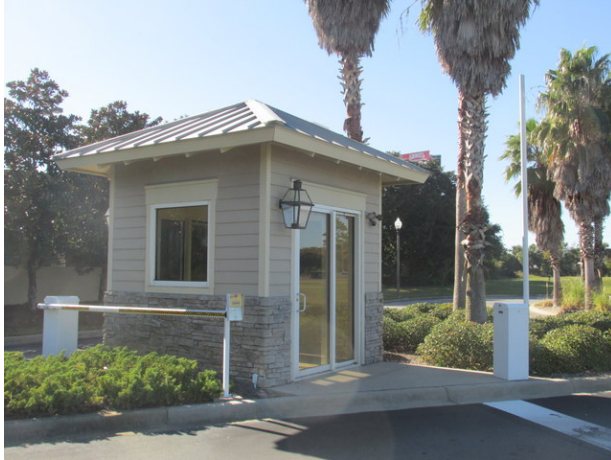
Condition: The operators were not in operation at the time of our inspection.

Swing-arm gate operators at gate house

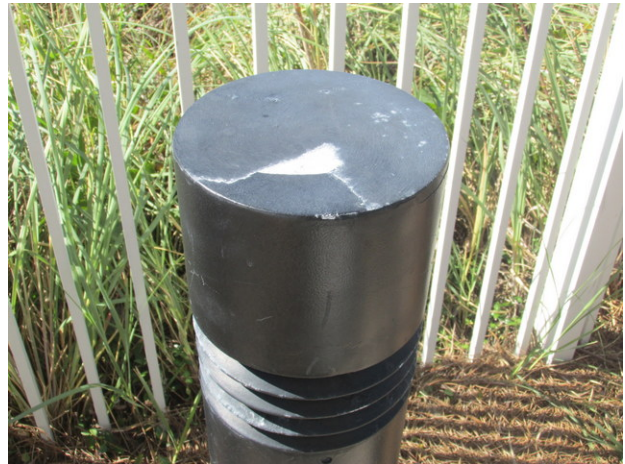
Condition: We note several bollards with deteriorated finishes. The Association should apply finishes to the bollards on an as-needed basis and fund this activity through the operating budget.

Deteriorated finishes at bollard-type light fixture at Tower 1 pool area

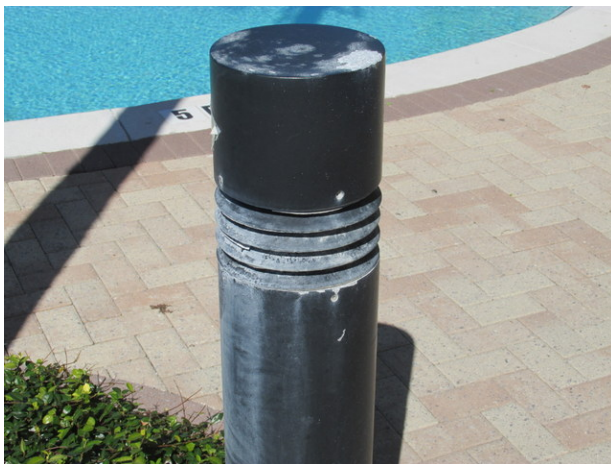
Deteriorated finishes at bollard-type light fixture at Tower 1 pool area

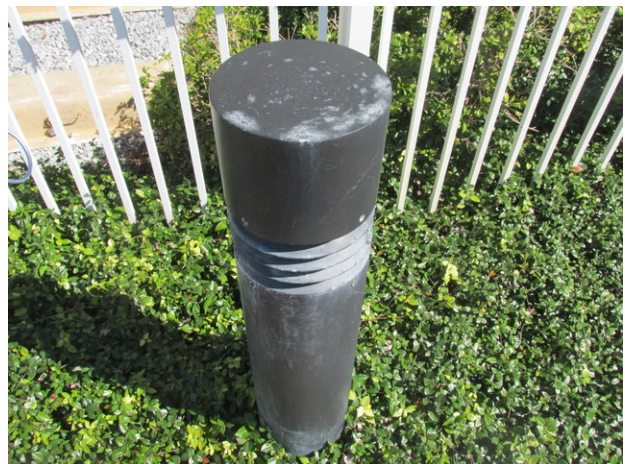
Deteriorated finishes at bollard-type light fixture at Tower 1 pool area

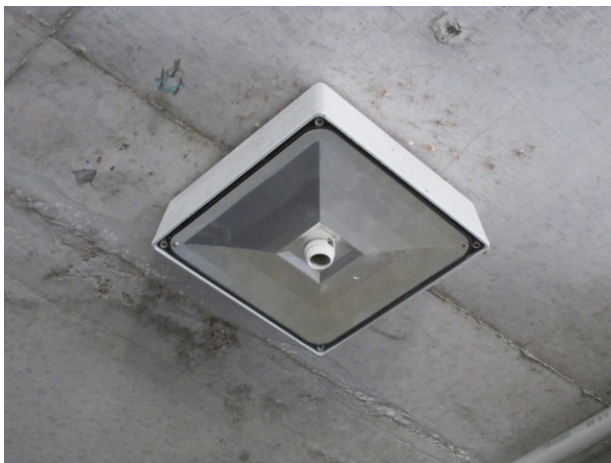
Condition: Good overall condition. We note missing fixtures and covers at the separate garage structure.

Missing bulb and cover at light fixture at separate garage structure

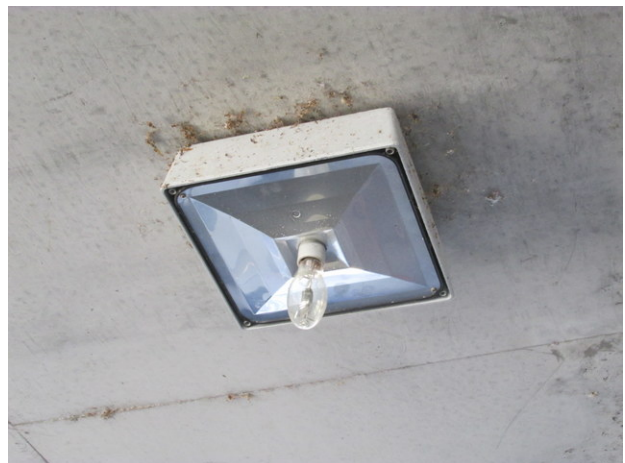
Missing cover at light fixture at separate garage structure
