## Report of Findings

**Grand Panama Beach Resort Hurricane Michael Damage Evaluation**

**Claim No: 4156891**

September 2, 2020

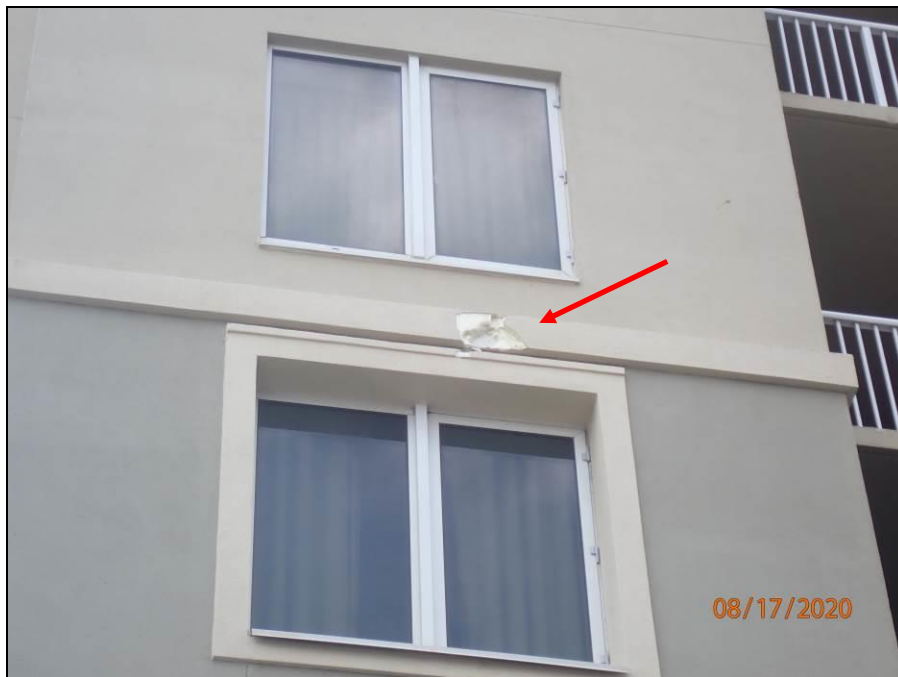
**Photograph 2**

- There was visible impact damage to the EIFS trim between the fourth and fifth floors on the exterior, north wall near the northeast corner of the building (**Photograph 2**). There was also visible impact damage to the top of the EIFS trim around the easternmost fourth-floor window on the north wall of the building.

View of the impact damage to the EIFS trim between the fourth and fifth floors on the exterior, north wall of Tower #1 (arrow). Also note impact damage to the EIFS trim above the fourth-floor window.

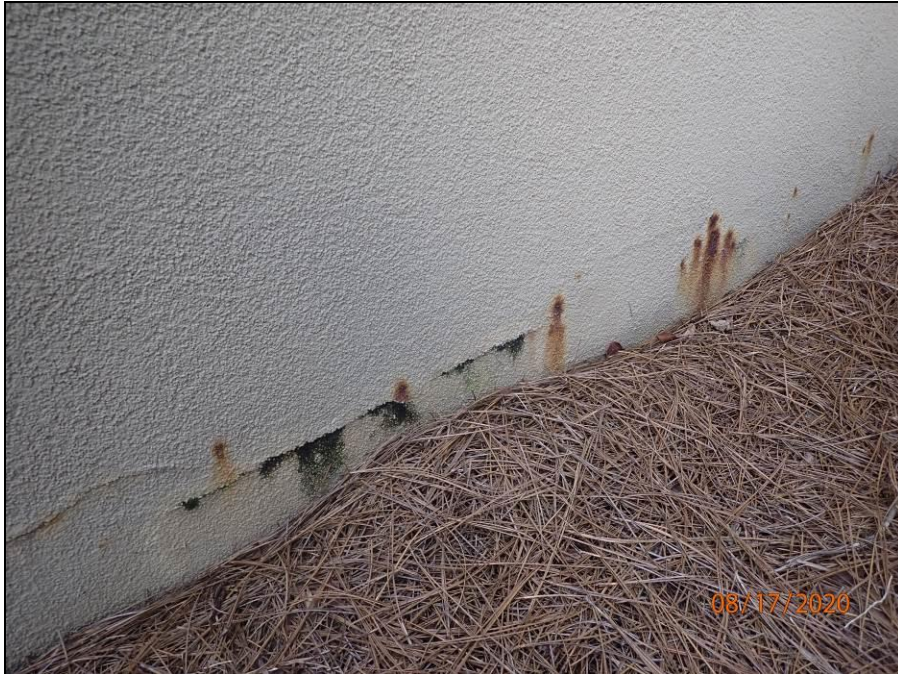
**Photograph 3**

- There were sporadic cracks, “bulges”, and water stains on the exterior stucco cladding extending from the ground surface to a point approximately 3 feet above the ground surface on the exterior, north and west walls of Tower #1 (**Photographs 3 and 4**). Pine straw had been installed as landscaping on the ground surface along the north and west walls of Tower #1. The pine straw abutted against and rose above the bottom of the stucco cladding on the exterior, north and west walls of Tower #1, which restricted the drainage of incidental water that penetrated the stucco lamina (**Photographs 5 and 6**).

View of typical cracks, “bulges”, and water/rust stains on the lower portion of the stucco cladding along the north wall of Tower #1. Note pine straw that abutted against and rose above the bottom of the stucco cladding.

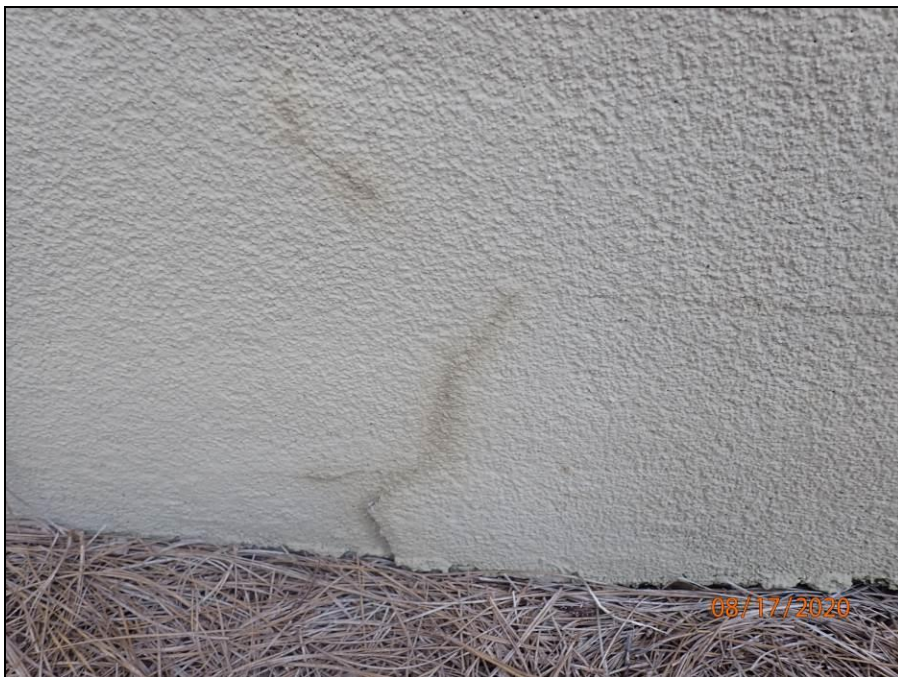
**Photograph 4**

View of typical cracks, “bulges”, and water stains on the lower portion of the stucco cladding along the west wall of Tower #1. Note pine straw that abutted against and rose above the bottom of the stucco cladding.

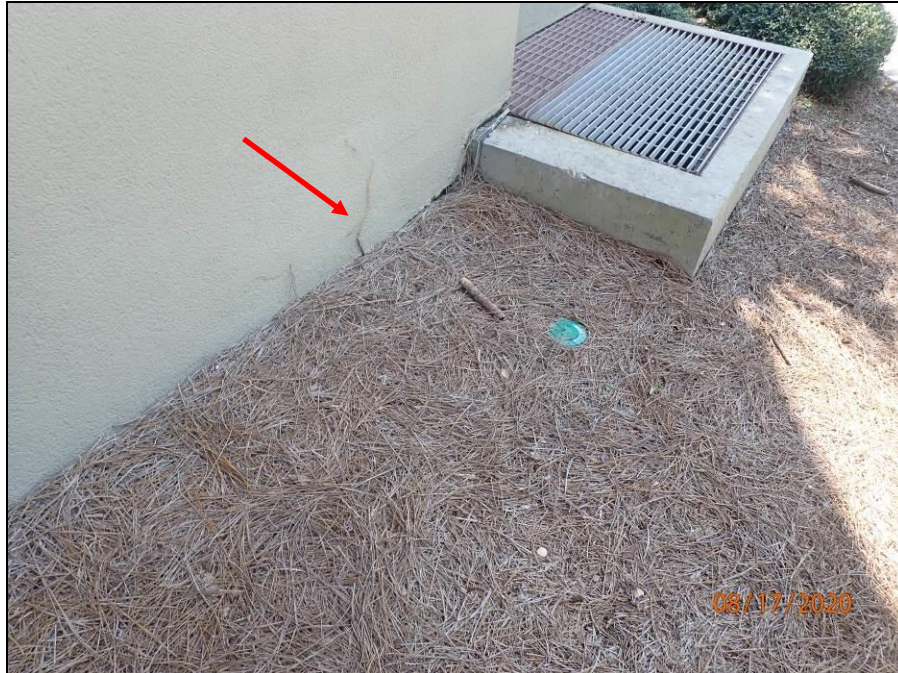
**Photograph 5**

View of the pine straw that abutted against and rose above the bottom of the stucco cladding along the west wall of Tower #1. Also note stucco crack (arrow).

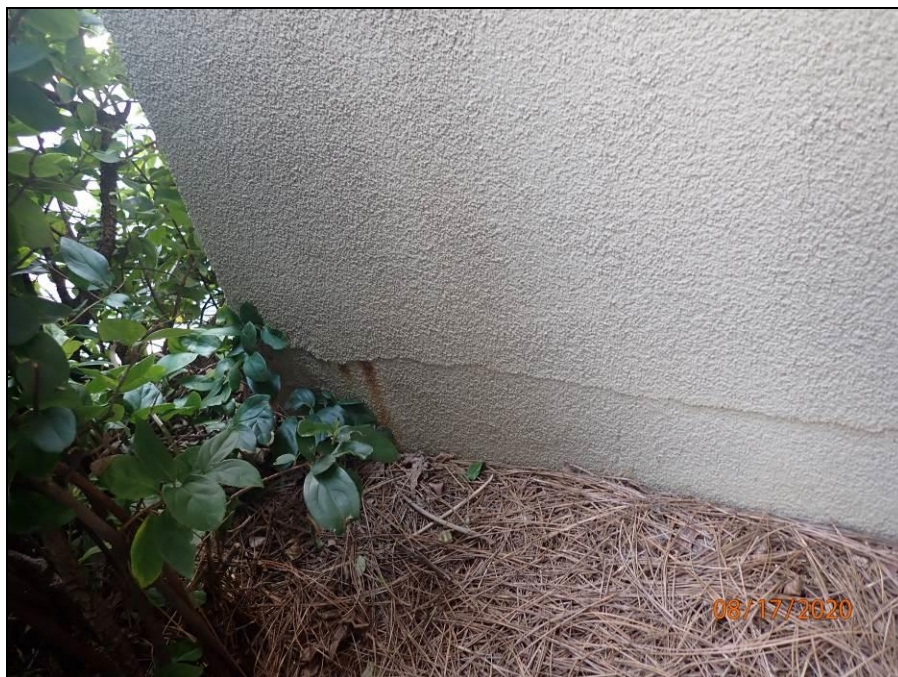
**Photograph 6**

View of the pine straw that abutted against and rose above the bottom of the stucco cladding along the north wall of Tower #1. Also note stucco crack and water/rust stains.

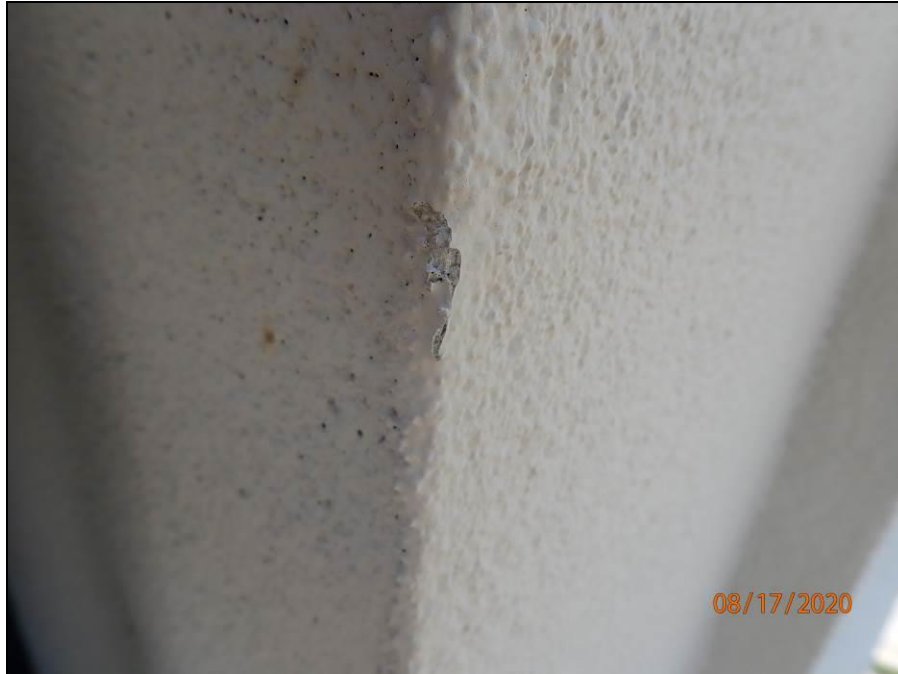
**Photograph 7**

Close-up view of typical scars/abrasions to the finish coat of the stucco on the north wall of Tower #1.

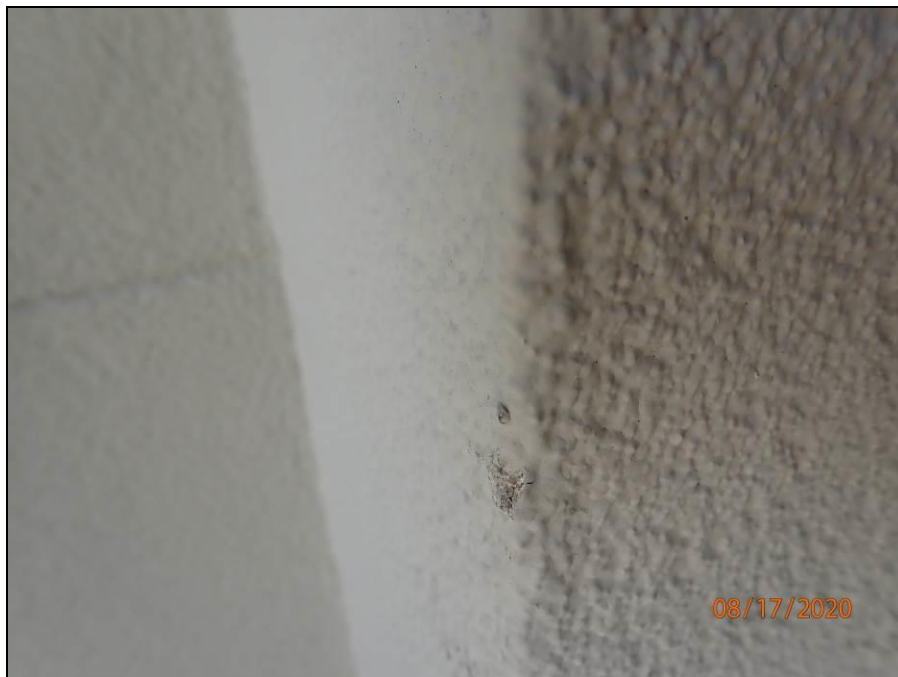
**Photograph 8**

Close-up view of typical scars/abrasions to the finish coat of the stucco on the north wall of Tower #1.

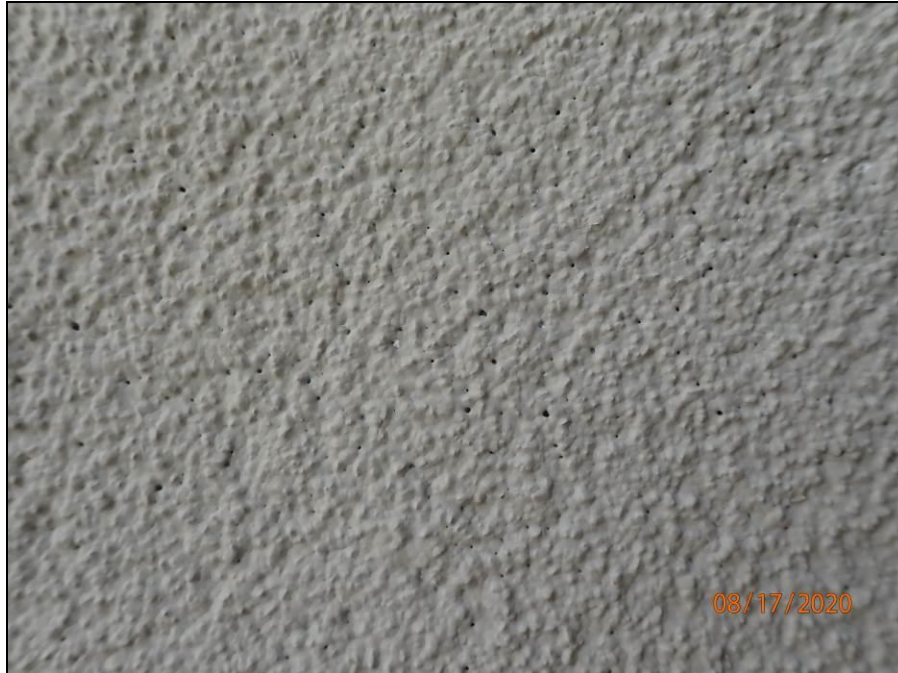
**Photograph 9**

Close-up view of typical scars/abrasions to the stucco finish coat on the north wall of Tower #1.

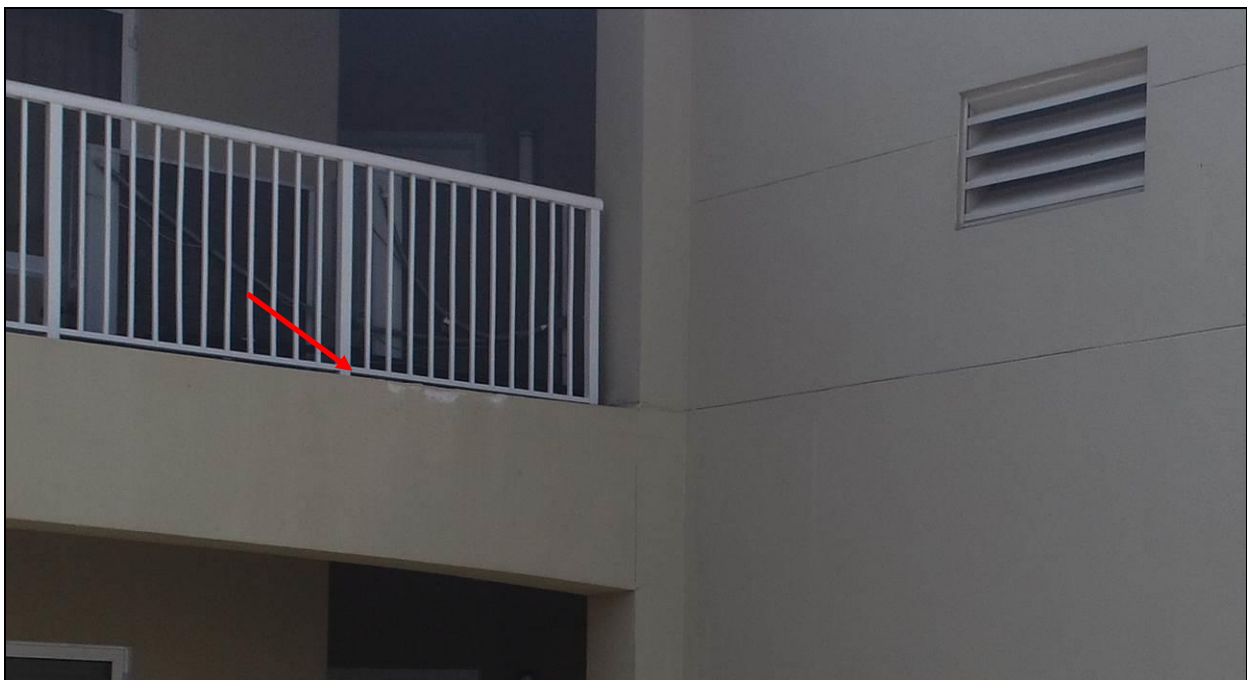
**Photograph 10**

Drone photograph of the north wall on the 22<sup>nd</sup> floor of Tower #1. Note chips/spalls to stucco cladding below railing (arrow), as well as typical abrasions to the stucco.

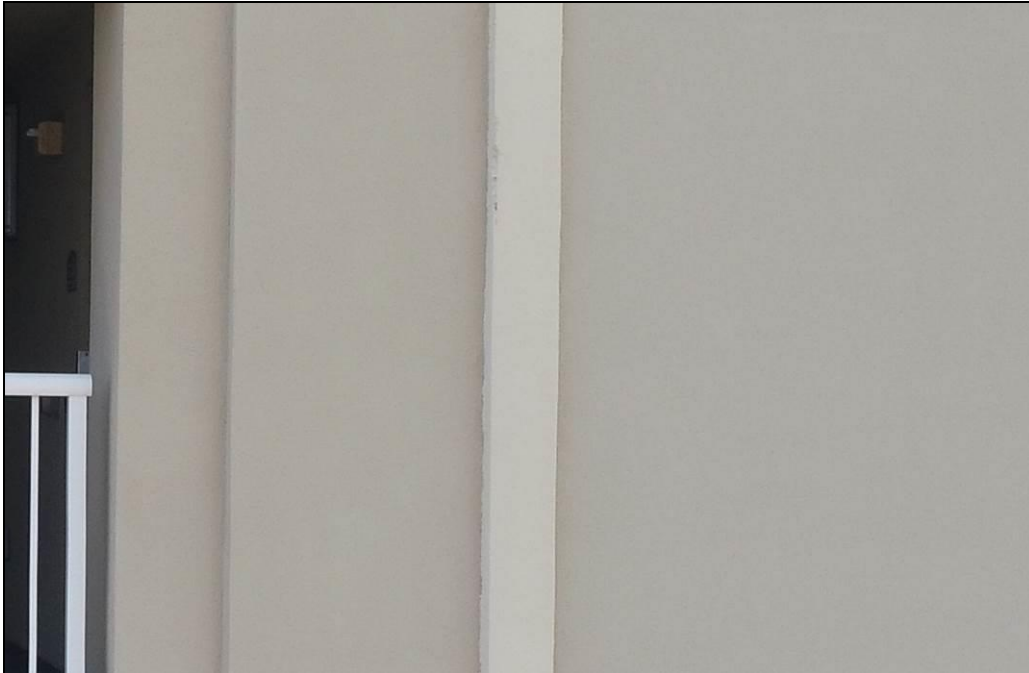
**Photograph 11**

Drone photograph of the north wall on the 13<sup>th</sup> floor of Tower #1. Note chips/spalls to the EIFS trim, as well as typical abrasions to the stucco.

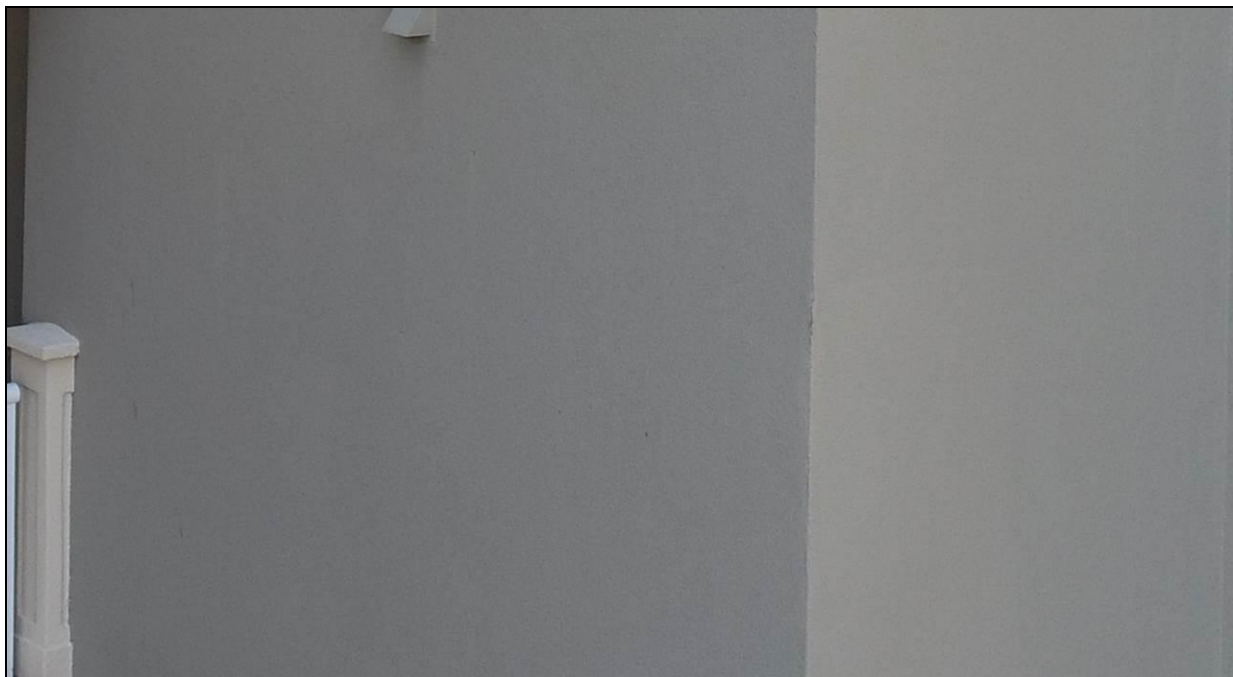
**Photograph 12**

Drone photograph of the north wall on the fifth floor of Tower #1. Note typical abrasions, chips, and scars on the stucco.

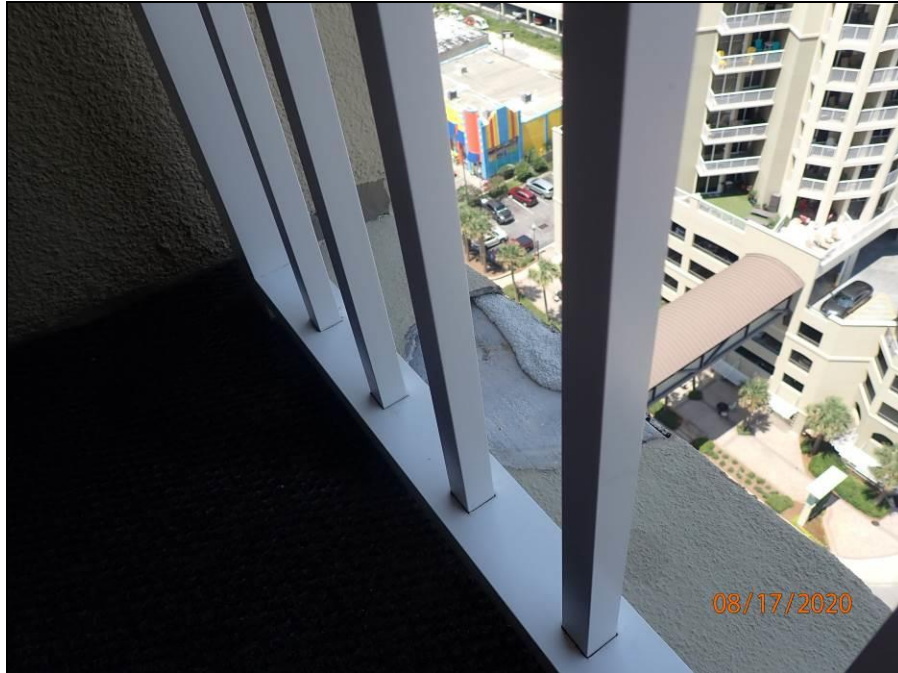
**Photograph 13**

- There was a spalled/missing section of stucco cladding below the guardrail on the easternmost 18<sup>th</sup>-floor balcony on the north wall of the building consistent with wind-borne debris impacts and/or wind-induced movement of the guardrail post at its mounting location at the 18<sup>th</sup>-floor concrete slab (**Photograph 13**).

View of spalled/missing section of stucco cladding below the guardrail on the easternmost 18<sup>th</sup>-floor balcony on the north wall of Tower #1.

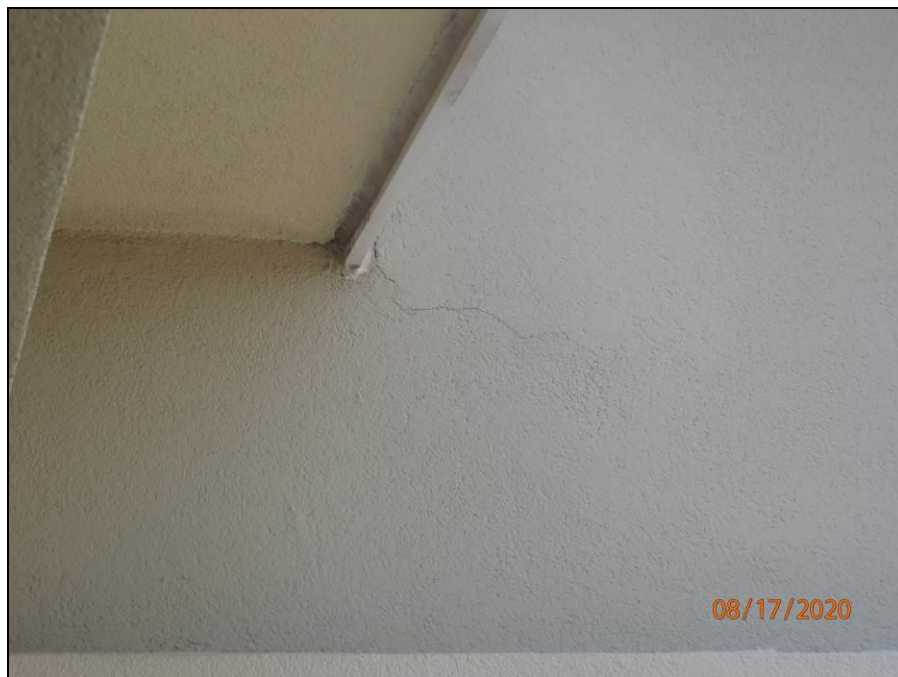
**Photograph 14**

- There were hairline-width cracks in the exterior stucco cladding on the 22<sup>nd</sup> floor of the building at the interface of the roof overhangs and north wall, consistent with minor wind-induced oscillation of the roof covering over the building (**Photograph 14**).

View of a typical stucco crack on the 22<sup>nd</sup> floor of Tower #1 at the interface of a roof overhang and the north wall of the building.

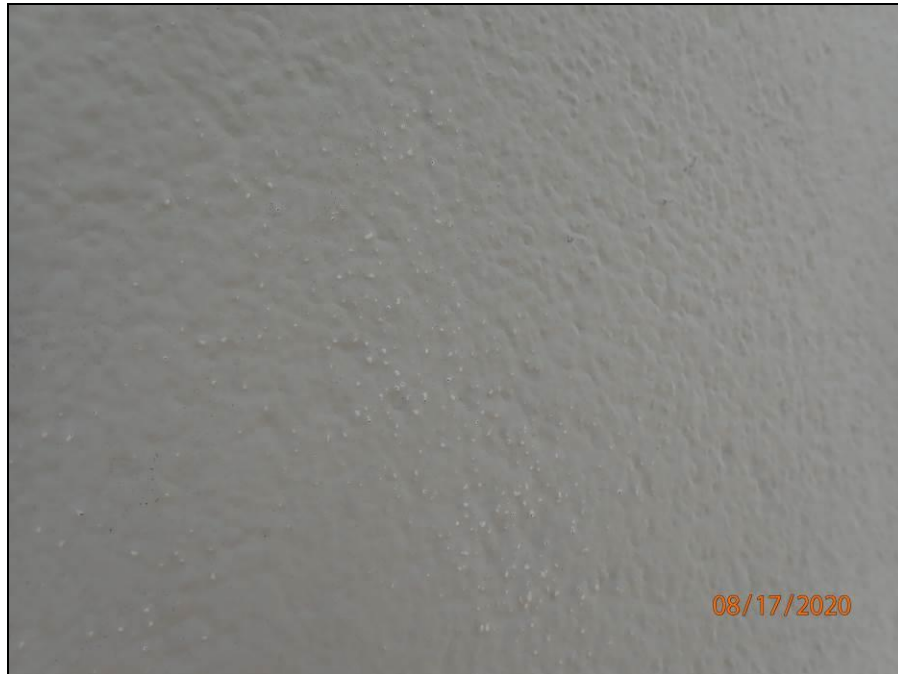
**Photograph 15**

Close-up view of typical scars/abrasions to the finish coat of the stucco on the east wall of Tower #1.

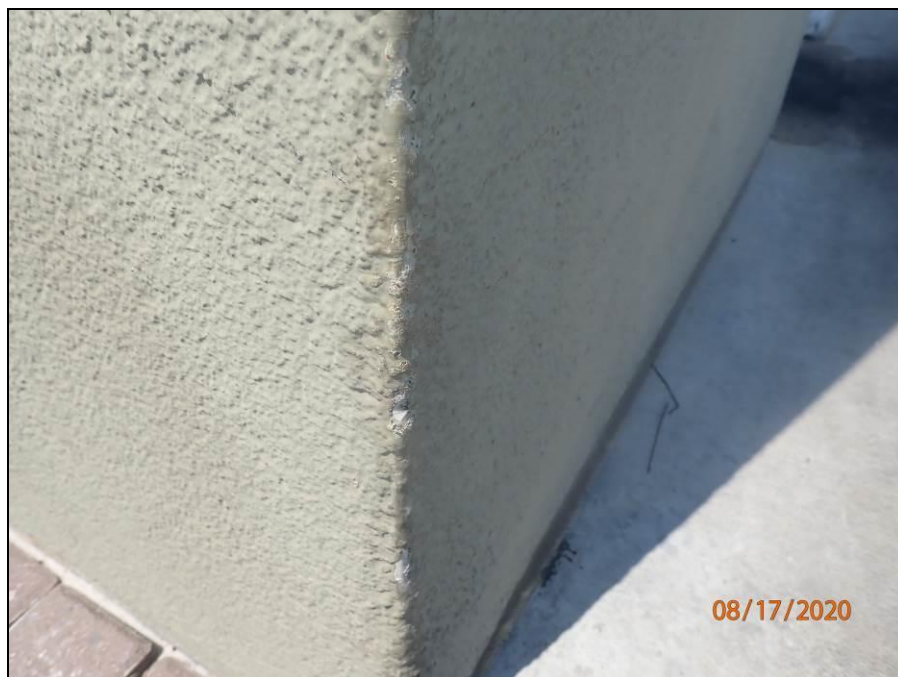
**Photograph 16**

Close-up view of typical scars/abrasions to the stucco finish coat at the southeast corner of Tower #1.

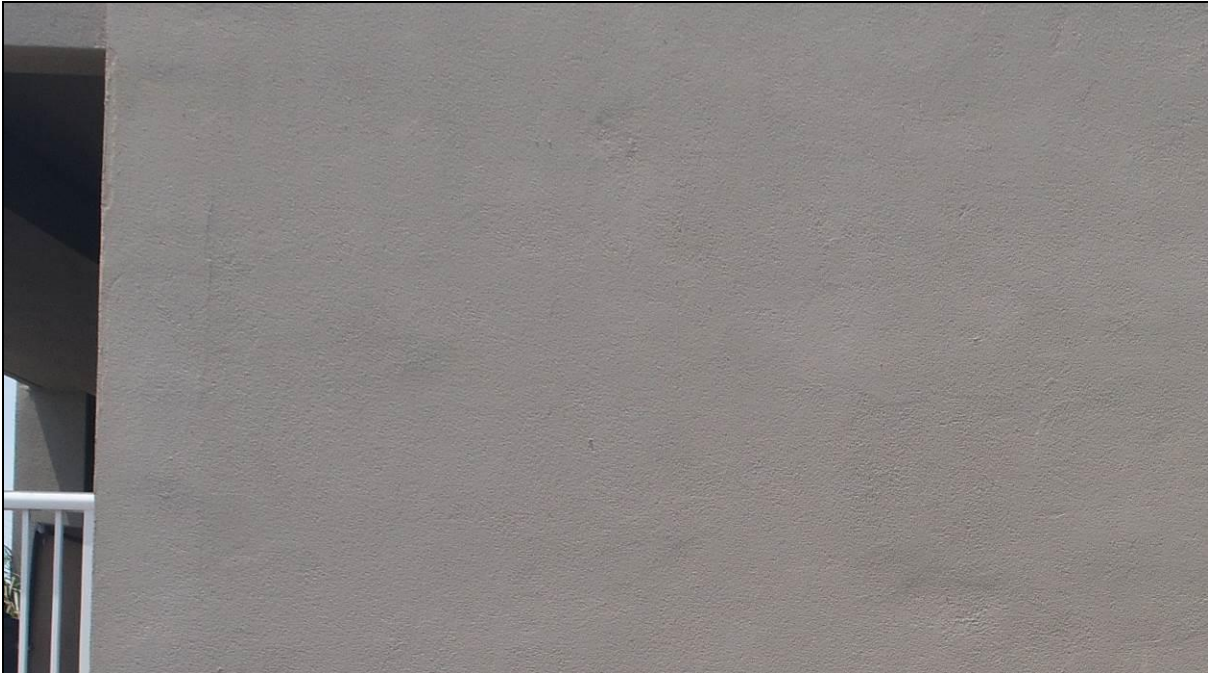
**Photograph 17**

Drone photograph of the east wall on the fourth floor of Tower #1. Note typical abrasions, chips, and scars on the stucco.

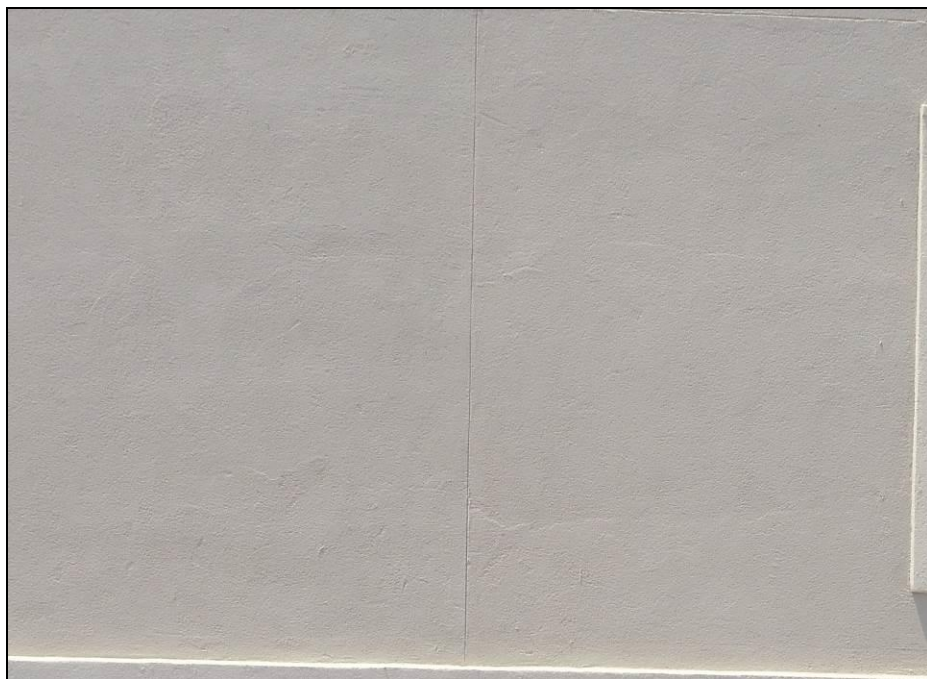
**Photograph 18**

Drone photograph of the east wall on the eighth floor of Tower #1. Note typical abrasions, chips, and scars on the stucco.

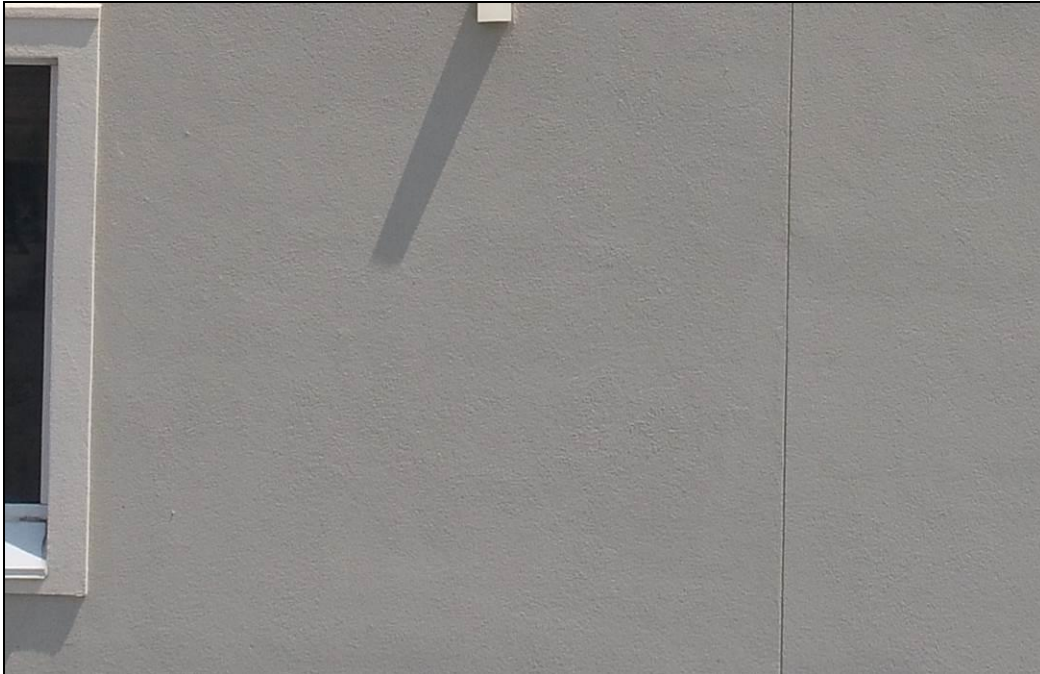
**Photograph 19**

loads/forces and/or minor wind-borne debris impacts during the passage of Hurricane Michael (**Photographs 19 through 22**). The degree and extent of the scarring and/or abrasions to the finish coat of the exterior stucco and/or EIFS on the south and west walls of Tower #1 was less than that of the scarring and/or abrasions on the north and east walls of the building, a condition consistent with the directionality of the wind forces at the property location during the passage of Hurricane Michael, which would have been primarily from the north and east.

Drone photograph of the west wall on the 14<sup>th</sup> floor of Tower #1. Note typical abrasions, chips, and scars on the stucco.

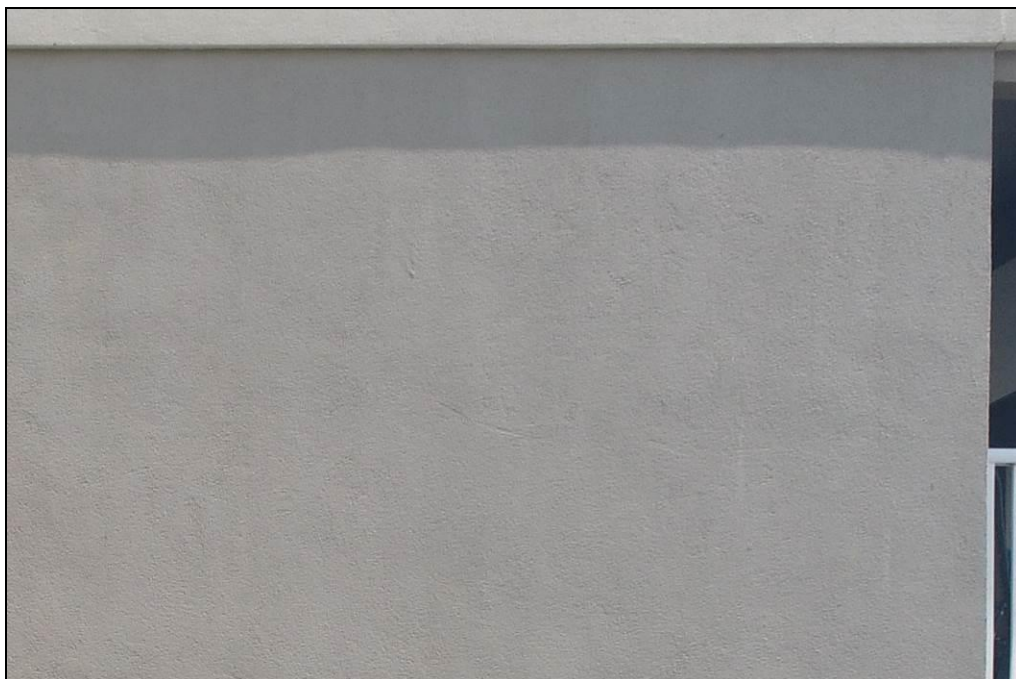
**Photograph 20**

Drone photograph of the west wall on the fifth floor of Tower #1. Note typical abrasions, chips, and scars on the stucco.

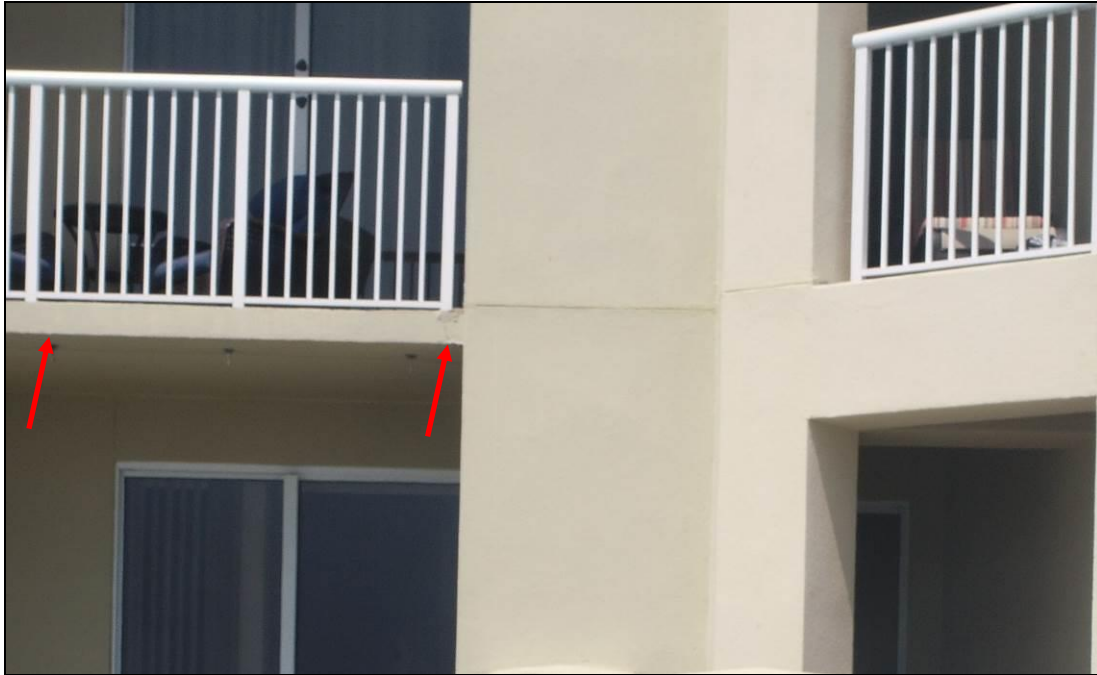
**Photograph 21**

Drone photograph of the south wall on the 10<sup>th</sup> floor of Tower #1. Note typical abrasions, chips, and scars on the stucco, as well as chips/spalls to stucco cladding below railing (arrows).

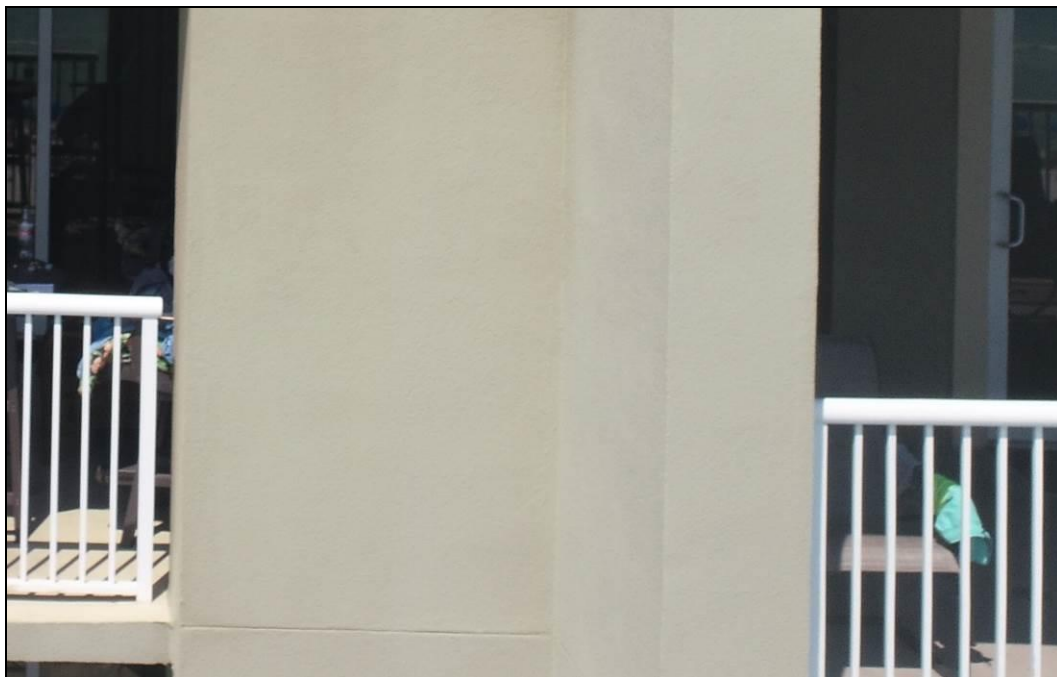
**Photograph 22**

Drone photograph of the south wall on the sixth floor of Tower #1. Note typical abrasions, chips, and scars on the stucco.

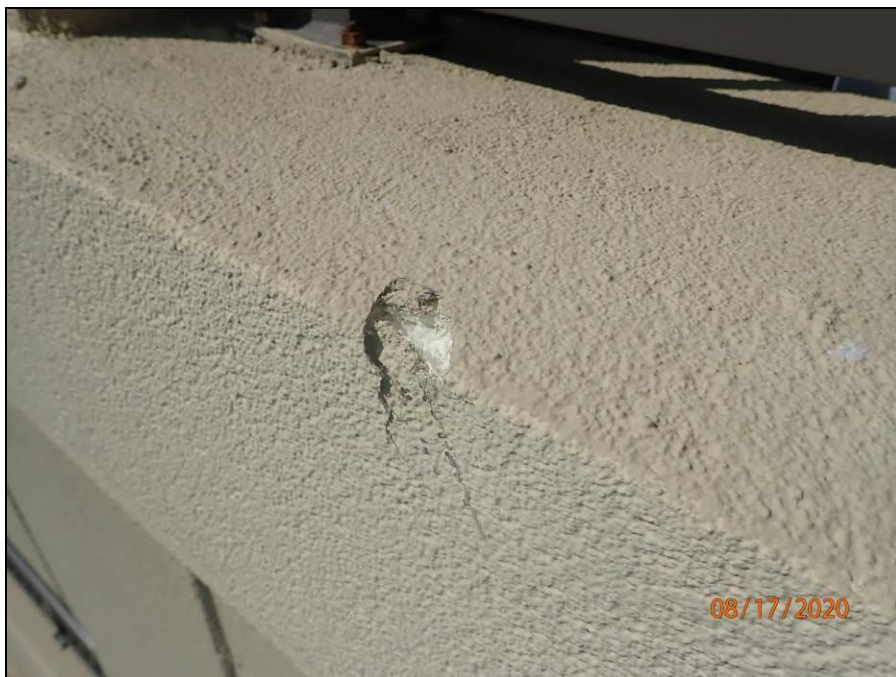
**Photograph 24**

View of a typical impact mark to the EIFS cladding on the exterior south wall of the fourth floor of the lower parking garage of Tower #2.

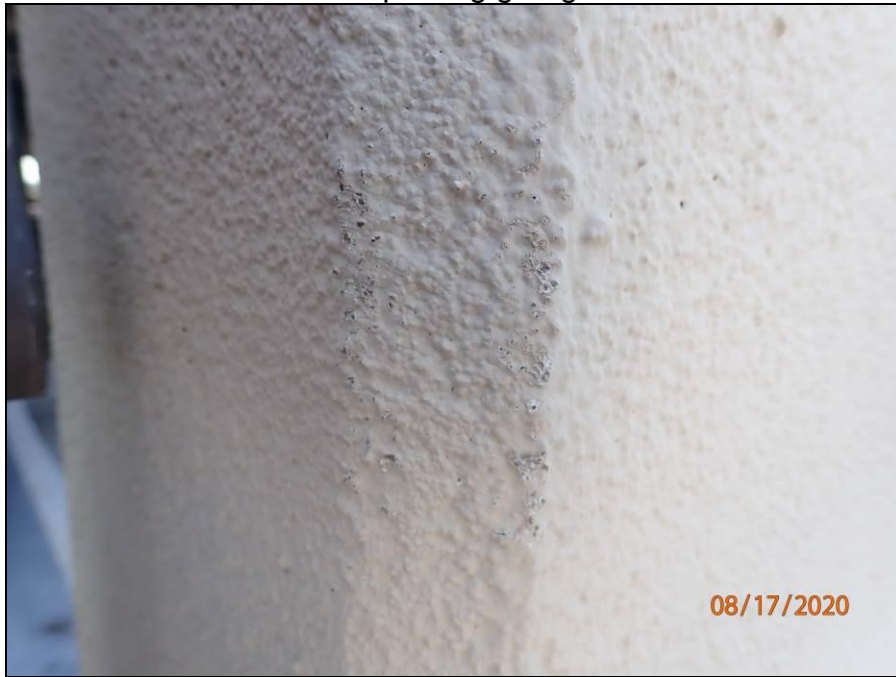
**Photograph 25**

Close-up view of typical scars/abrasions to the finish coat of the stucco on the exterior, north wall of the third floor of the lower parking garage of Tower #2.

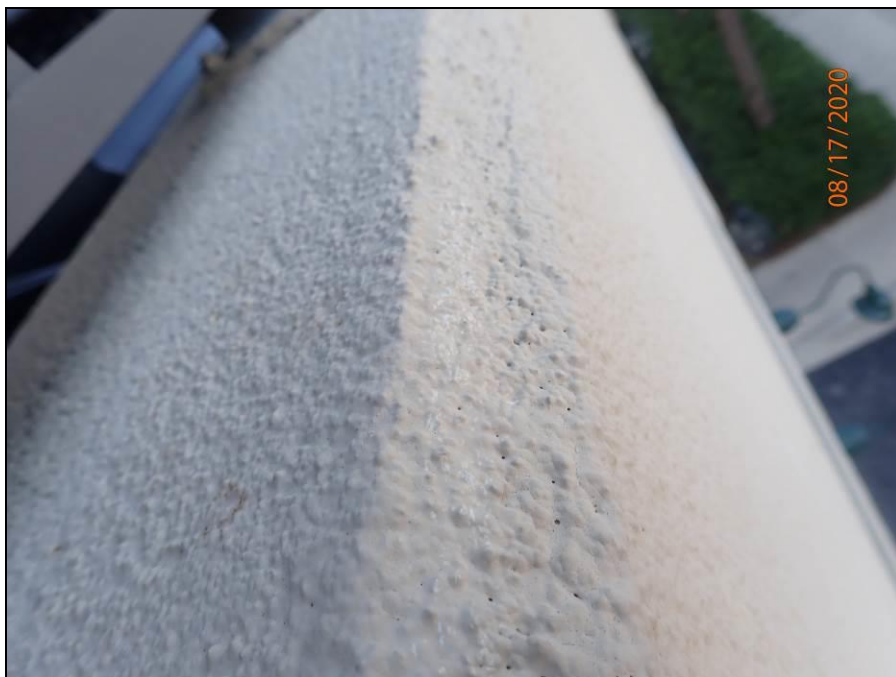
**Photograph 26**

Close-up view of typical scars/abrasions to the finish coat of the stucco on the exterior east wall of the second floor of the lower parking garage of Tower #2.

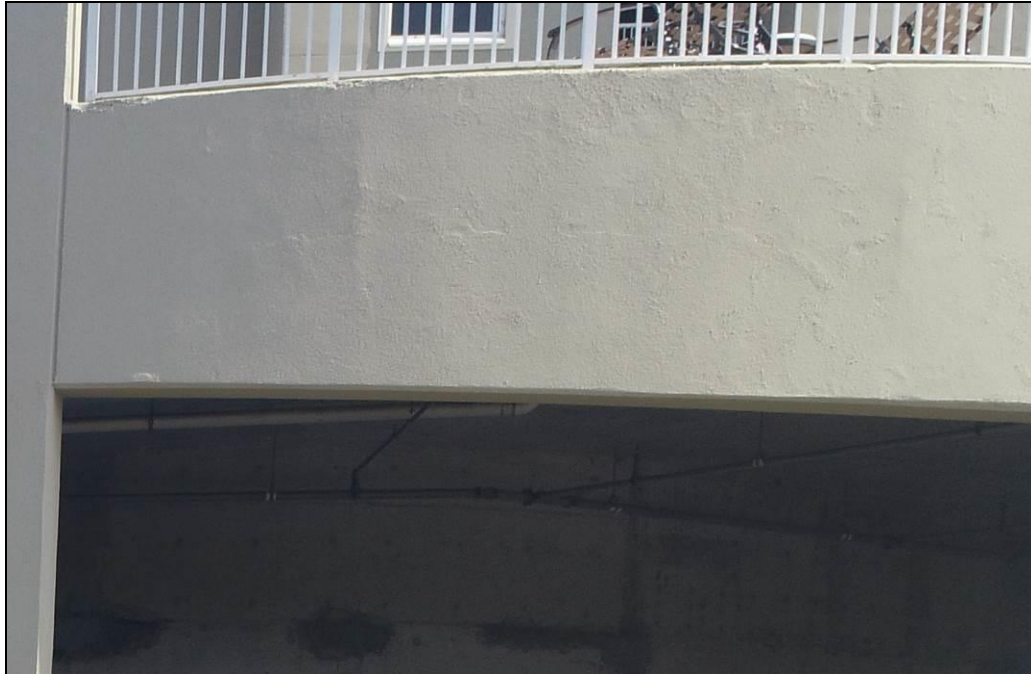
**Photograph 27**

Drone photograph of the exterior, north wall of the pool deck of Tower #2. Note typical abrasions, chips, and scars on the stucco.

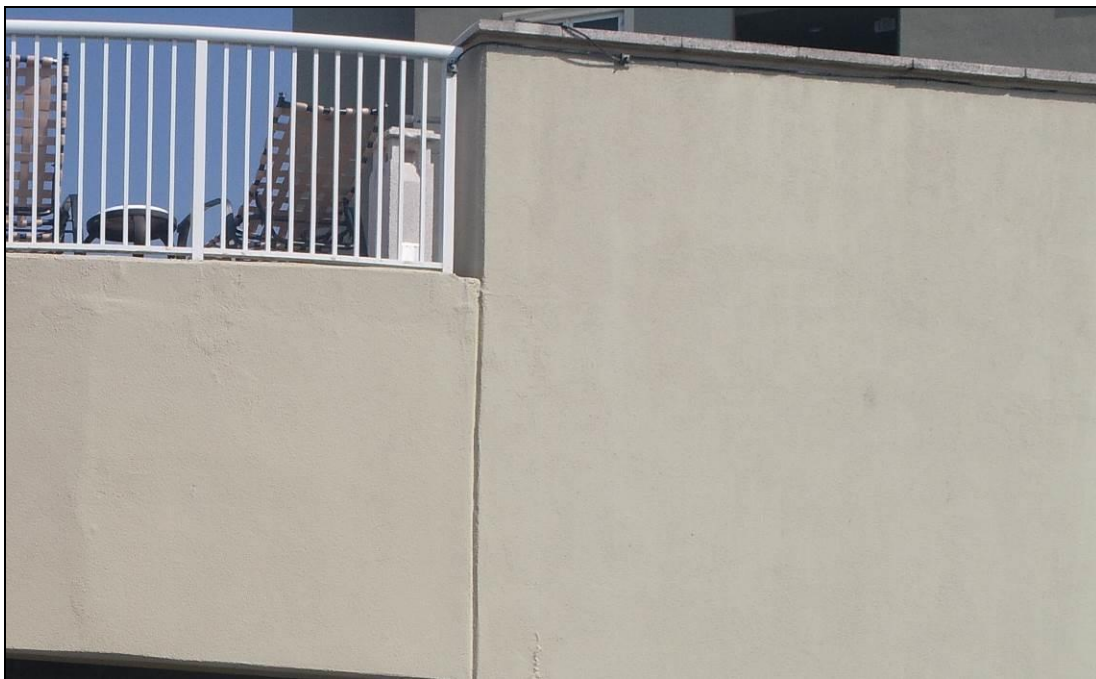
**Photograph 28**

Drone photograph of the exterior west wall of the pool deck of Tower #2. Note typical abrasions, chips, and scars on the stucco.

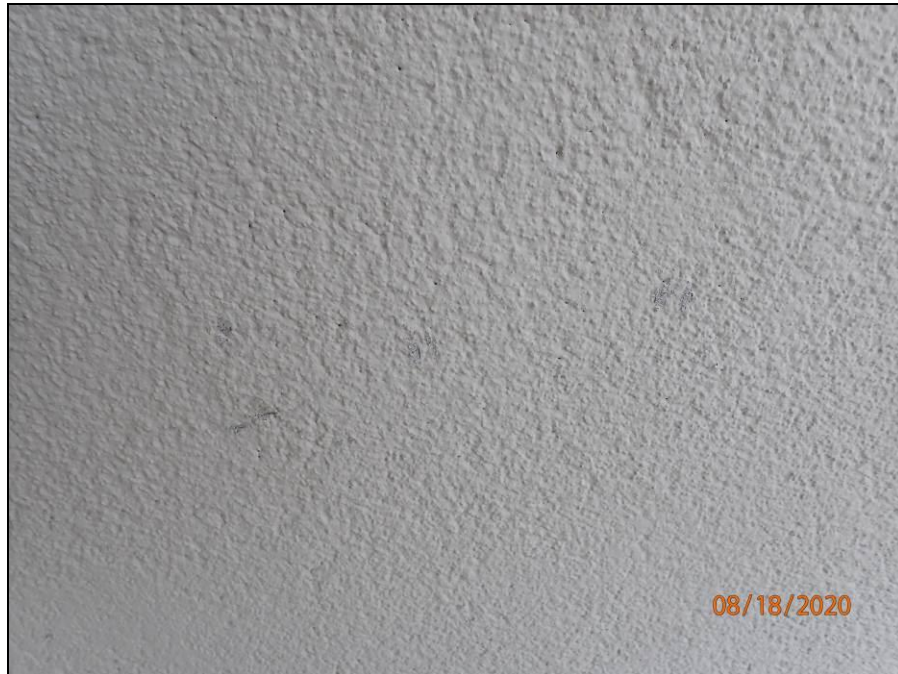
**Photograph 29**

Close-up view of typical scars/abrasions to the finish coat of the stucco on the north wall of the third floor of Tower #2.

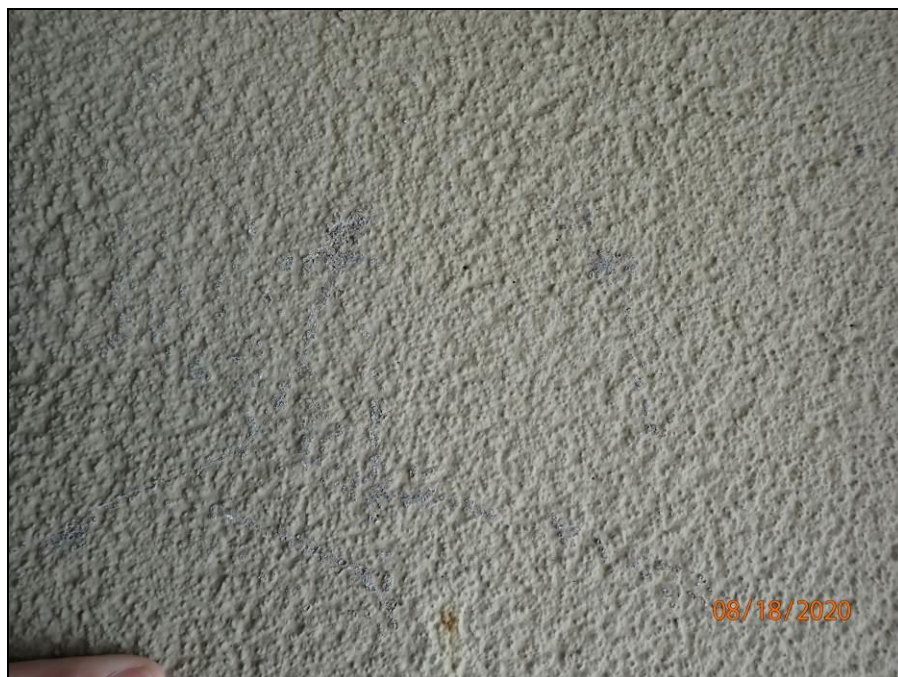
**Photograph 30**

Close-up view of typical scars/abrasions to the finish coat of the stucco on the east wall of the first floor of Tower #1.

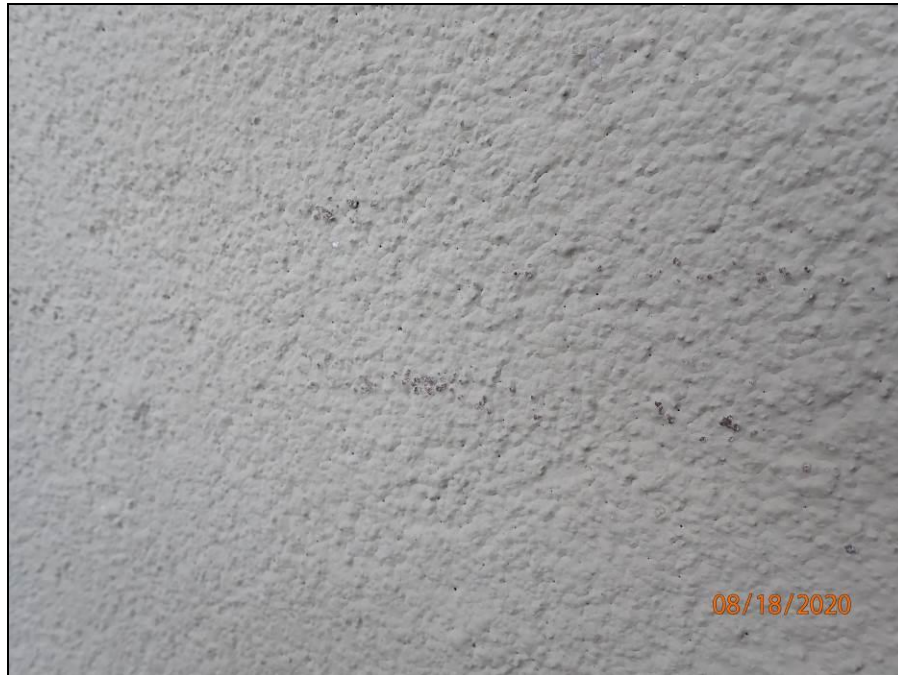
**Photograph 31**

Close-up view of typical scars/abrasions to the finish coat of the stucco on the north wall of the sixth floor of Tower #2.

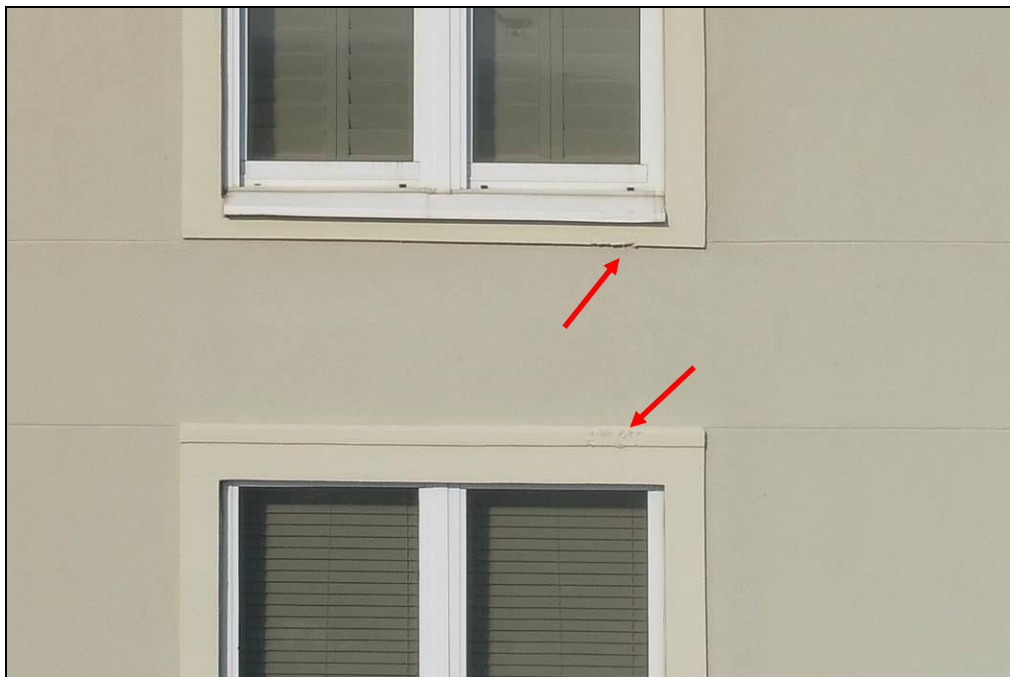
**Photograph 32**

Drone photograph of the exterior east wall of Tower #2. Note typical abrasions, chips, and scars on the stucco, as well as typical impact marks to the EIFS trim around the 14<sup>th</sup> and 15<sup>th</sup> floor windows (arrows).

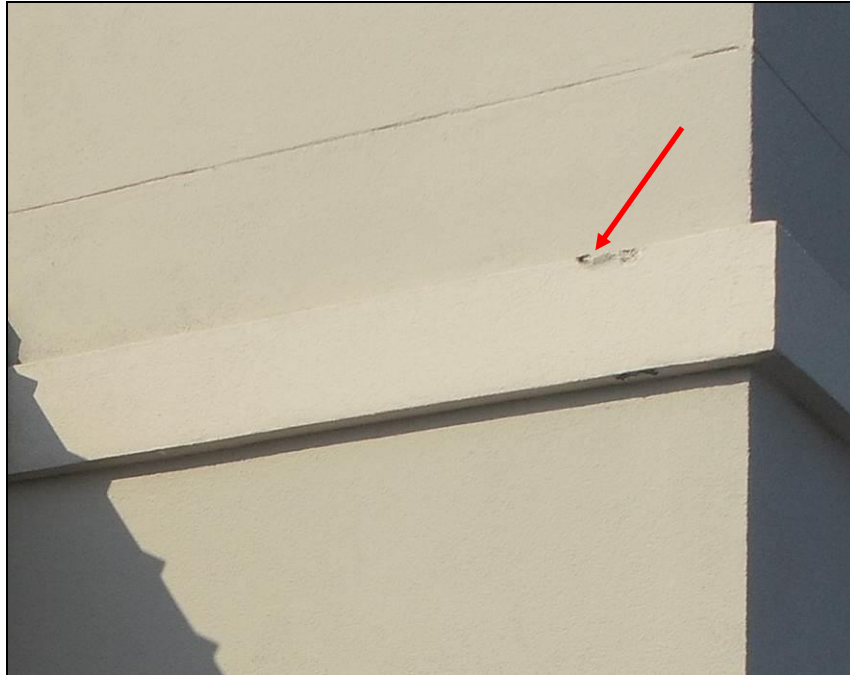
**Photograph 33**

Drone photograph of the exterior east wall of the 15<sup>th</sup> floor of Tower #2. Note typical abrasions, chips, and scars on the stucco, as well as typical impact marks to the EIFS trim (arrow).

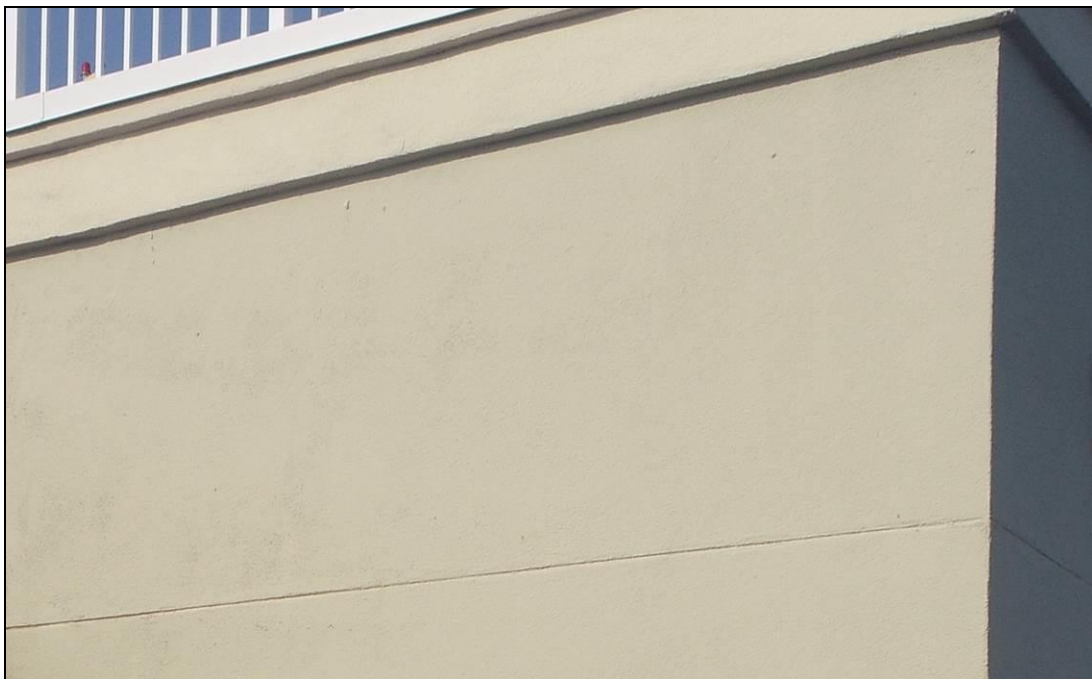
**Photograph 34**

Drone photograph of the exterior, north wall of the 13<sup>th</sup> floor of Tower #2. Note typical abrasions, chips, and scars on the stucco.
