## Report of Findings

**Grand Panama Beach Resort Hurricane Michael Damage Evaluation**

**Claim No: 4156891**

September 2, 2020

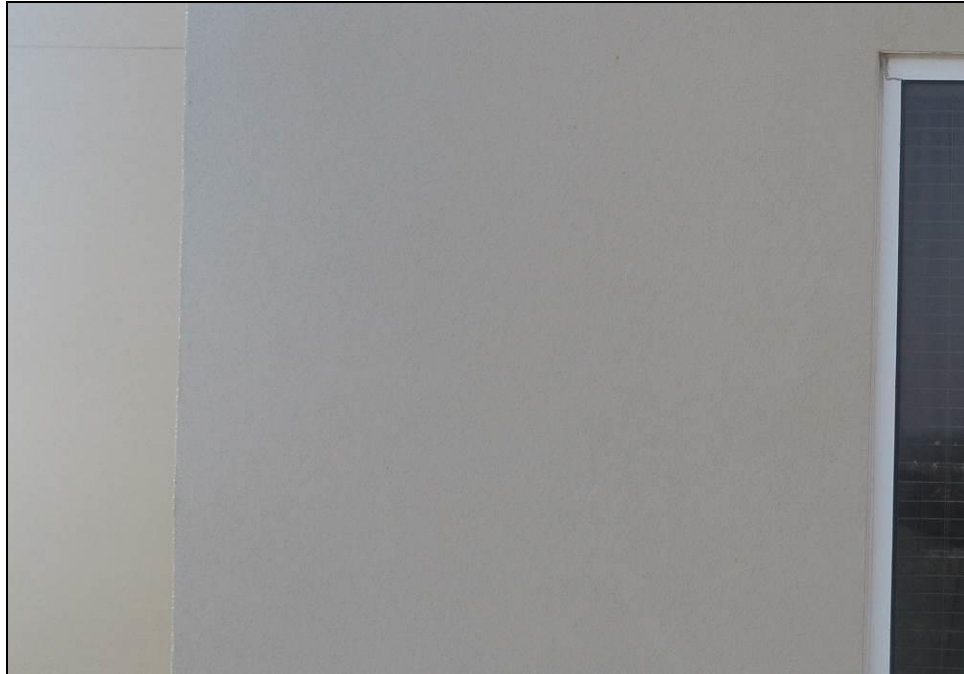
**Photograph 35**

Drone photograph of the exterior, north wall of the seventh floor of Tower #2. Note typical abrasions, chips, and scars on the stucco.

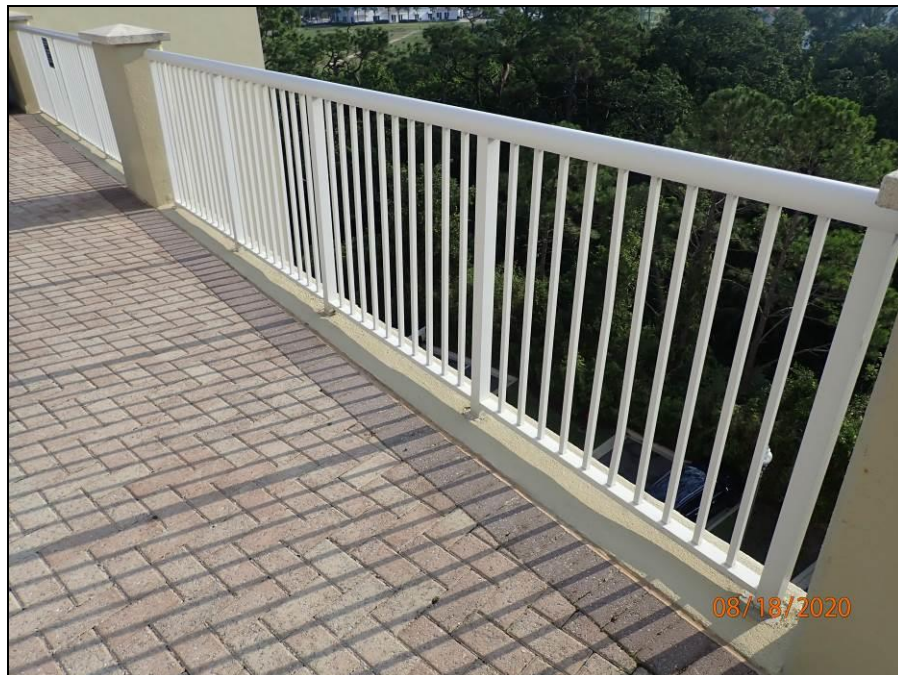
**Photograph 36**

- A guardrail existed around the perimeter of the pool deck of Tower #2 (**Photograph 36**). There were spalled/missing sections of stucco cladding and/or concrete around and adjacent to the guardrail post mounting locations throughout the pool deck of Tower #2 (**Photographs 37 through 39**). The damage was consistent with wind-borne debris impacts to the guardrails and/or wind-induced movement of the guardrail posts at their respective mounting locations on the pool deck of Tower #2. A cementitious mixture had been previously installed inside of the guardrail post mounting locations in order to re-secure the guardrails to the concrete pool deck.

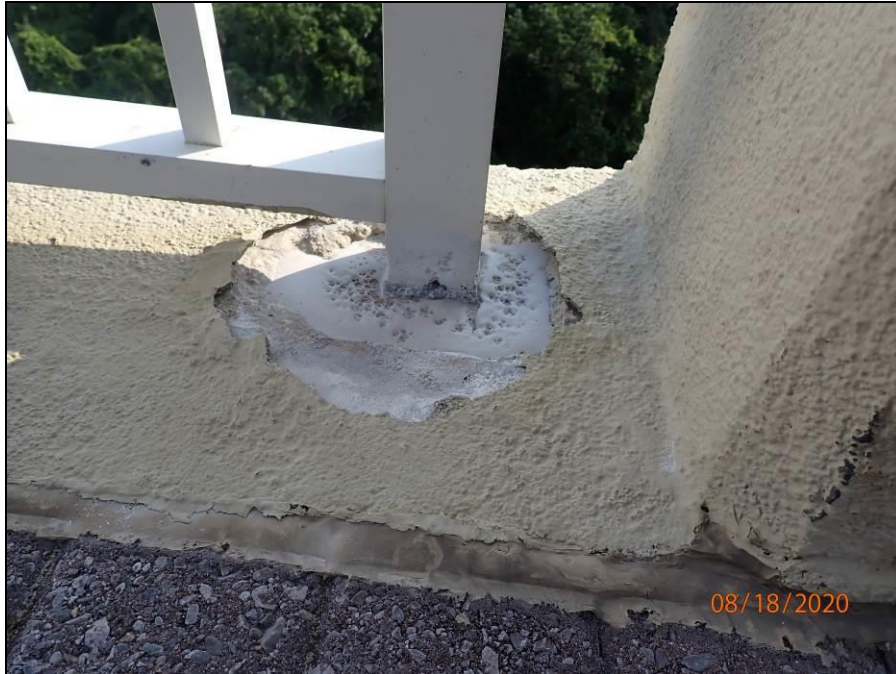
**Photograph 37**

View of a typical guardrail post mounting location on the pool deck of Tower #2. Note spalled stucco around the guardrail post mounting location.

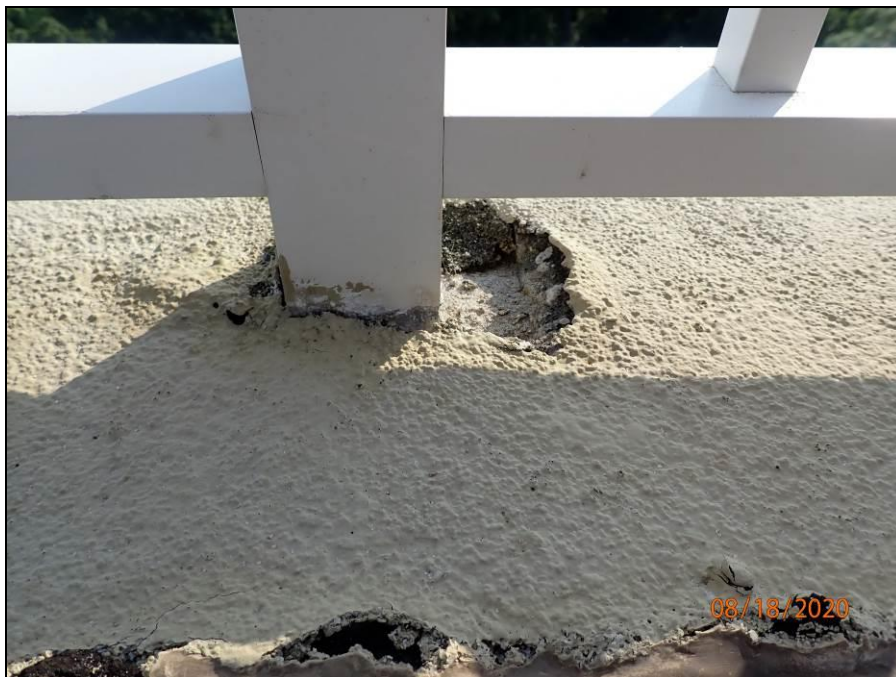
**Photograph 38**

View of a typical guardrail post mounting location on the pool deck of Tower #2. Note spalled stucco around the guardrail post mounting location.

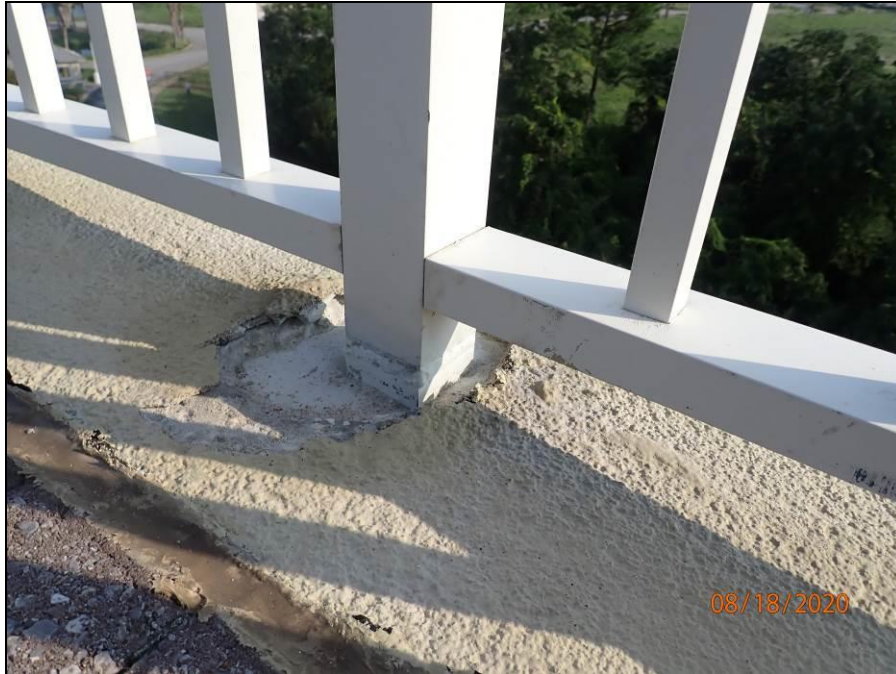
**Photograph 39**

View of a typical guardrail post mounting location on the pool deck of Tower #2. Note spalled stucco around the guardrail post mounting location.

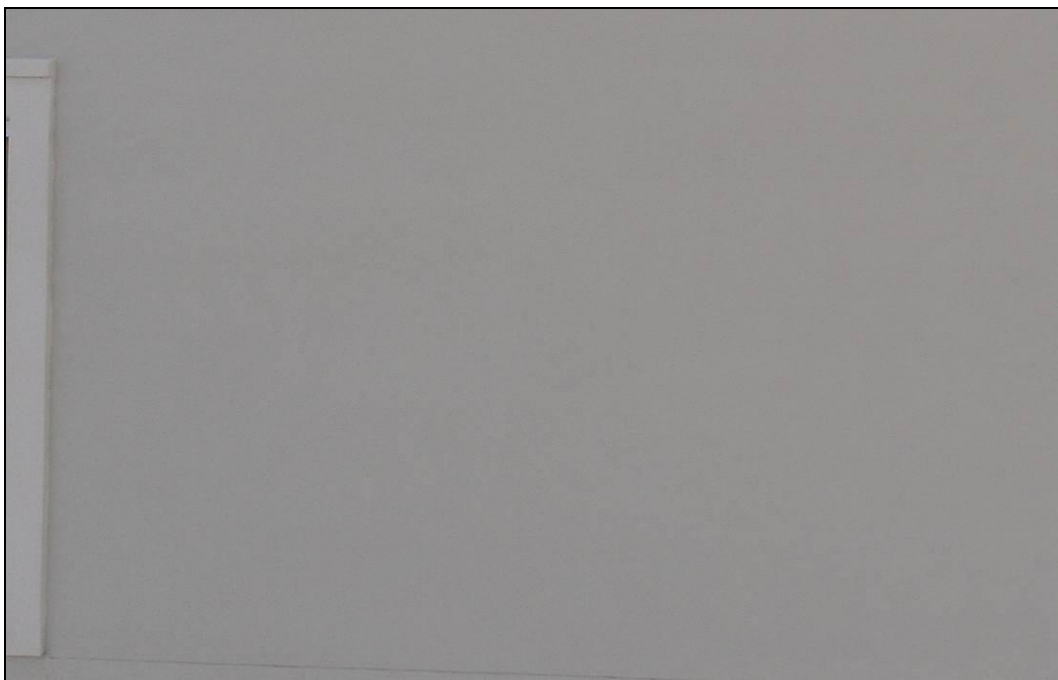
**Photograph 40**

Drone photograph of the exterior west wall of the sixth floor of Tower #2. Note typical abrasions, chips, and scars on the stucco.

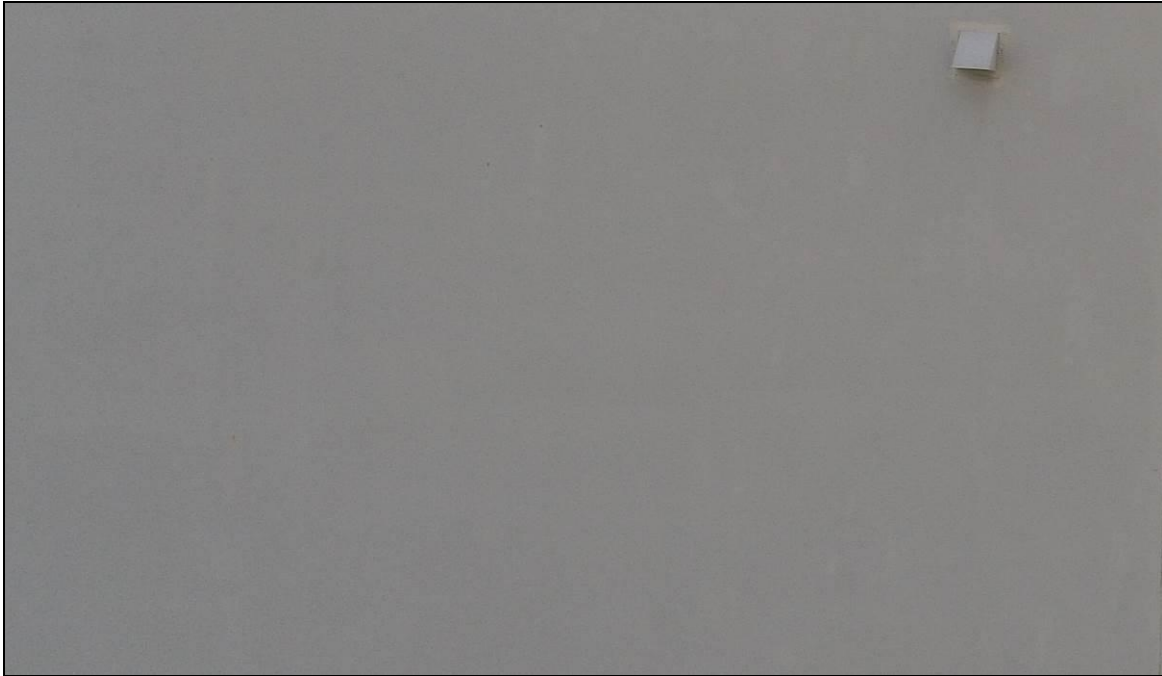
**Photograph 41**

Drone photograph of the exterior west wall of the third floor of Tower #2. Note typical abrasions, chips, and scars on the stucco.

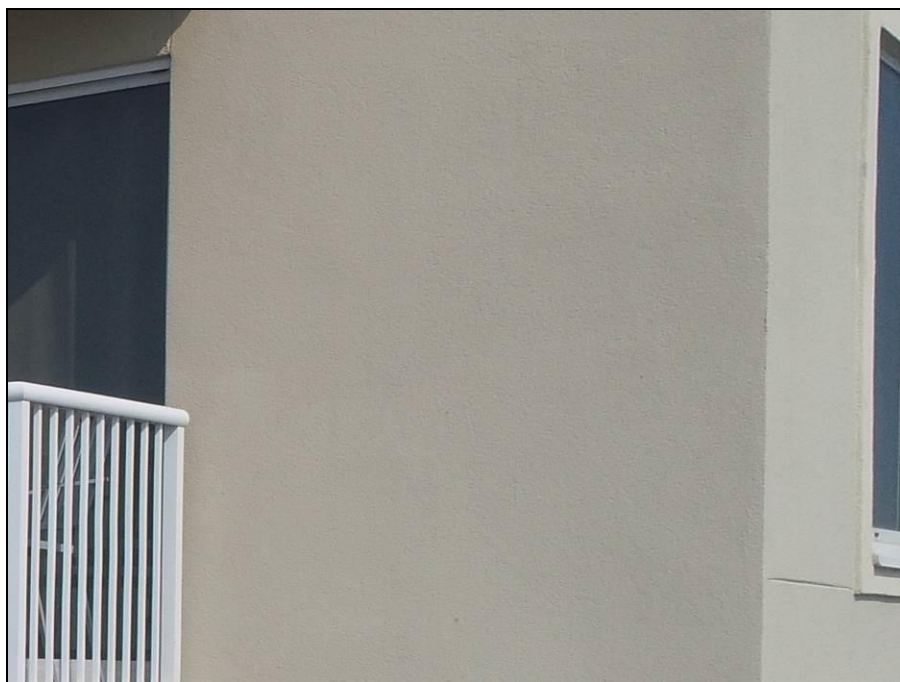
**Photograph 42**

Drone photograph of the exterior south wall of the eighth floor of Tower #2. Note typical abrasions, chips, and scars on the stucco.

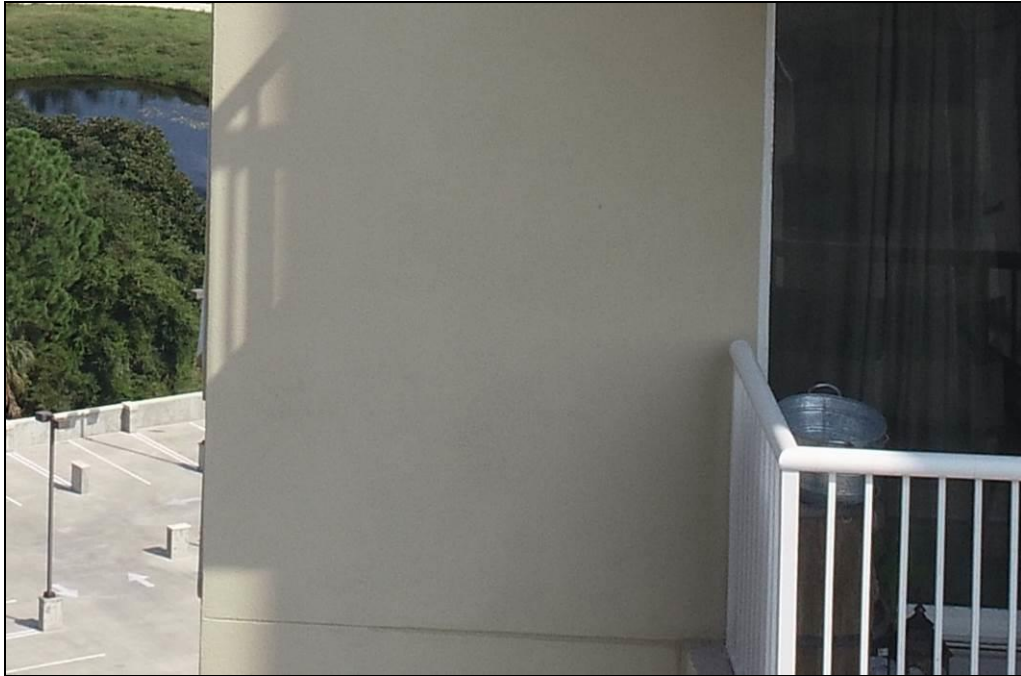
**Photograph 43**

Drone photograph of the exterior south wall of the 12<sup>th</sup> floor of Tower #2. Note typical abrasions, chips, and scars on the stucco.

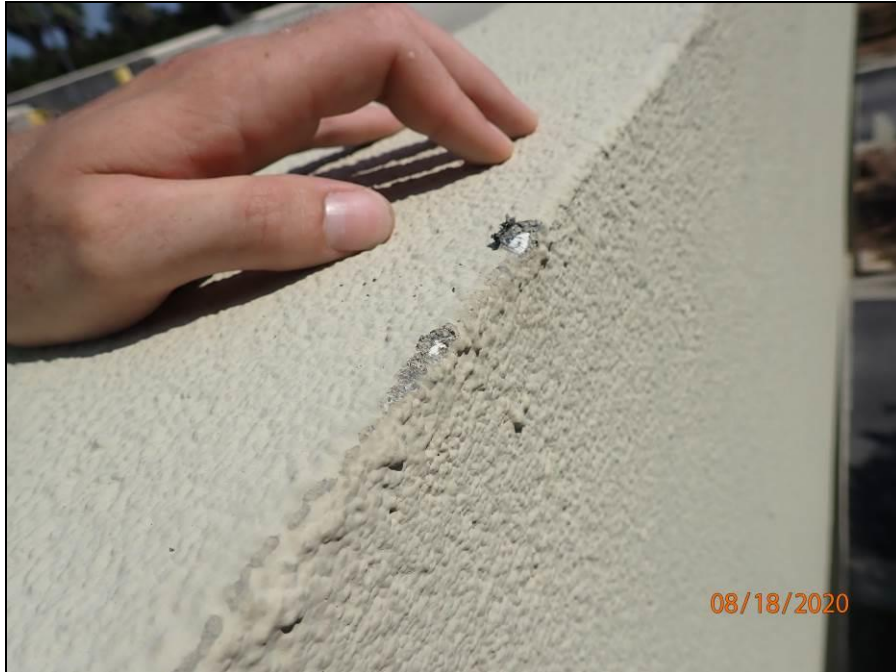
**Photograph 45**

Close-up view of typical scars/abrasions to the stucco finish coat on the east wall of the second floor of the detached parking garage.

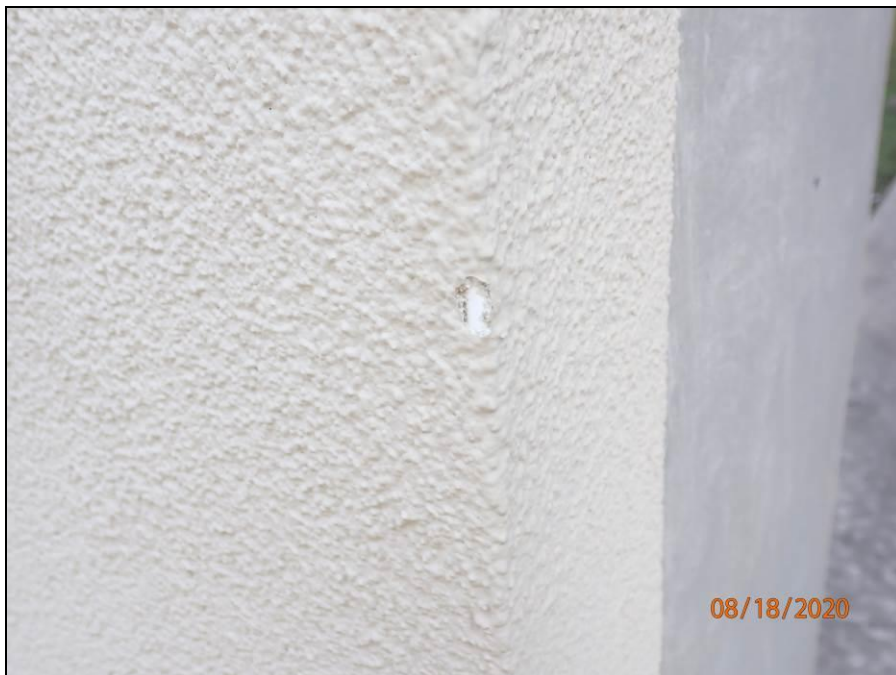
**Photograph 46**

Close-up view of a typical scar/abrasion to the stucco finish coat at the southwest corner of the first floor of the detached parking garage.

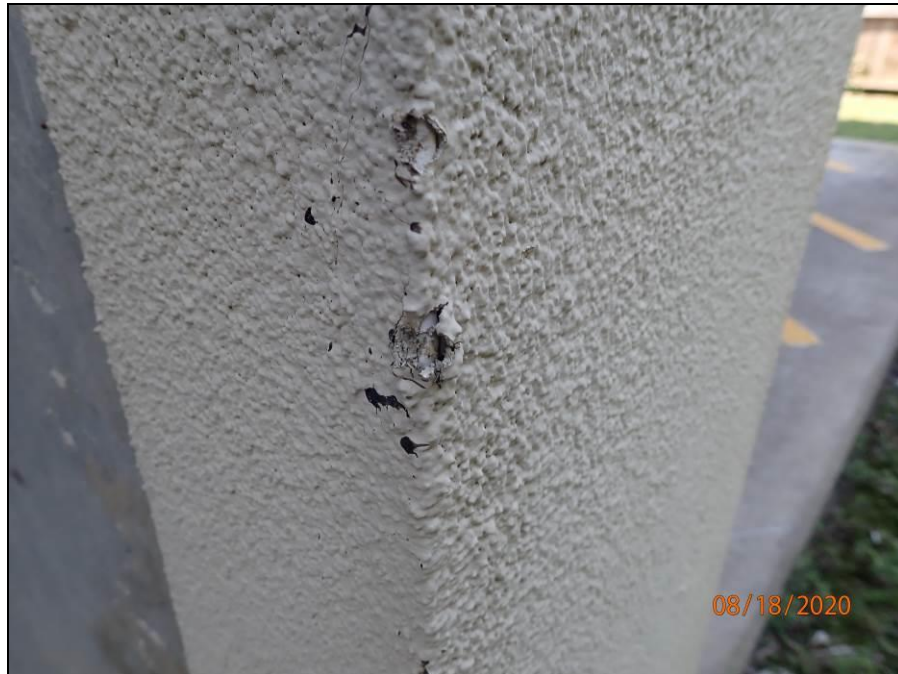
**Photograph 47**

Close-up view of typical scars/abrasions to the stucco finish coat on the south wall of the first floor of the detached parking garage.

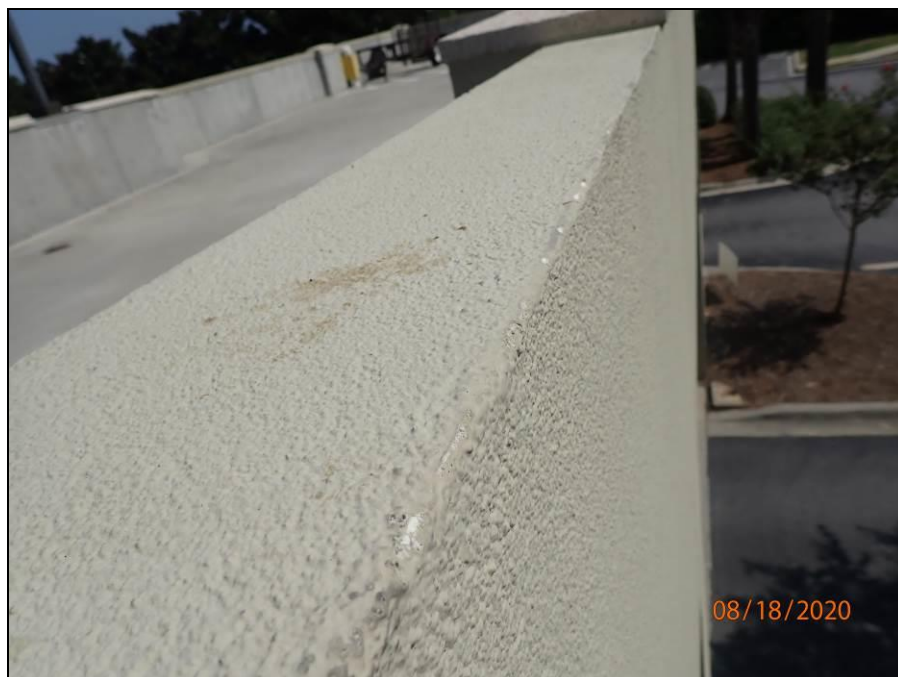
**Photograph 48**

Close-up view of typical scars/abrasions to the stucco finish coat on the east wall of the second floor of the detached parking garage.

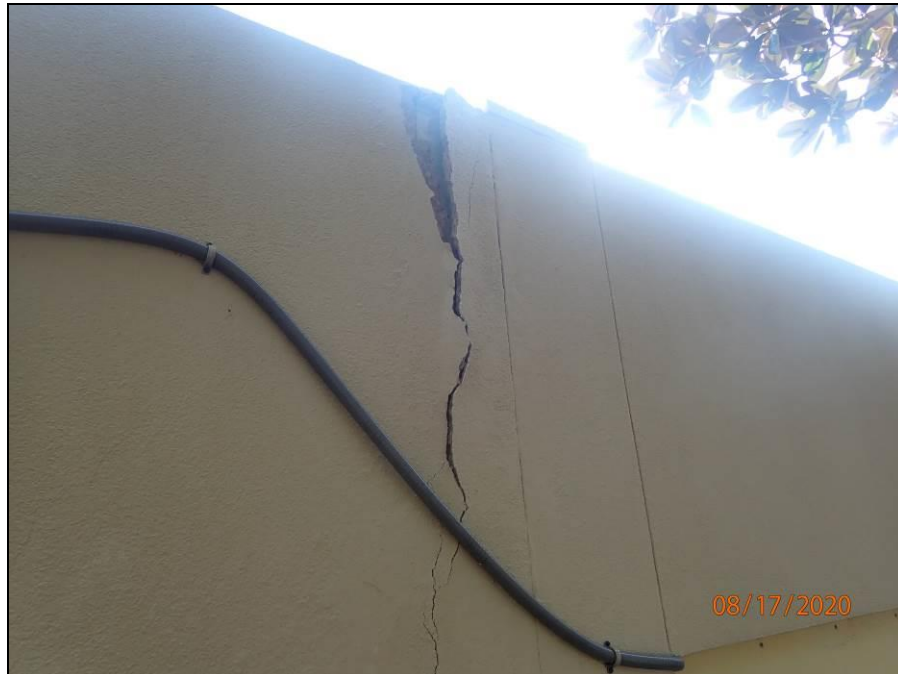
**Photograph 49**

- There was a large crack in the exterior stucco cladding, as well as outward displacement of the stucco cladding, near the approximate center of the north wall of the detached parking garage (**Photograph 49**). There was trash and debris inside of the displaced section of stucco cladding, as well as evidence of attempted prior repairs/patching to the lower portions of the crack (**Photographs 50 and 51**). There was impact damage on the lower portion of the concrete wall at the perimeter of the detached parking garage directly opposite the cracked/displaced section of stucco cladding (**Photographs 52 and 53**). The impact damage to the concrete wall was located within a garage parking space.

During our inspection of the detached parking garage located north of Tower #2, we observed a large crack in the exterior stucco cladding, as well as outward displacement of the stucco cladding, near the approximate center of the north wall of the garage building. There were trash and debris inside of the displaced section of stucco cladding, as well as evidence of attempted prior repairs/patching to the lower portions of the crack; indications that the crack had existed for some time. Upon inspection of the opposite side of the crack, we observed that there was visible impact damage on the lower portion of the concrete wall at the perimeter of the detached parking garage directly opposite the cracked/displaced section of stucco cladding. The impact damage to the concrete wall was located within a parking space for the detached parking garage and was consistent with impact from a vehicle attempting to enter the parking space at this location.

View of the cracked/displaced section of stucco cladding near the approximate center of the north wall of the detached parking garage.

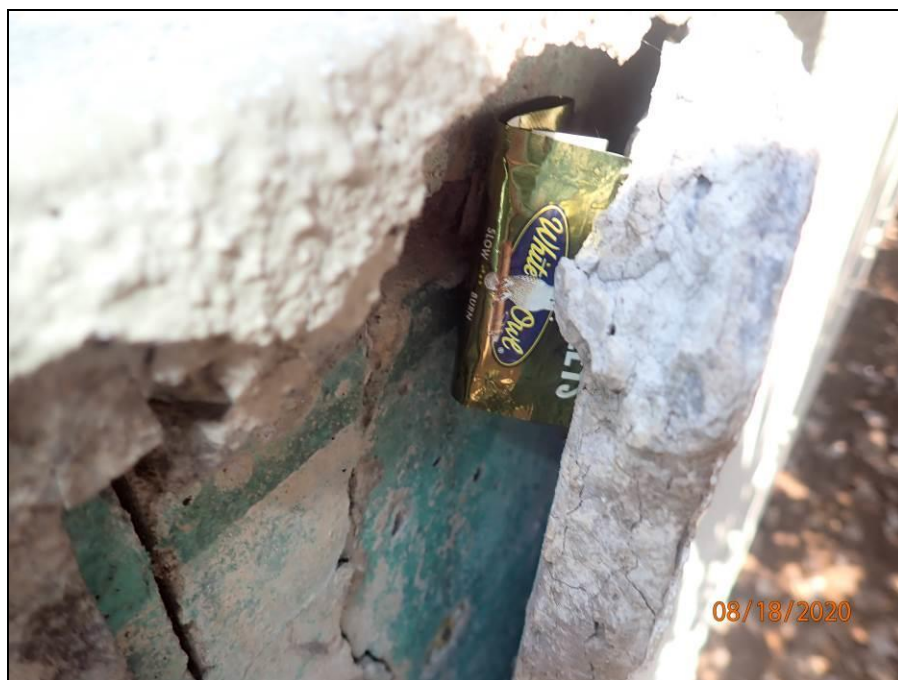
**Photograph 50**

View inside of the displaced section of stucco cladding shown in **Photograph 49**. Note trash inside of the displaced section of stucco cladding.

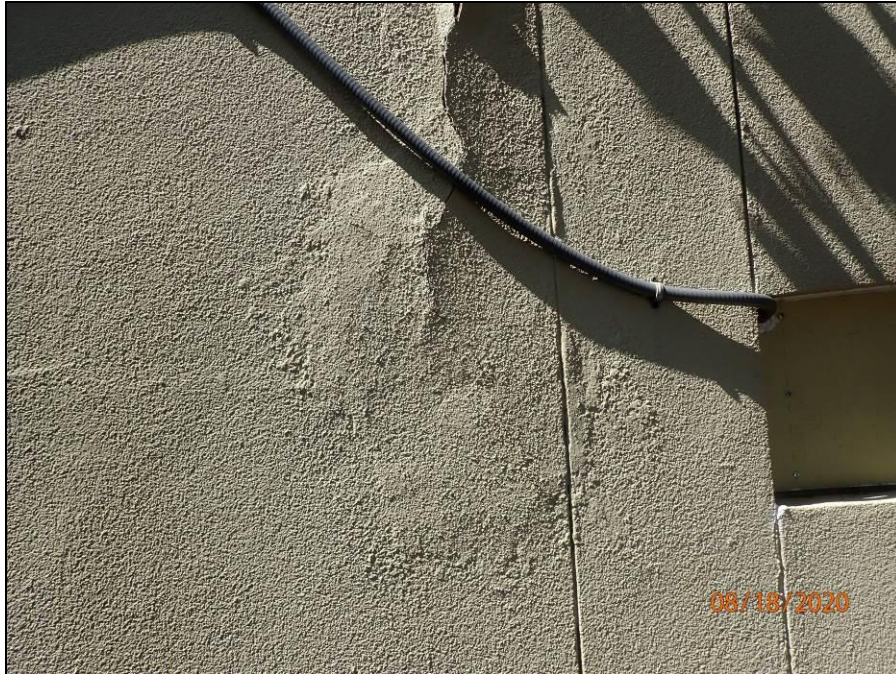
**Photograph 51**

View of the bottom of the cracked/displaced section of stucco cladding shown in **Photograph 49**. Note prior patch/repair to the bottom of the crack.

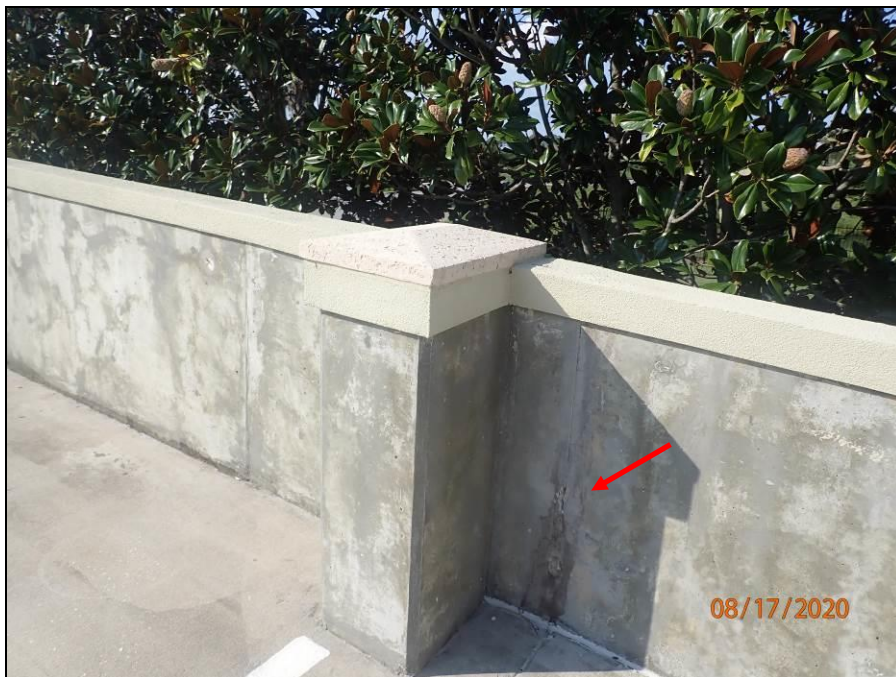
**Photograph 52**

View of the north wall of the detached parking garage directly opposite the cracked/displaced section of stucco cladding shown in **Photograph 49**. Note impact mark to the concrete wall within the parking space (arrow).

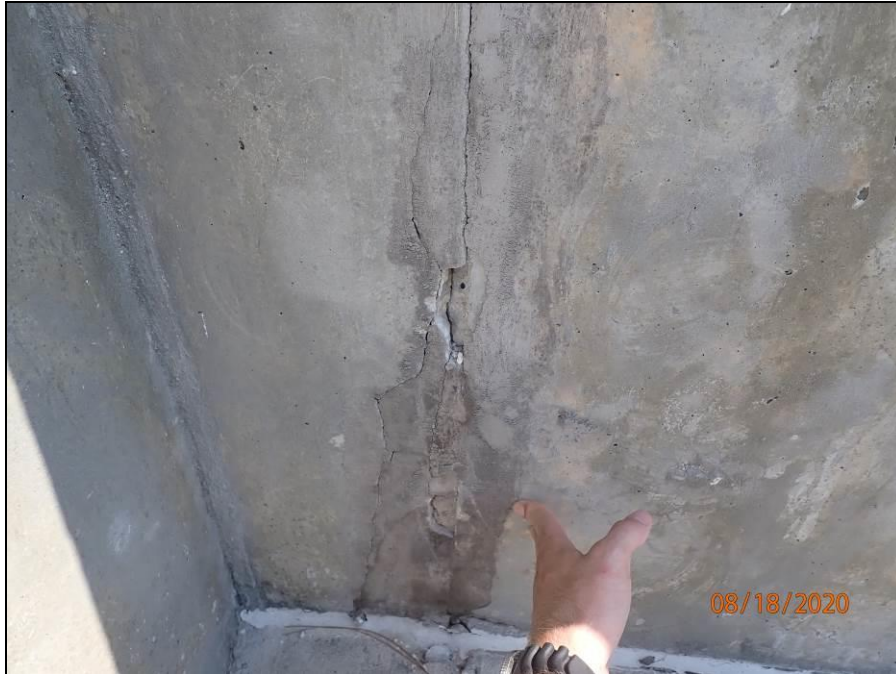
**Photograph 53**

Close-up view of the impact damage to the north wall of the detached parking garage shown in **Photograph 52**.
