MKA PHOTO RECORD

GRAND PANAMA BEACH RESORT CONDO ASSOCIATION

MKA PROJECT NO. 2020.2295

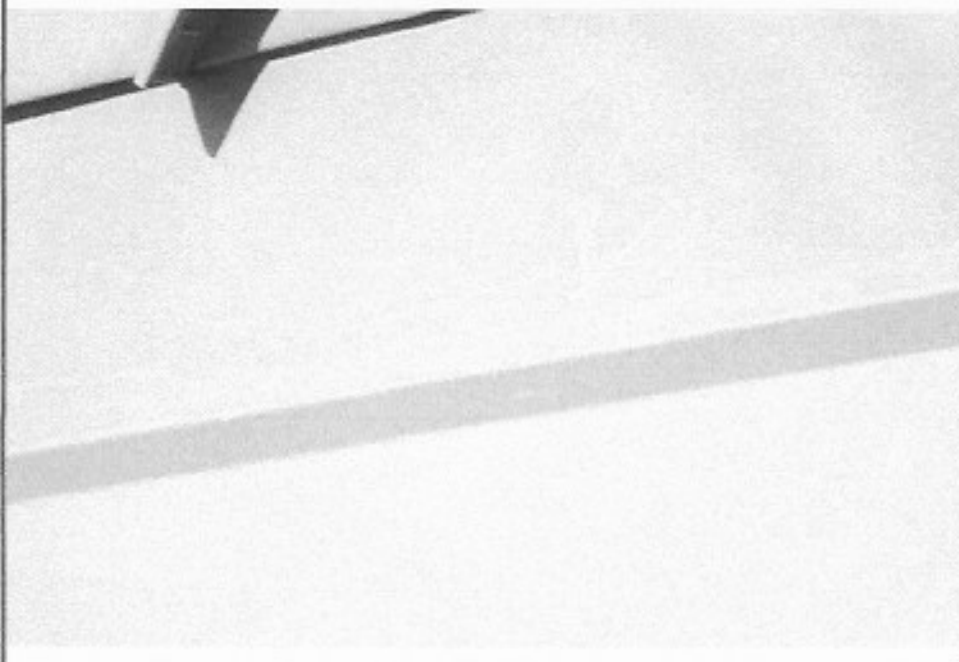
<p>PHOTO # 19</p>
	<p>PHOTO BY ACM</p>
	<p>PHOTO DATE August 17, 2020</p>

LOCATION:	Roof
COMMENTS:	Surface scraping to panel
NOTES:

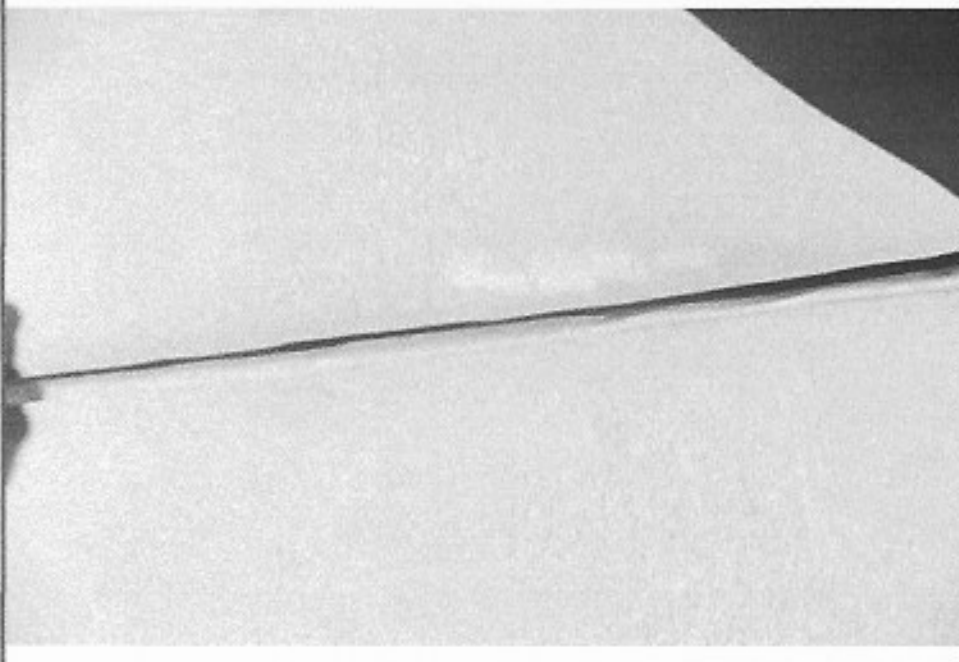
<p>PHOTO # 20</p>
	<p>PHOTO BY ACM</p>
	<p>PHOTO DATE August 17, 2020</p>

LOCATION:	Roof
COMMENTS:	Surface scraping to panel
NOTES:	Deformation in panel seam

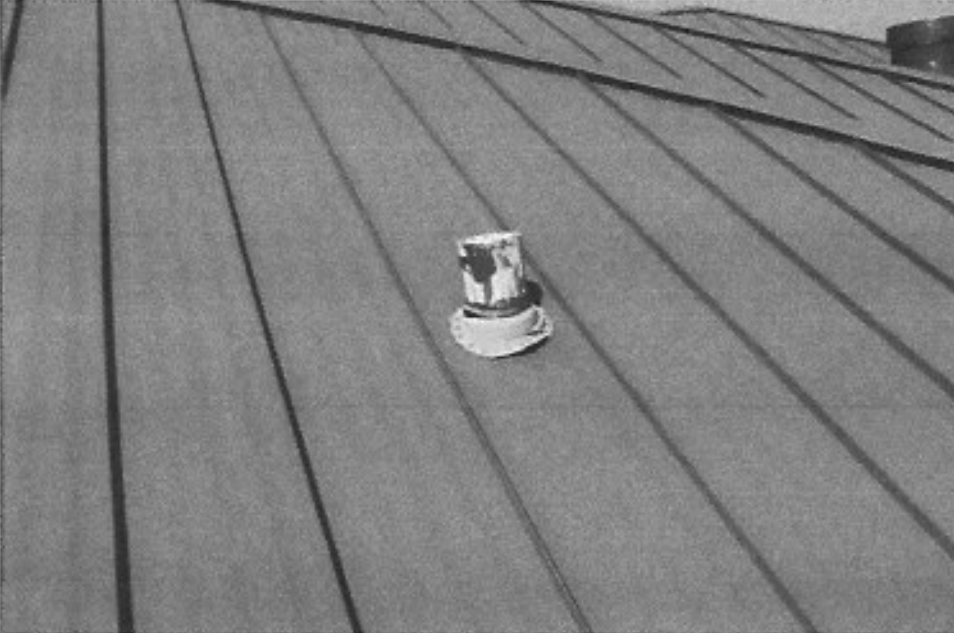
PHOTO # 21
	PHOTO BY ACM
	PHOTO DATE August 17, 2020

LOCATION:	North Tower
COMMENTS:	Unsecured flashing
NOTES:

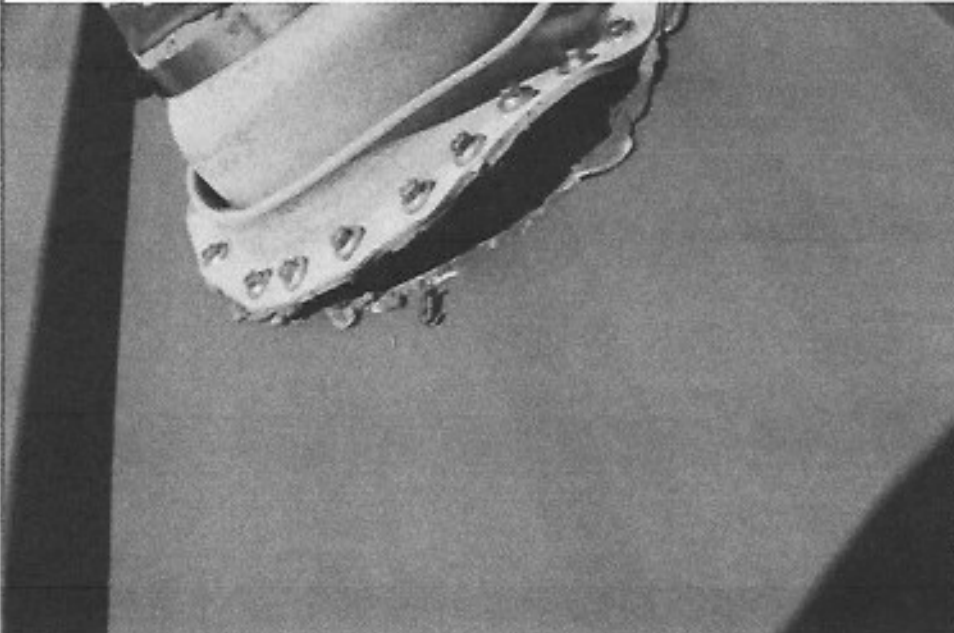
PHOTO # 22
	PHOTO BY ACM
	PHOTO DATE August 17, 2020

LOCATION:	North Tower
COMMENTS:	Unsecured flashing
NOTES:

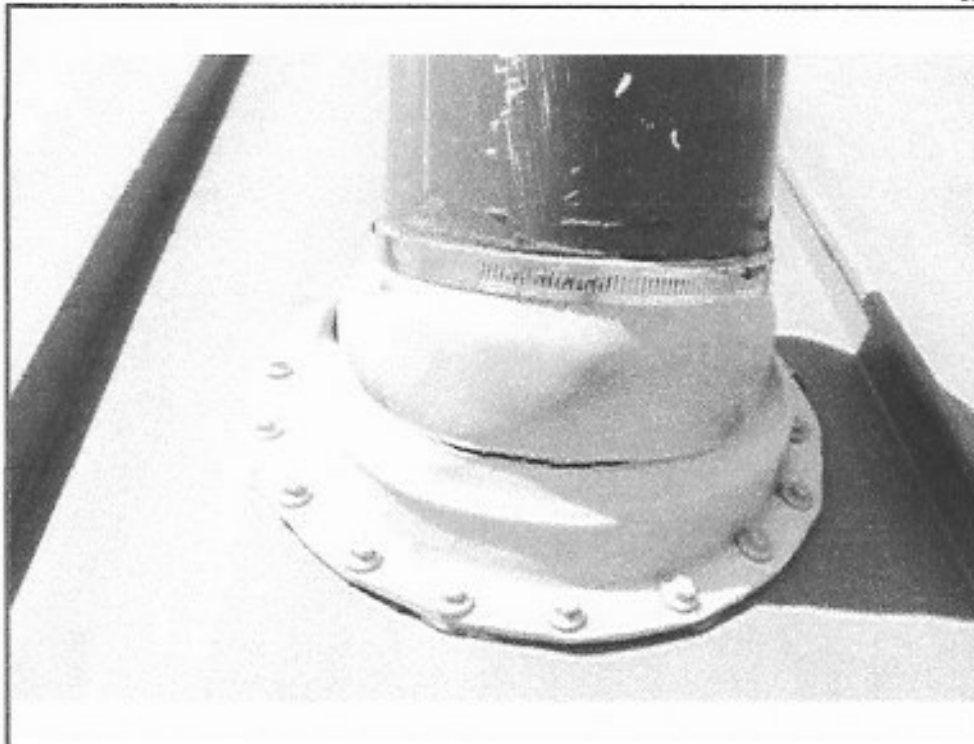
PHOTO #
23

LOCATION: South Tower
COMMENTS: Tear in flashing
NOTES:

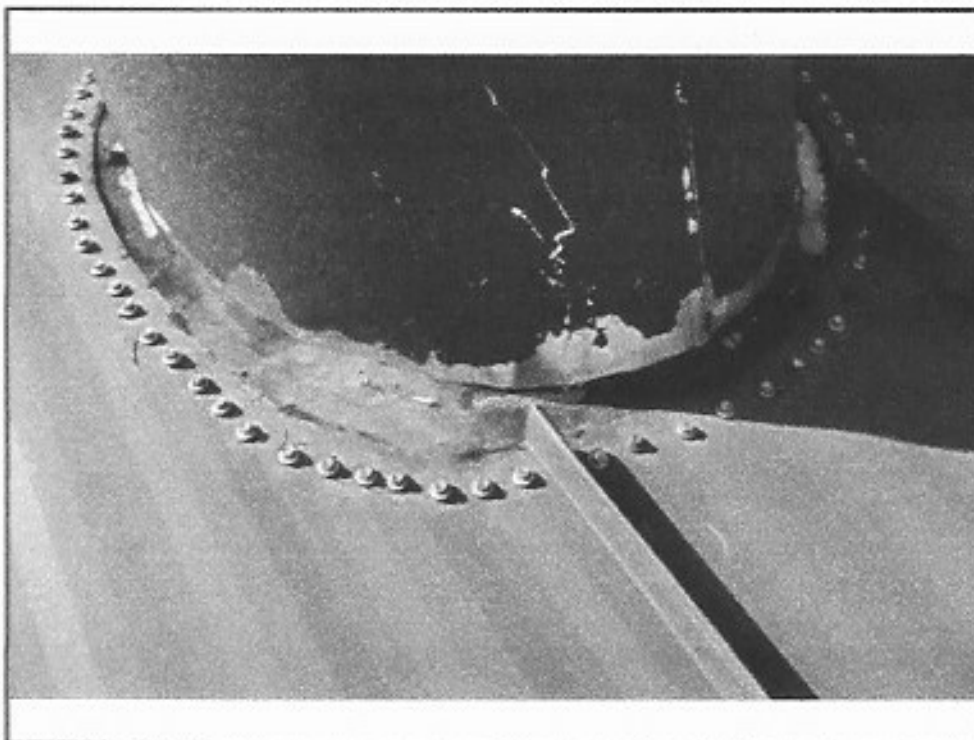
PHOTO #
24

LOCATION: Roof
COMMENTS: Improper pipe flashing
NOTES:

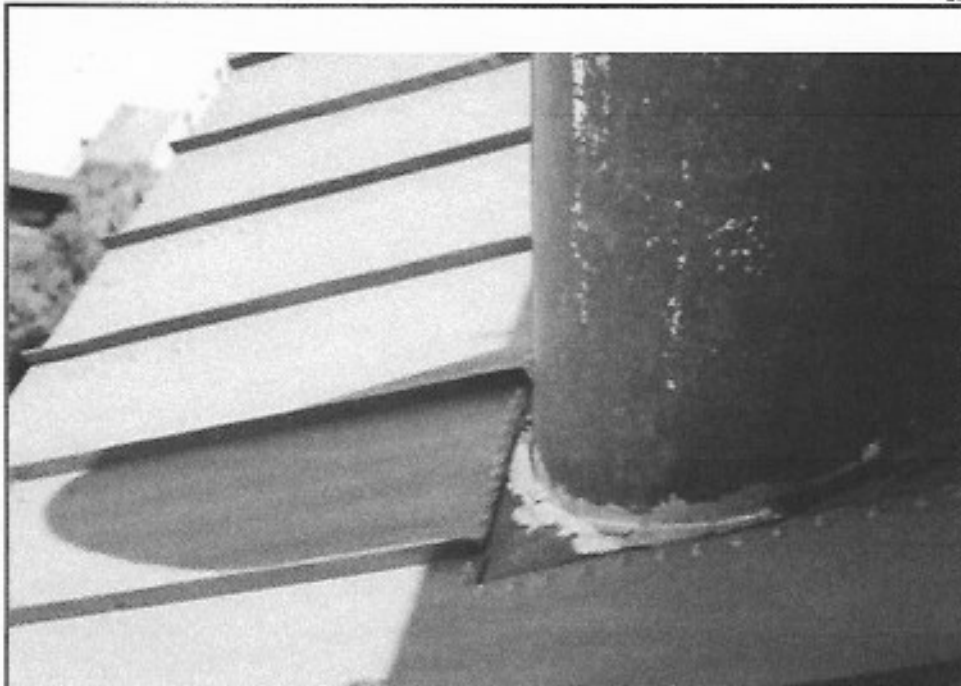
25

LOCATION: Roof**COMMENTS:** Improper pipe flashing**NOTES:**

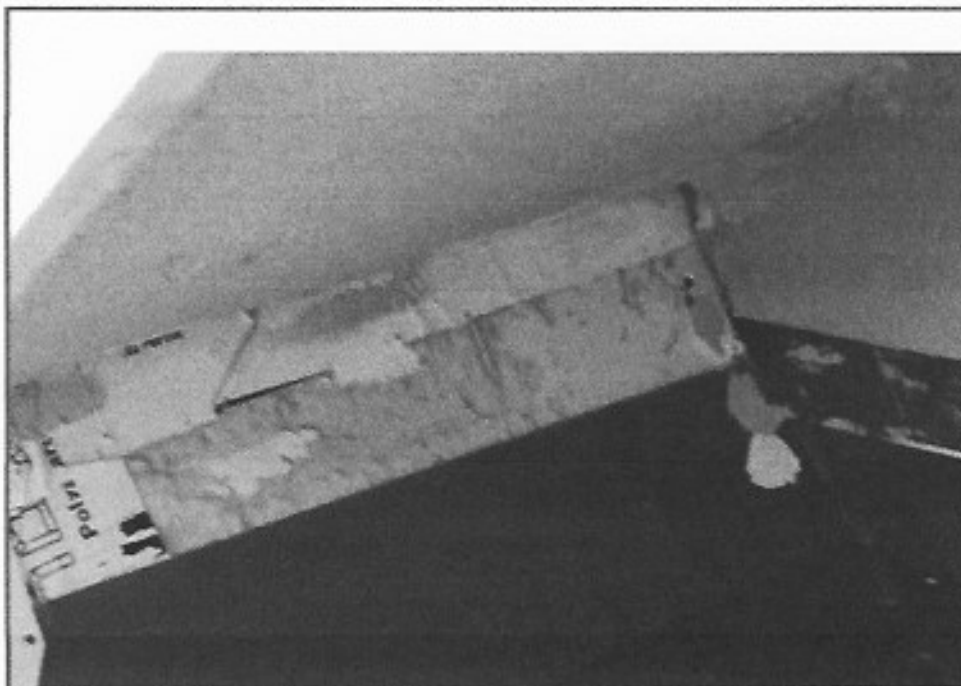
26

LOCATION: Roof**COMMENTS:** Incomplete roof system at sidewall/rafter flashing**NOTES:**

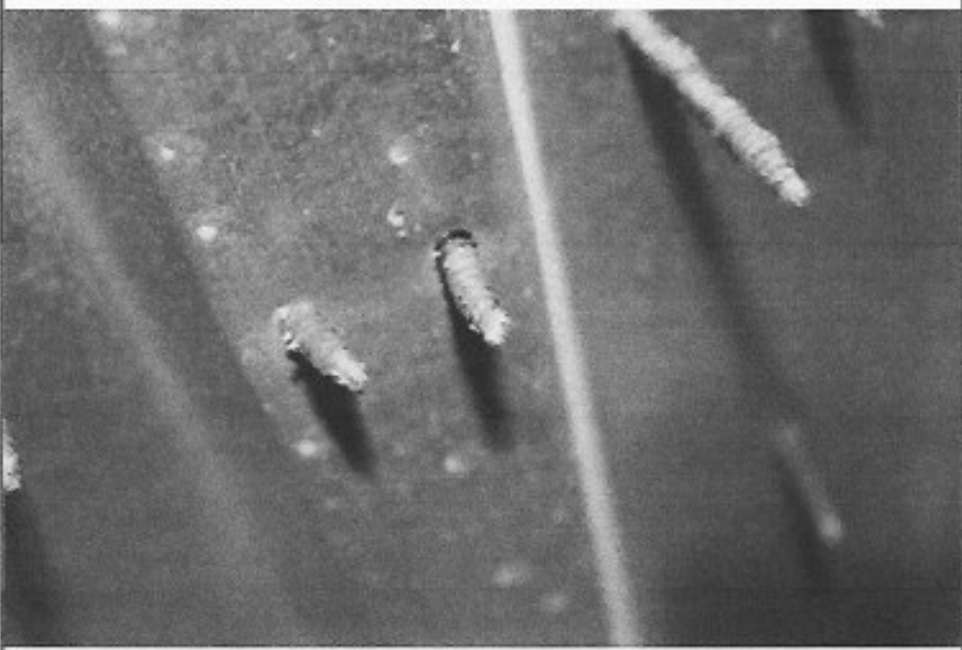
PHOTO # 27
	PHOTO BY ACM
	PHOTO DATE August 17, 2020
LOCATION: Attic	
COMMENTS: View of fasteners	
NOTES:

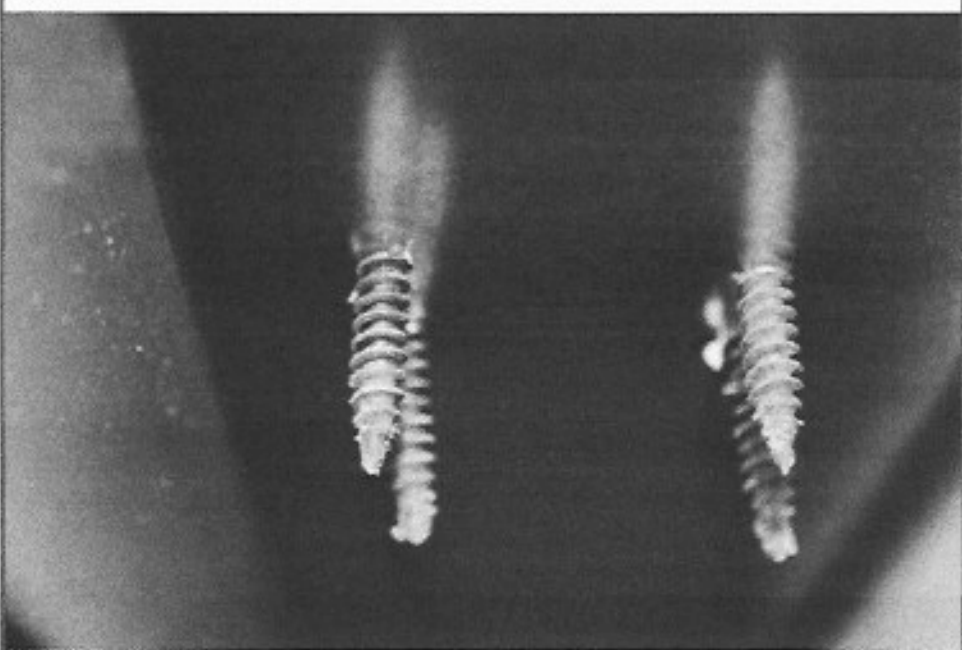
PHOTO # 28
	PHOTO BY ACM
	PHOTO DATE August 17, 2020
LOCATION: Attic	
COMMENTS: View of fasteners	
NOTES:

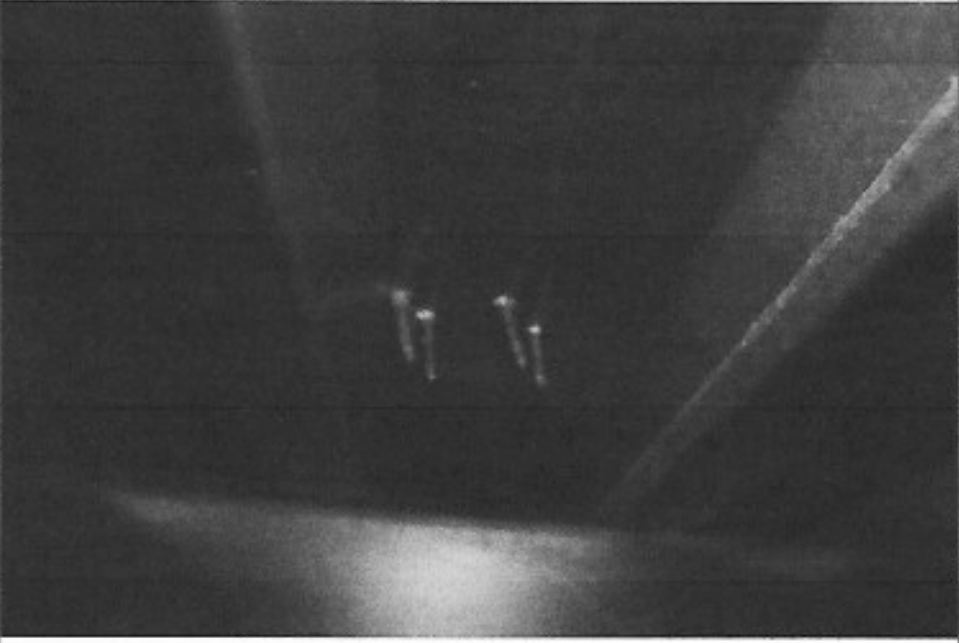
<p>PHOTO # 29</p>						
	<p>PHOTO BY ACM</p>						
	<p>PHOTO DATE August 17, 2020</p>

<table><tr> <td style="width: 15%;">LOCATION:</td> <td>Attic</td> </tr><tr> <td>COMMENTS:</td> <td>View of fasteners</td> </tr></table>

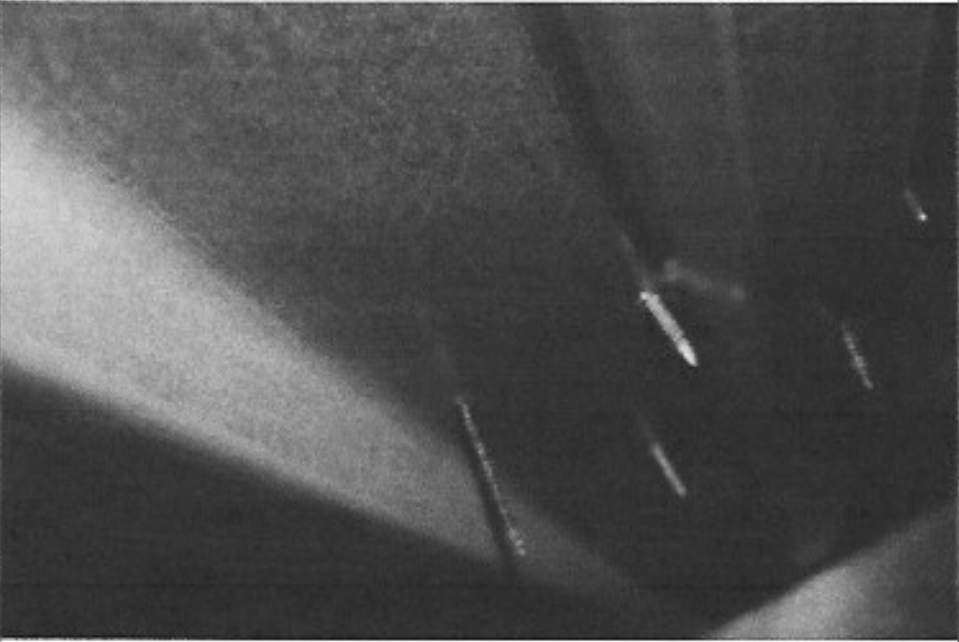
<p>PHOTO # 30</p>						
	<p>PHOTO BY ACM</p>						
	<p>PHOTO DATE August 17, 2020</p>

<table><tr> <td style="width: 15%;">LOCATION:</td> <td>Attic</td> </tr><tr> <td>COMMENTS:</td> <td>View of fasteners</td> </tr></table>

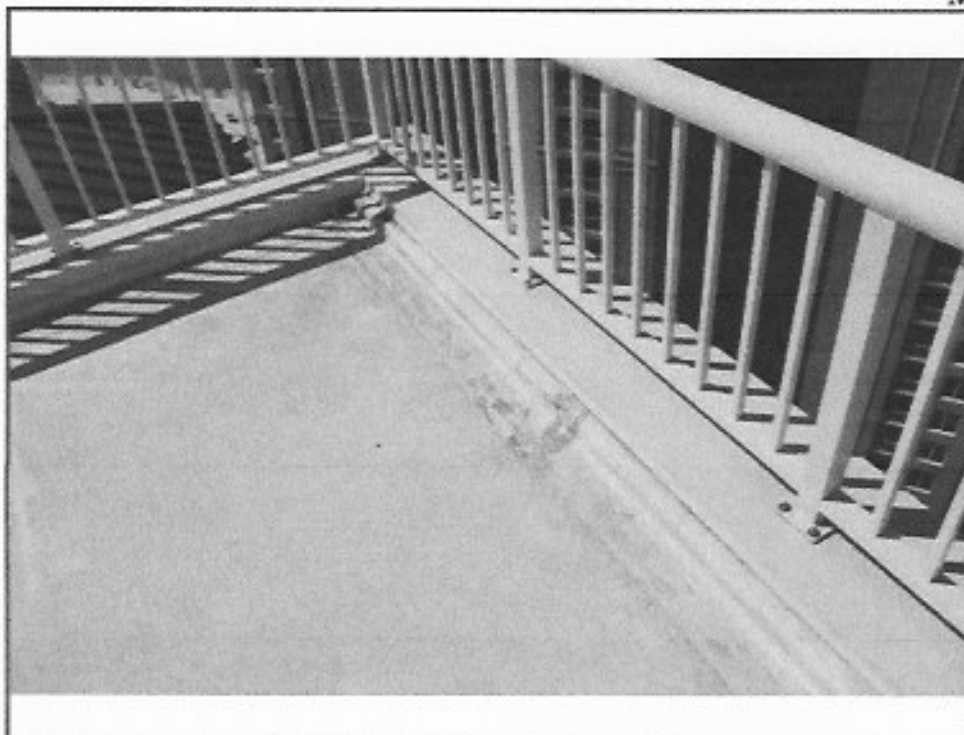
PHOTO #
31

LOCATION:	Attic
COMMENTS:	View of low slope roof area
NOTES:

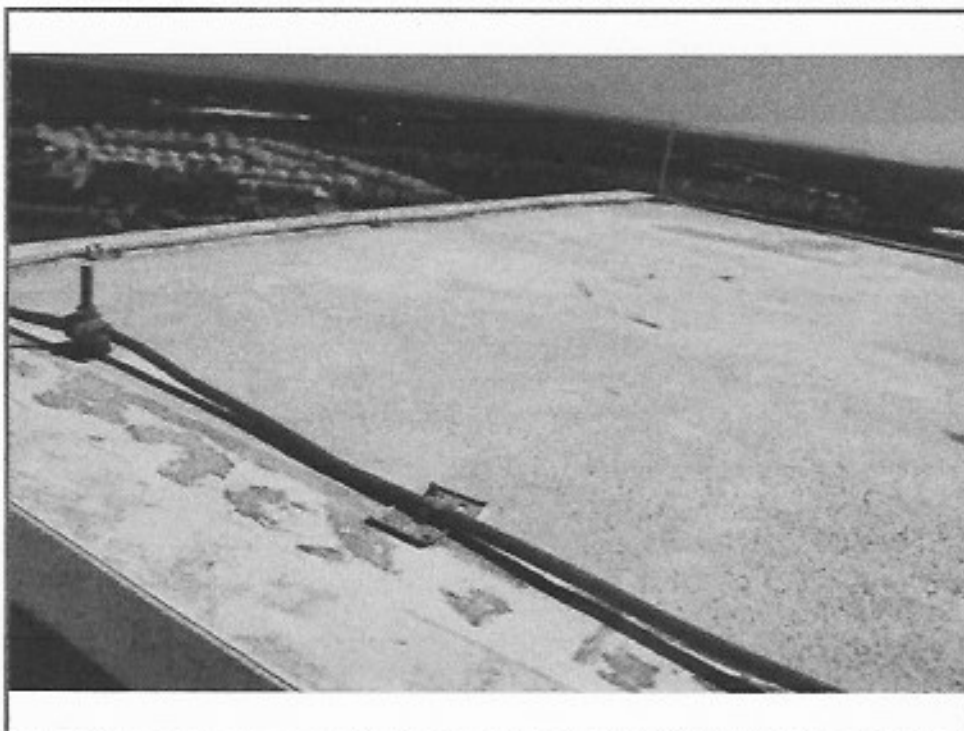
PHOTO #
32

LOCATION:	Attic
COMMENTS:	View of low slope roof area
NOTES:

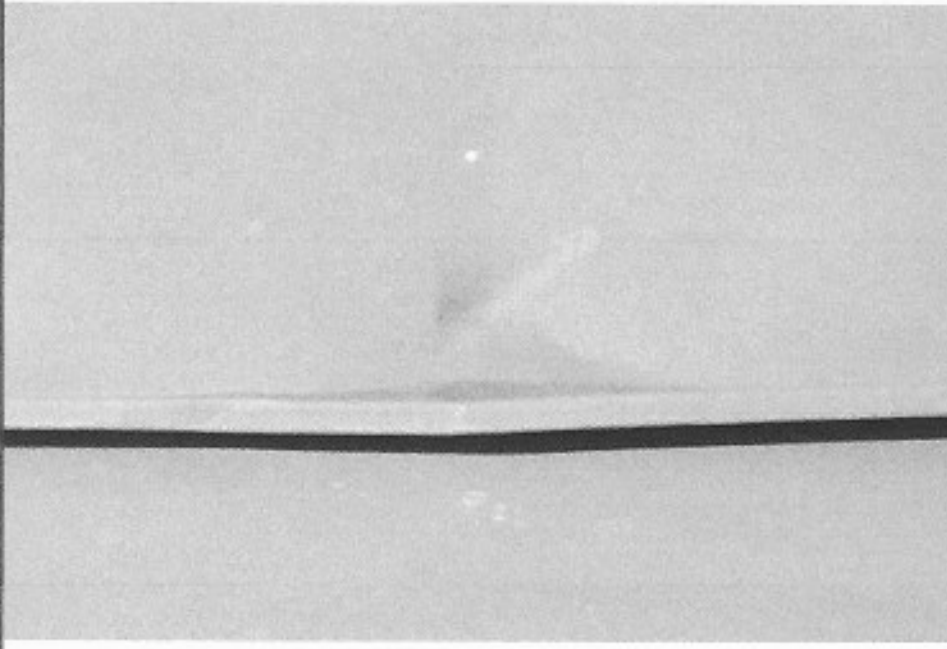
<p>PHOTO # 33</p>
	<p>PHOTO BY ACM</p>
	<p>PHOTO DATE August 17, 2020</p>

LOCATION:	Walkway
COMMENTS:	Debris impact at walkway roof area
NOTES:
