August 23, 2024

Project: **Grand Panama Condominium
Panama City Beach, FL**

Regarding: **Abbreviated Exterior Condition Survey – Skybridge**

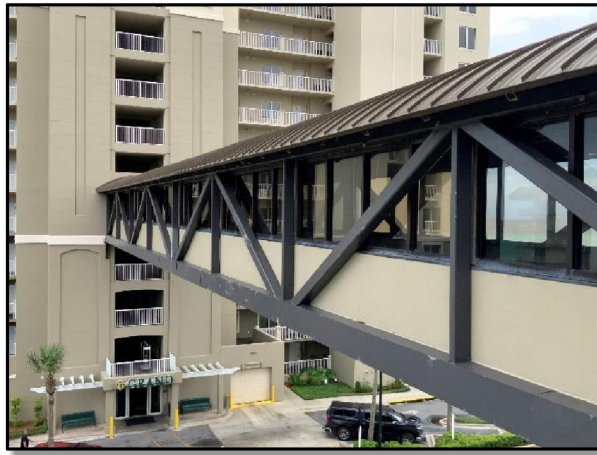
Figure 2.1.1 – Grand Panama - Skybridge

- 2.1 Upon arriving on-site, Derek Gilbert, CAM, provided general information about the Skybridge and recent projects. Mr. Gilbert informed BECI that the parking garage immediately adjacent to the Skybridge had recently undergone a restoration project in which the workmanship from the General Contractor was still under warranty. BECI observed the Skybridge to consist of a hollow steel section (HSS) superstructure with a corrugated steel roof deck and walking surface deck. BECI observed the Skybridge to be connected to the building by way of steel attachment brackets at the North and South Ends of the bridge. BECI observed the Skybridge roof to consist of standing seam metal roof panels (Reference Figure 2.1.1 and Photo Exhibit Nos. 1 through 4).

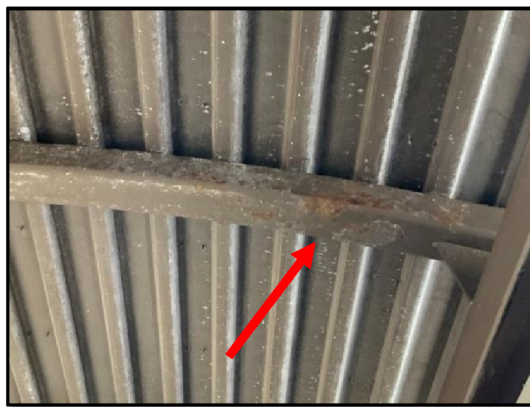
- 2.2 BECI began our observations at the **steel framing and columns** from the interior side of the Skybridge, as well as beneath the bridge. BECI observed the steel framing and columns to be in fair condition overall. BECI observed coating failure and surface corrosion to be typical at the steel bracing, columns, steel angle window attachment brackets, the Skybridge attachment brackets below the bridge, and roof purlins throughout the Skybridge assembly (Reference Figure 2.2.1 and Photo Exhibit Nos. 5 through 11). BECI did not observe any section loss of the steel framing components at areas of corrosion at the time of the inspection. However, if left unaddressed, corrosion will continue to deteriorate, eventually leading to section loss in the steel members, which can compromise the structural integrity of the Skybridge structure.

Figure 2.2.1 – Close-up view of failed coating and corrosion at steel roof purlin.

- 3.1 BECI recommends that all corrosion, oxidation, and existing coatings at all steel framing members, columns, decking, and steel attachment brackets be removed until bright steel is observed. BECI recommends that new high-performance marine-grade coatings be applied to all steel components to prevent further corrosion and deterioration within the next 12-18 months. BECI also recommends that adjacent concrete surfaces be repaired and waterproofed within the next 12-18 months in conjunction with the application of new metal coatings and removal and replacement of existing sealants.

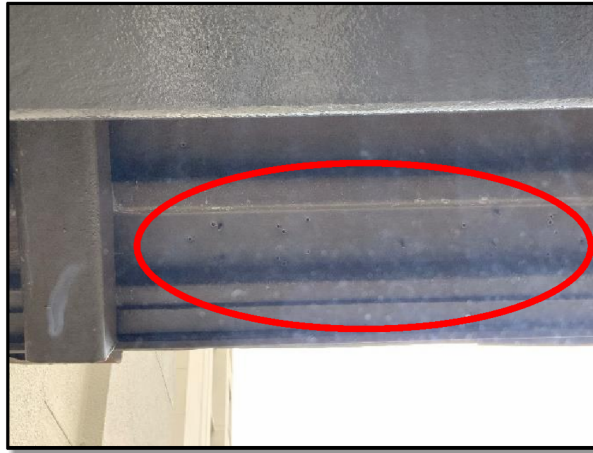
- 2.3 BECI also observed the **steel decking** at both the roof deck and walking surface deck to be in fair condition overall. BECI observed failed coatings and surface corrosion to be typical throughout the steel roof deck (Reference Photo Exhibit Nos. 12 and 13). BECI also observed an isolated area of abandoned fastener penetrations in the steel roof deck at the South End of the West Elevation, near the eave of the Skybridge roof (Reference Figure 2.3.1 and Photo Exhibit No. 14). Abandoned fastener penetrations, if left unaddressed, can allow the salt air from the coastal environment to prematurely deteriorate and corrode the surrounding steel roof deck.

Figure 2.3.1 – Roof Deck – Overall view of abandoned fastener penetrations.

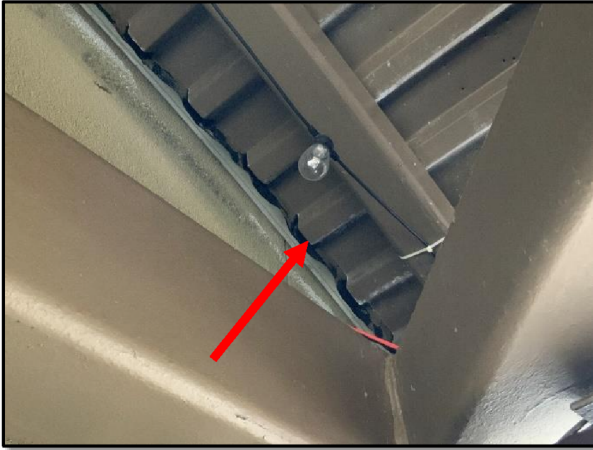
- 2.4 BECI observed the metal roof panels at the Skybridge to be in fair condition overall, at the time of the survey. BECI observed areas of what appeared to be impact or hail damage to be typical across the roof (Reference Photo Exhibit Nos. 15 and 16). BECI observed that the roofing underlayment was terminated below at the roof deck and was visible at the interior of the Skybridge near the South entrance, indicating that the roofing underlayment was not turned vertically up the wall behind the flashing, not in conformance with NRCA Roofing Standards (Reference Figure 2.4.1 and Photo Exhibit Nos. 17 and 18). BECI observed headwall flashing at the South end of the Skybridge roof had been sealed at the cladding level, sealing the drainage plane of the cladding assembly (Reference Figure 2.4.2 and Photo Exhibit Nos. 19 and 20). It should be noted that no leaking was reported at the time of our survey. However, this lack of redundancy in the waterproofing system makes the interior spaces vulnerable to moisture intrusion in the event of failure of the stucco cladding above the headwall flashing, the headwall flashing itself, or the roofing underlayment.

Figure 2.4.1 – Close-up view of roofing underlayment terminated at end of steel roof deck.

- 3.2 BECI also recommends that the existing headwall flashings be removed, that the existing roofing underlayment be integrated with the existing waterproofing at the cladding of the vertical wall, and that new headwall flashings be installed and left unsealed to promote drainage of the cladding assembly above. BECI recommends that consideration be given to removing and replacing the Skybridge roof with a new roof system within the next 4 – 5 years.

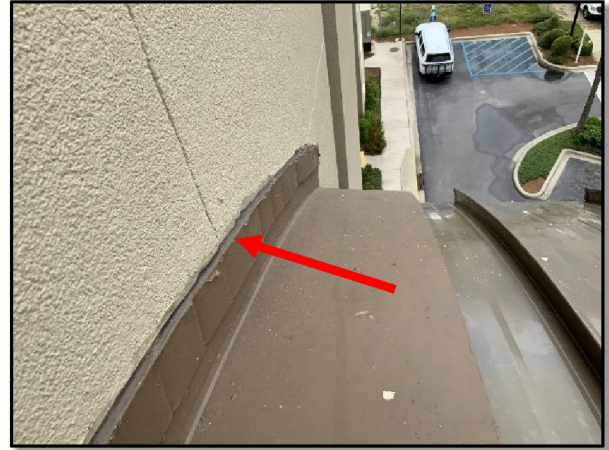
Figure 2.4.2 – Close-up view of headwall flashing sealed to conventional stucco cladding.

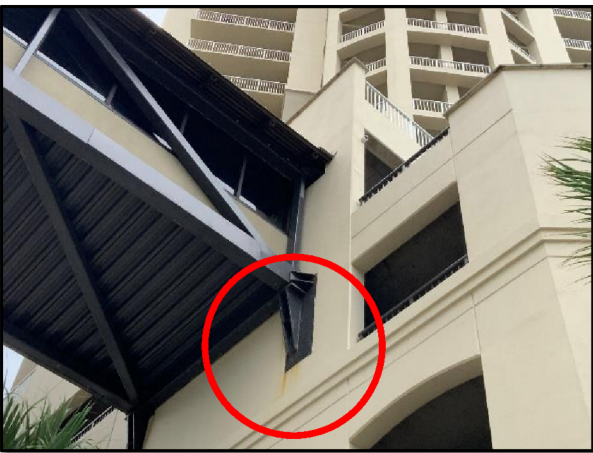
- 2.5 BECI then observed the **cladding** adjacent to the Skybridge as part of our survey. BECI observed the cladding to be in fair condition overall. BECI observed areas of staining at the stucco cladding beneath the bridge attachment brackets below the north end of the bridge (Reference Figure No. 2.5.1 and Photo Exhibit No. 21). BECI observed the concrete surfaces adjacent to the staining to be cracked and exposed to the elements, with no waterproofing observed (Reference Figure No. 2.5.2 and Photo Exhibit Nos. 22 through 24). If areas of uncoated and/or unsealed concrete are left unaddressed, the concrete can continue to absorb moisture potentially corroding the Skybridge attachment brackets prematurely.

Figure 2.5.1 – Overall view of staining at stucco cladding below Skybridge attachment bracket.

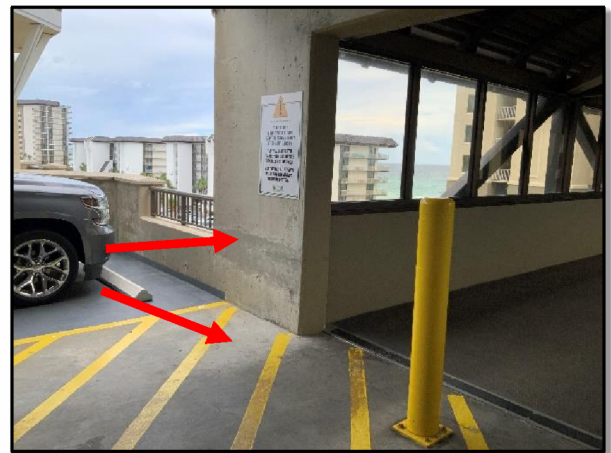
Figure 2.5.2 – Overall view of unsealed concrete surfaces adjacent to Skybridge.

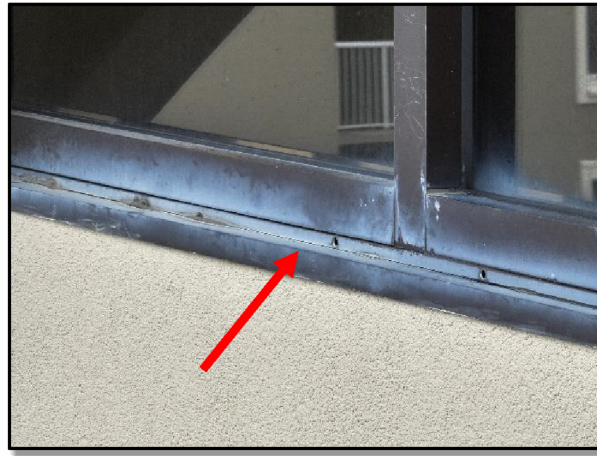
- 2.6 BECI also observed the **windows** to be in fair condition overall. BECI observed oxidation of the window sill flashings and frames to be widespread across both the East and West Elevations. BECI observed faded finishes at the window frames to be widespread as well,

indicating that the windows are nearing the end of their remaining useful life (RUL) (Reference Figure 2.6.1. and Photo Exhibit Nos. 25 and 26).

Figure 2.6.1 – Overall view of faded coatings and oxidation at window sill frame and flashing.

- 3.3 BECI is also of the opinion that the windows are nearing the end of their remaining useful life. BECI recommends that consideration be given to removing and replacing the windows at the Skybridge within the next 2 – 3 years.

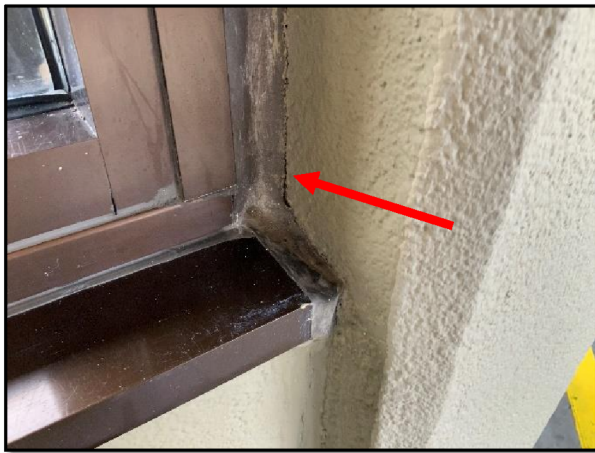
- 2.7 BECI also observed the **sealants** to be in fair condition overall, exhibiting isolated areas of failure at the north headwall flashing and the north expansion joint at the Skybridge interior (Reference Figure 2.7.1 and Photo Exhibit Nos. 27 and 28). BECI also observed missing sealants at the Skybridge-to-parking garage interface at the West Elevation, where the skybridge wall framing was left exposed (Reference Figure 2.7.2 and Photo Exhibit Nos. 29 and 30). If missing and failed sealants are left unaddressed, moisture can penetrate the Skybridge enclosure, prematurely deteriorating the underlying roofing components and steel superstructure.

Figure 2.7.1 – Close-up view of isolated area of failed sealant at North expansion joint.

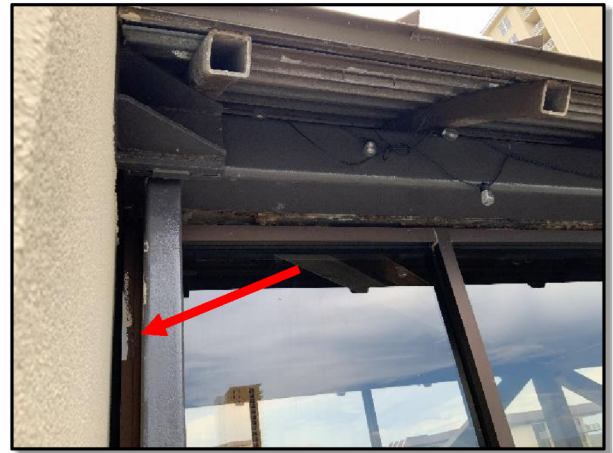
Figure 2.7.1 – Close-up view of missing sealant at Skybridge-to-Parking Garage interface.

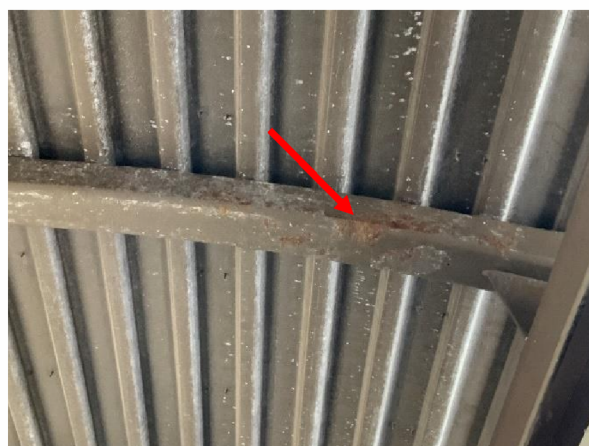
Photo 5
 Interior – Close-up view of failed coating and corrosion at steel roof purlin.

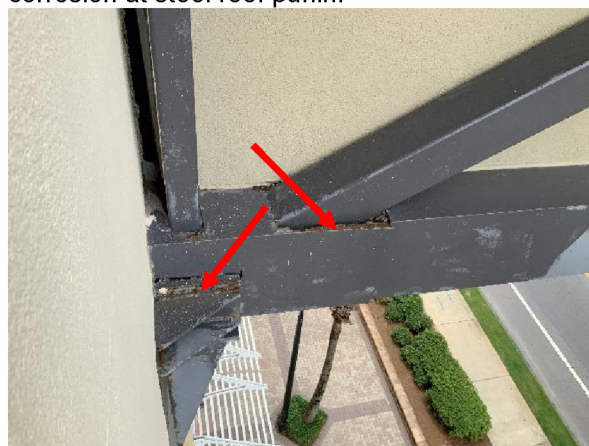
Photo 6
 West Elevation – Overall view of corroded attachment brackets and framing members.

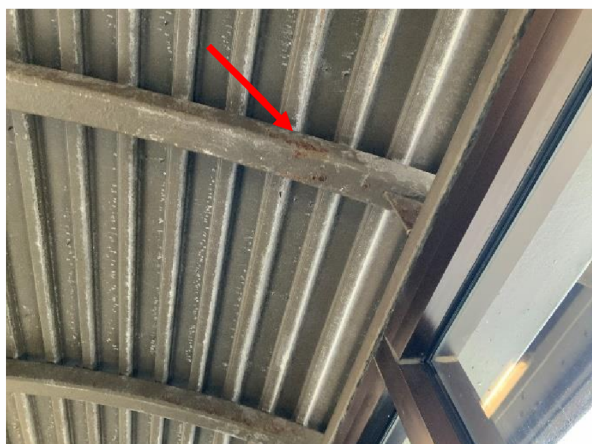
Photo 7
 Interior – Overall view of corrosion at roof purlin.

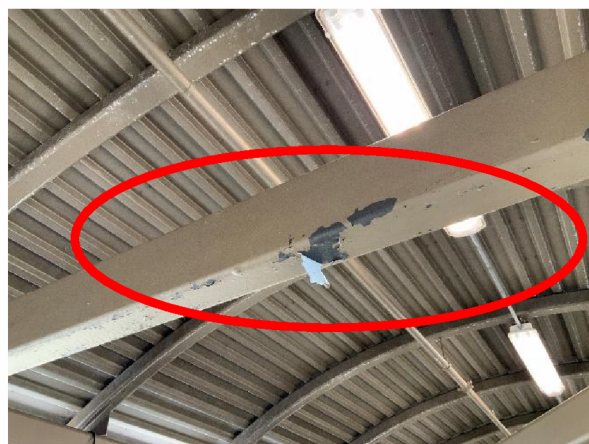
Photo 10
 Interior – Overall view of failed coatings at steel beam.

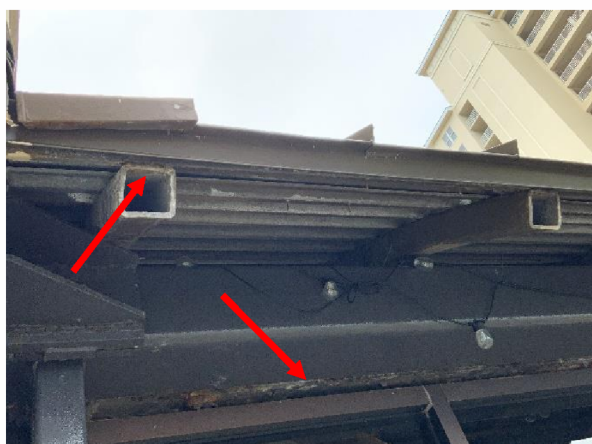
Photo 8
 West Elevation – Overall view of corrosion at roof purlin and steel beam.

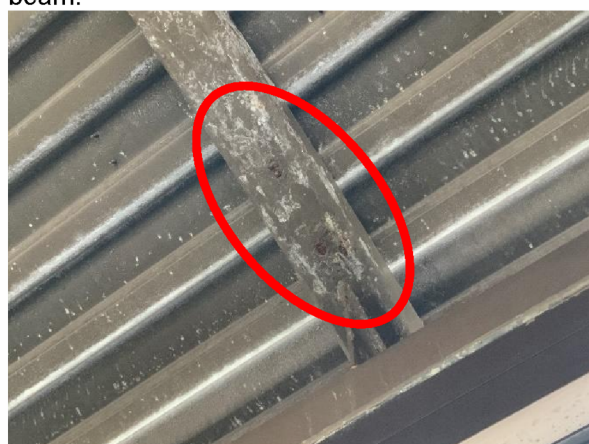
Photo 11
 Interior – Overall view of failed coatings and corrosion at roof purlin.

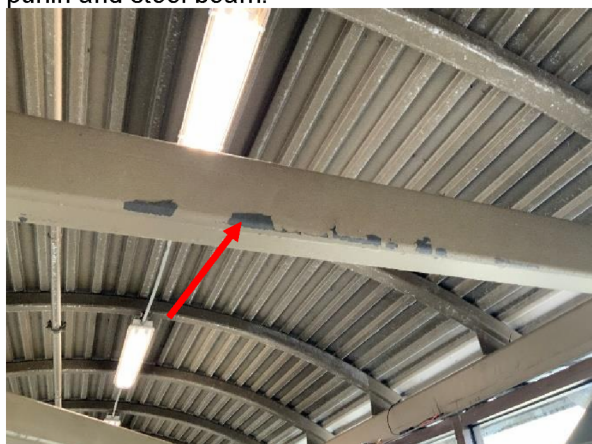
Photo 9
 Interior – Overall view of failed coatings at steel beam.

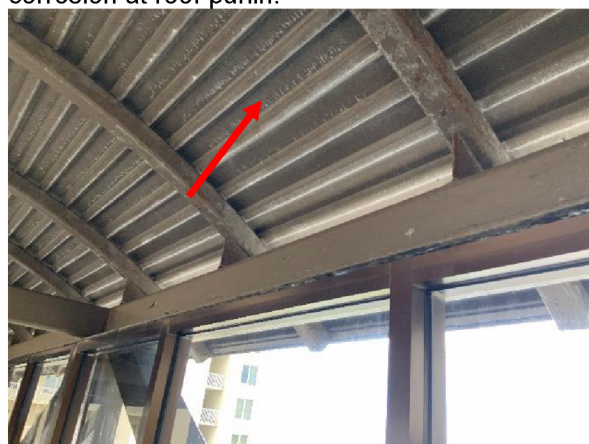
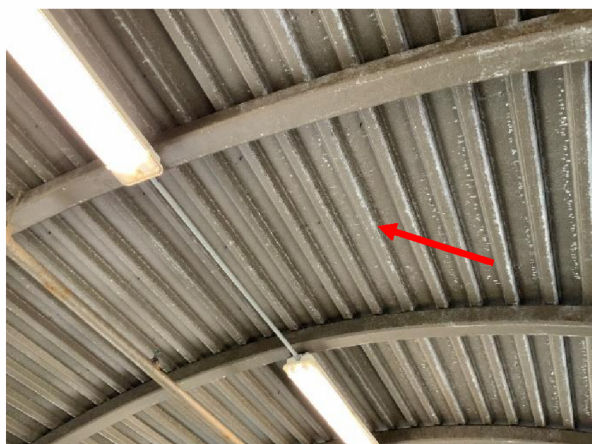
Photo 12
 Interior – Overall view of failed coatings at the steel roof deck.

Photo 13
 Interior – Overall view of failed coatings at the steel roof deck.

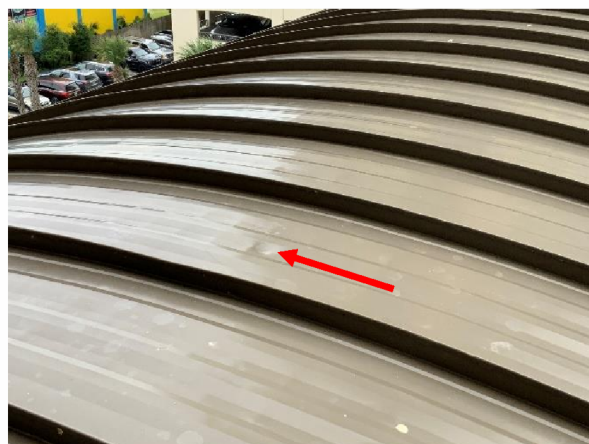
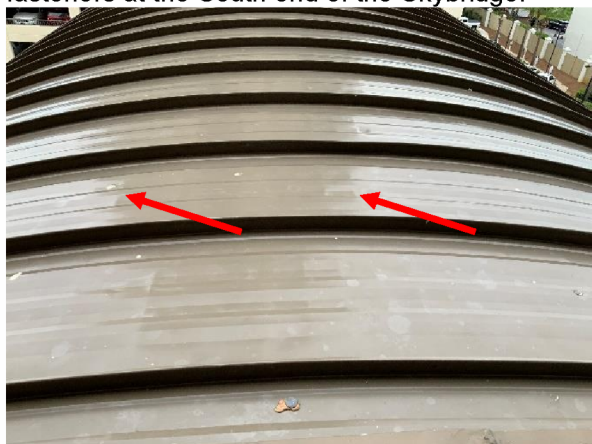
Photo 16
 Roof – Overall view impact damage to the roof panels.

Photo 15
 Roof – Overall view impact damage to the roof panels.

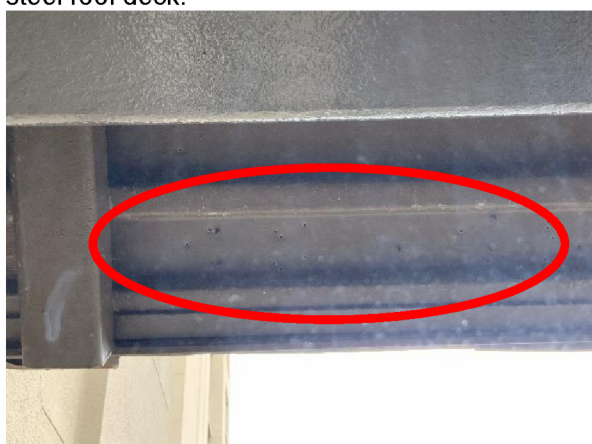
Photo 14
 West Elevation – Overall view abandoned fasteners at the South end of the Skybridge.

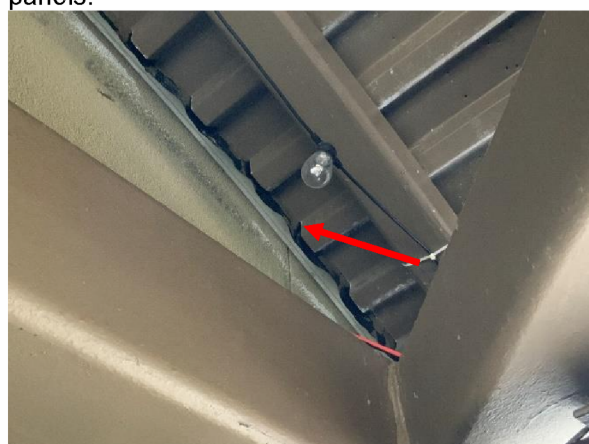
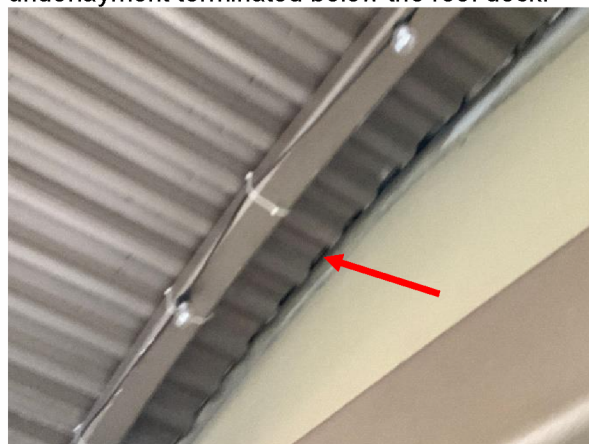
Photo 17
 South Elevation – Overall view of the roofing underlayment terminated below the roof deck.

Photo 18
 South Elevation – Overall view of the roofing underlayment terminated below the roof deck.

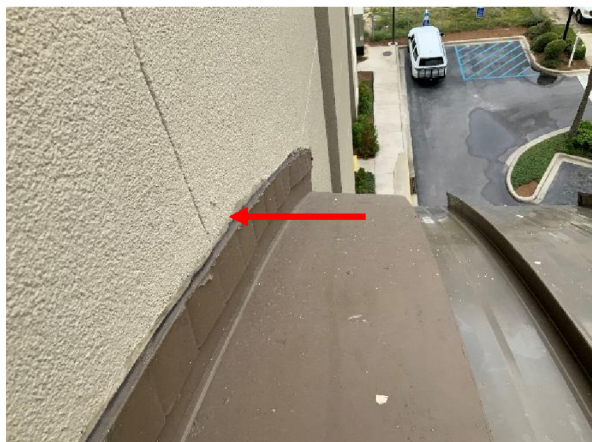
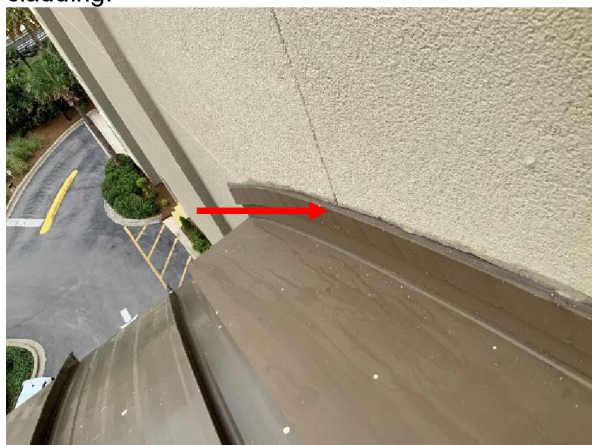
Photo 19
South Elevation – Overall view of the headwall flashing sealed to the conventional stucco cladding.

Photo 20
South Elevation – Overall view of the headwall flashing sealed to the conventional stucco cladding.

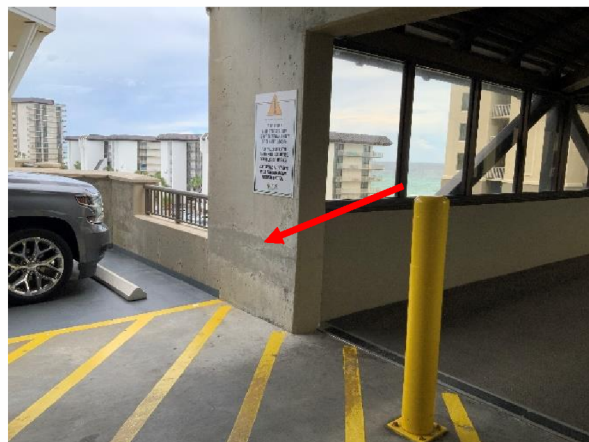
Photo 22
Parking Garage – Overall view of unsealed concrete adjacent to the stained stucco cladding.

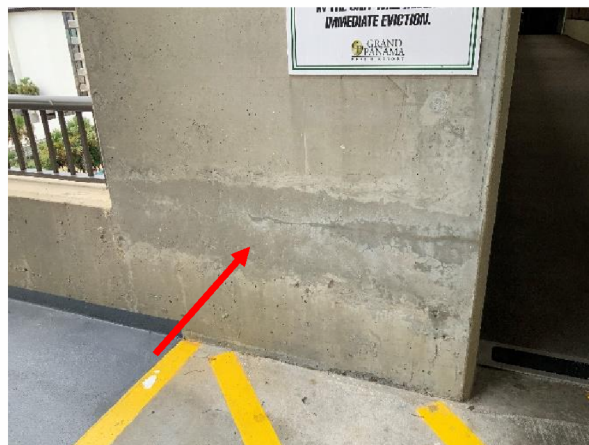
Photo 23
Parking Garage – Overall view of cracked and unsealed concrete column.

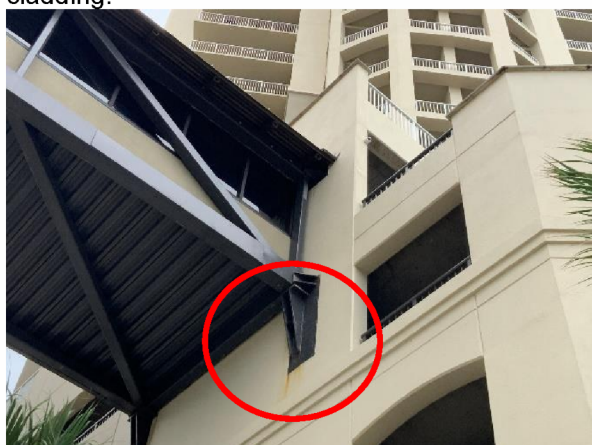
Photo 21
North Elevation – Overall view of staining at the stucco cladding beneath the Skybridge attachment bracket.

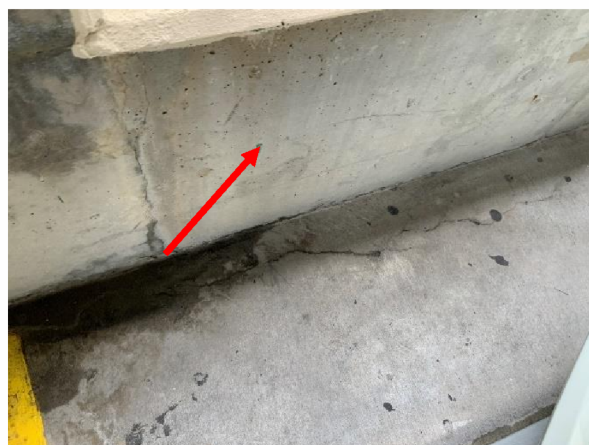
Photo 24
Parking Garage – Overall view of cracked and unsealed concrete knee wall.

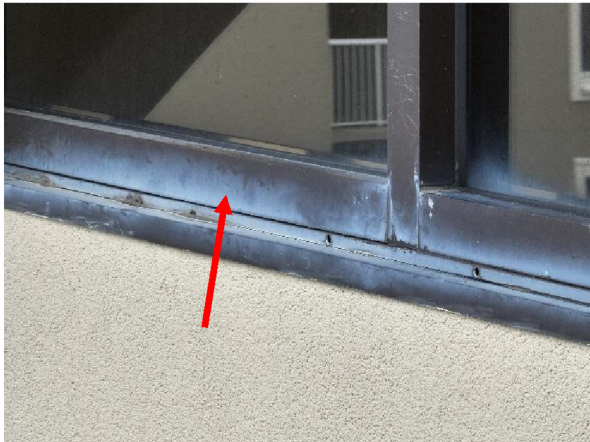
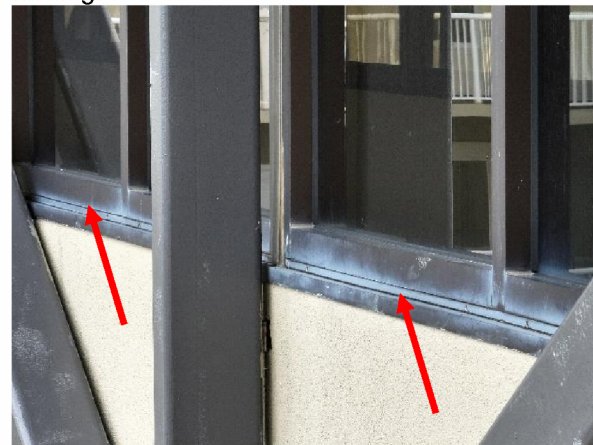
Photo 25
Window Assemblies – Overall view of faded finish and oxidation at the window sill frame and flashing.

Photo 26
Window Assemblies – Overall view of faded finish and oxidation at the window sill frame and flashing.

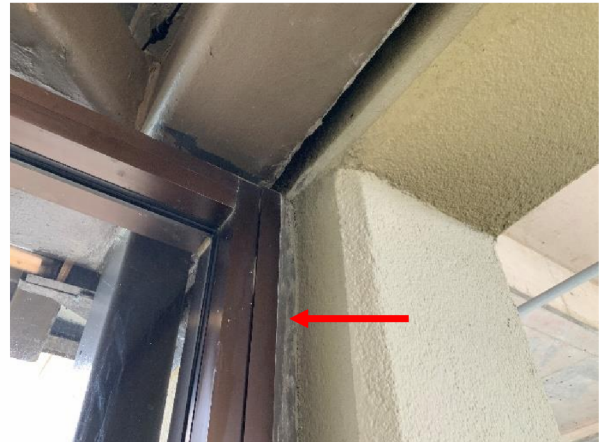
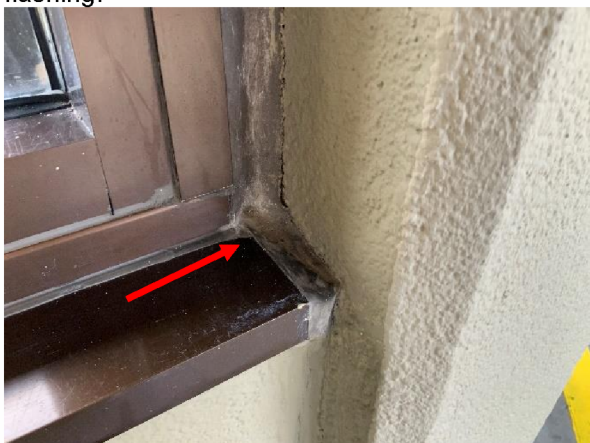
Photo 28
North Entrance – Overall view of isolated failed sealant at the expansion joint.

Photo 27
North Entrance – Overall view of isolated failed sealant at the expansion joint.

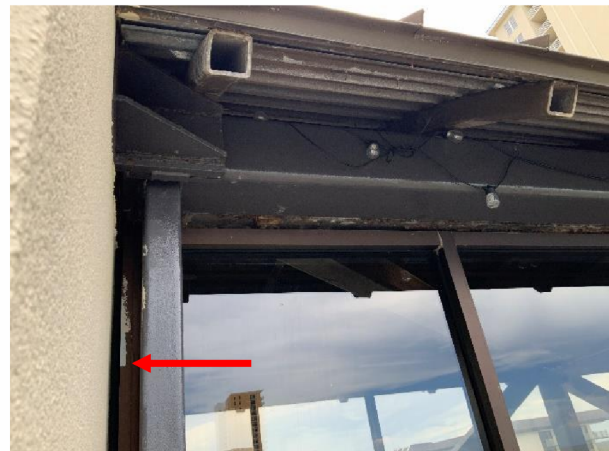
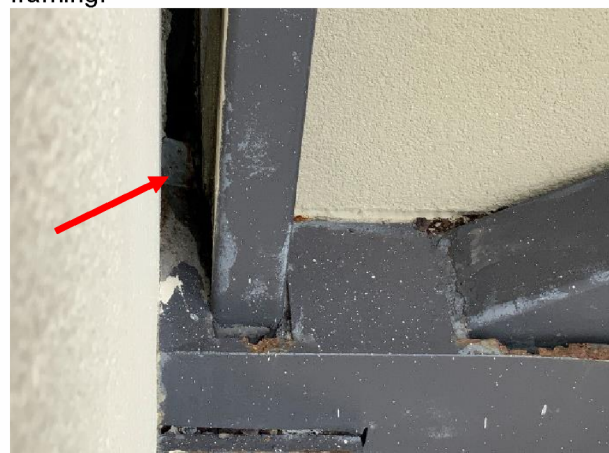
Photo 29
Skybridge-to-Garage Interface – West Elevation – Overall view of missing sealant and exposed framing.

Photo 30
Skybridge-to-Garage Interface – West Elevation – Overall view of missing sealant and exposed framing.
