**Roofing Plus**  
1525 University Drive  
Auburn, GA 30011  
7704641030

# Work Completed

## Rust stain on wall (Emergency)

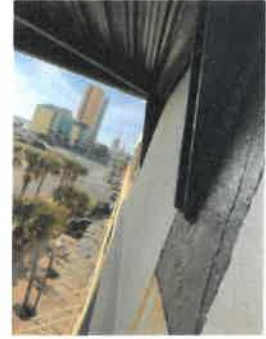
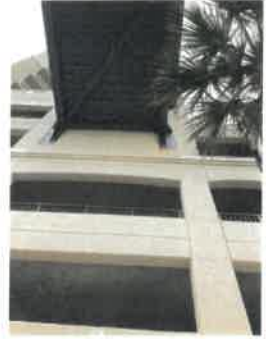
### Before:

There is rust on the wall around steel plate at the breeze way.

Investigate source of water getting into the wall. Tech found damage to the concrete joint at the entrance to the breezeway allowing water inside the wall. This water is exiting the wall at the steel wall plate causing the rust stains. Tech cleaned out the damaged joint and filled with caulking. This is a temporary repair to stop the water intrusion and should be further investigated by and structural engineer and permanently repaired.
