Grand Panama Beach Resort Condominium Association, Inc.

August 1, 2023 • Panama City Beach, FL

Grand Panama Beach Resort Condominium Association, Inc. Panama City Beach, Florida

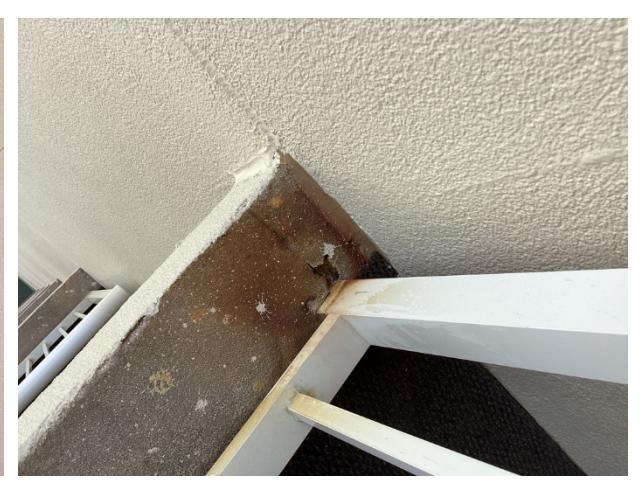
Condition: Good to fair overall. We note previous repairs at the embedded posts.

Concrete damage at railing connection

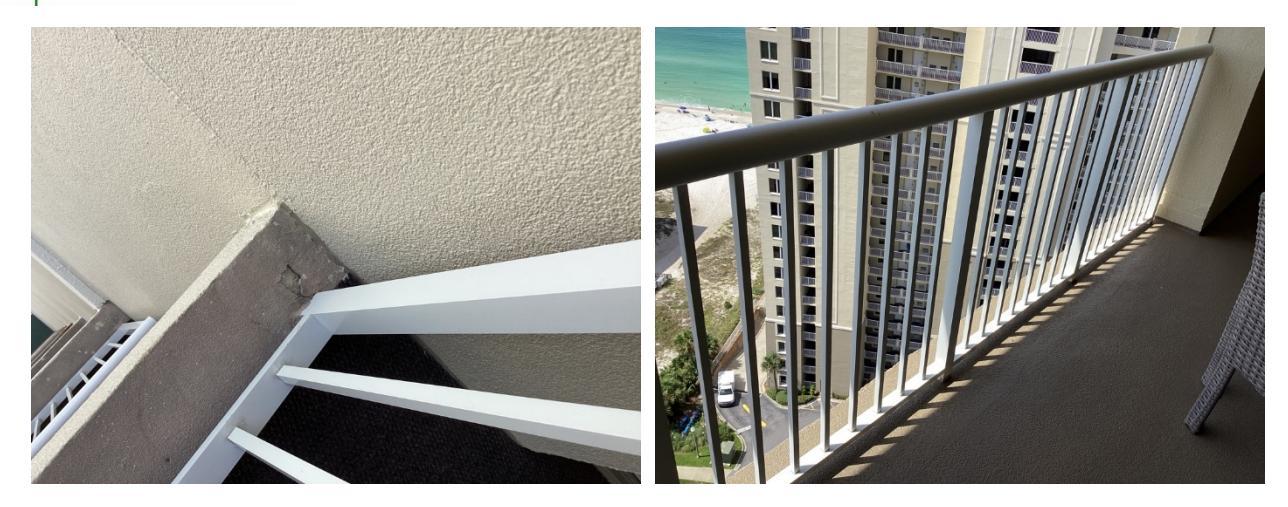
Concrete damage at railing connection

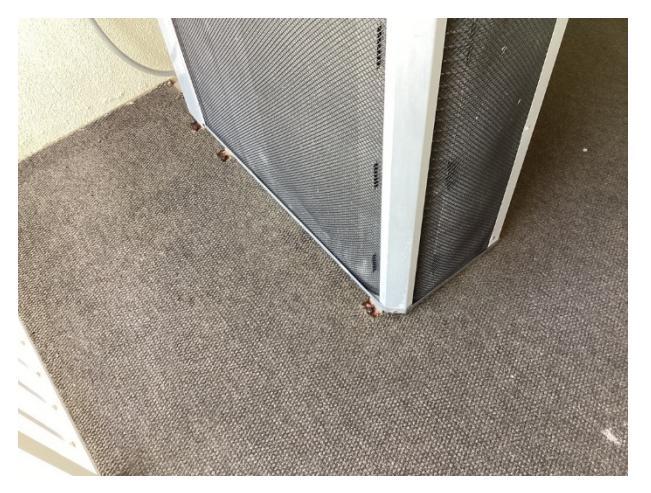
Condition: Fair overall with carpet stains, rust at the condensing units and moisture evident. We note carpet at the breezeways. Carpet conceals concrete deterioration, retains water and inhibits drainage. Water trapped by the carpet can result in accelerated concrete deterioration. Therefore, we do not recommend the use of carpet on breezeways surfaces.

Rust and moisture at condensing units atop breezeway carpet

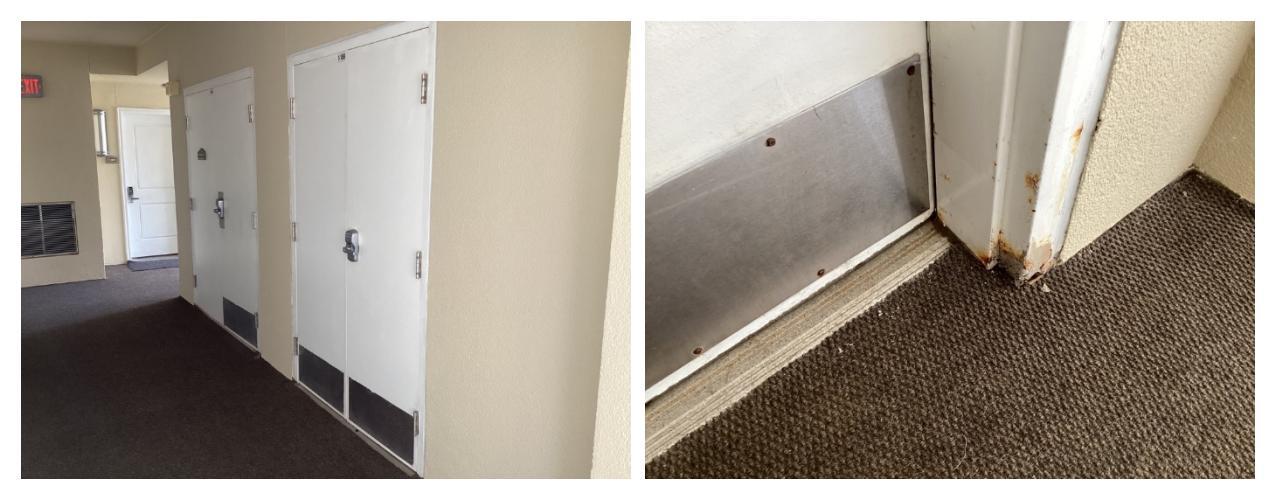
Condition: Good to fair overall with isolated rust evident

Rust at door frame

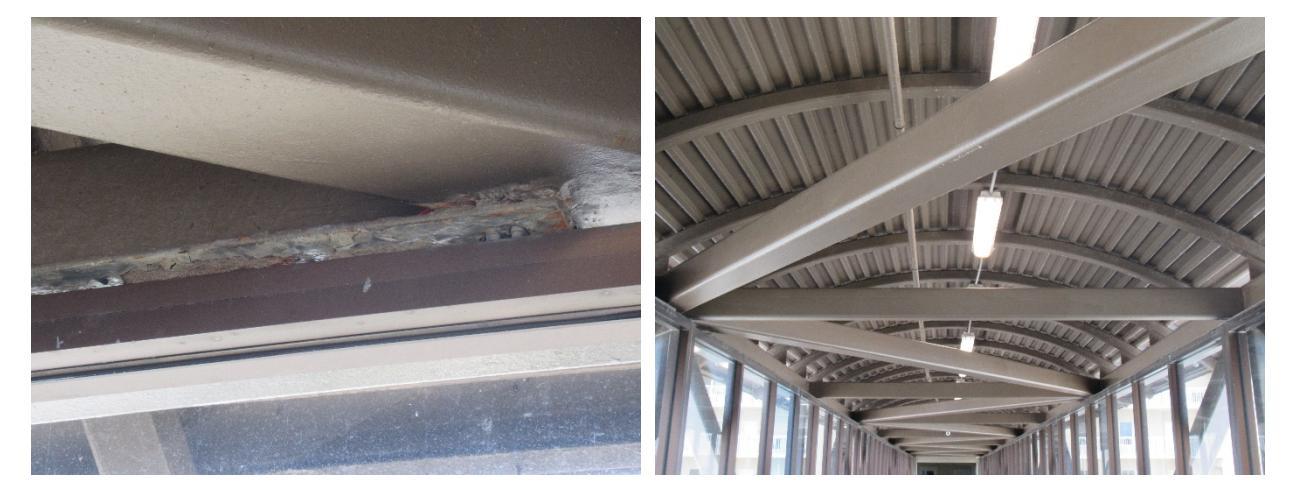
Condition: Good to fair overall with isolated finish deterioration evident.

Finish deterioration and minor corrosion

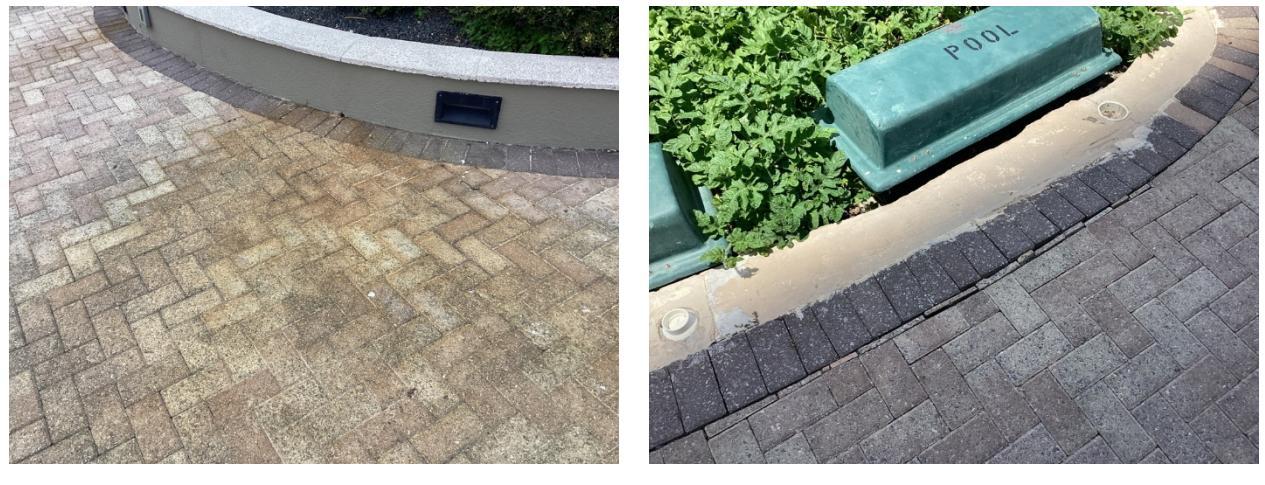
Condition: Good overall condition and Management does not report a recent history of water infiltration issues. We note isolated paver discoloration at the planter weep holes and isolated displaced pavers.

Discolored pavers at weep hole

Displaced pavers

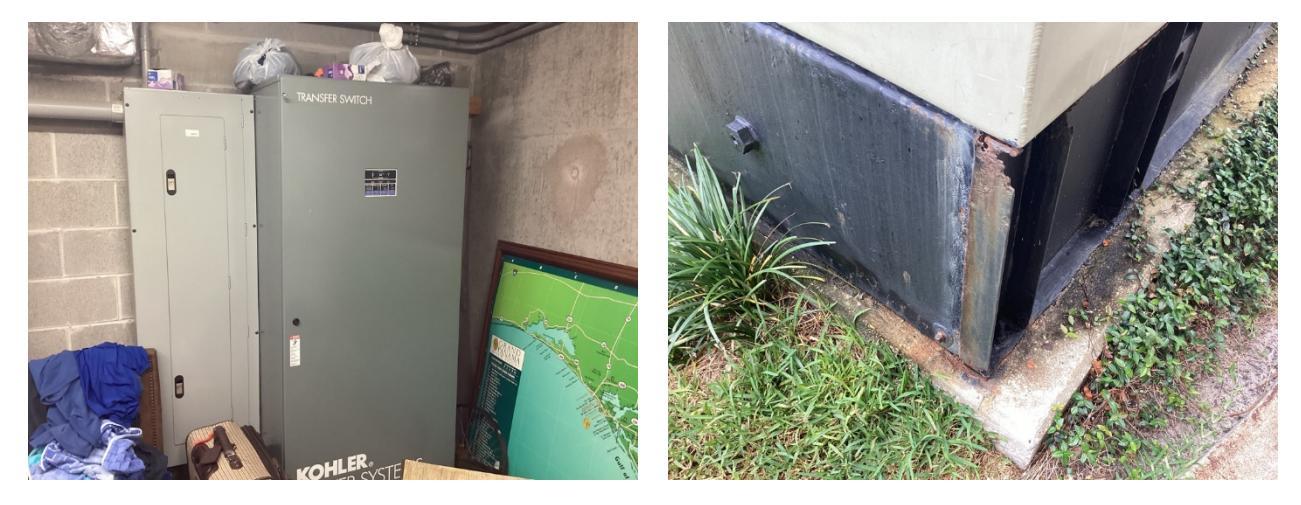
Rust at Tower 1 generator frame

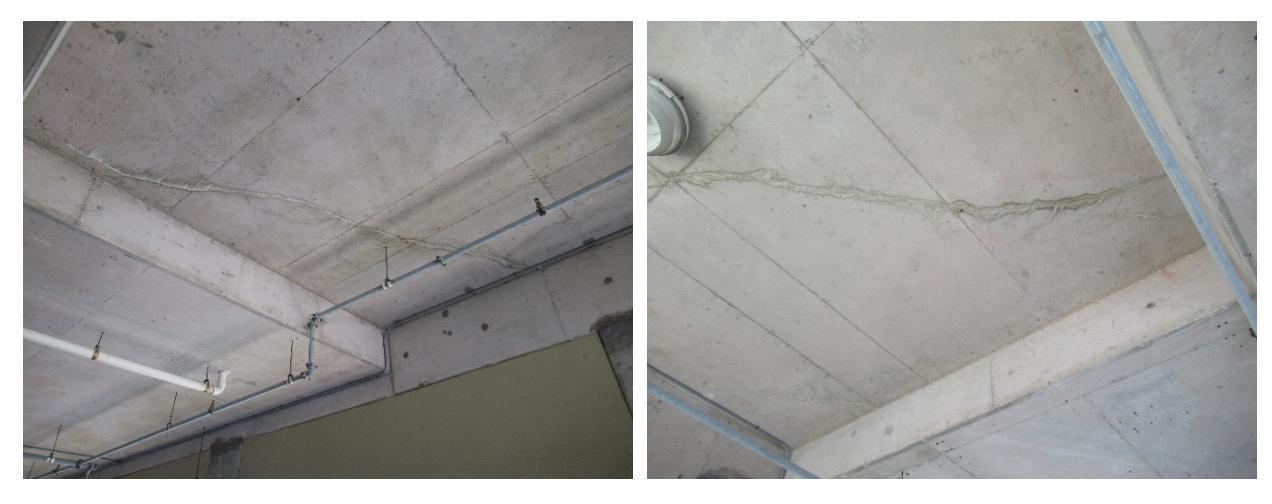
Underside cracks at Tower 2

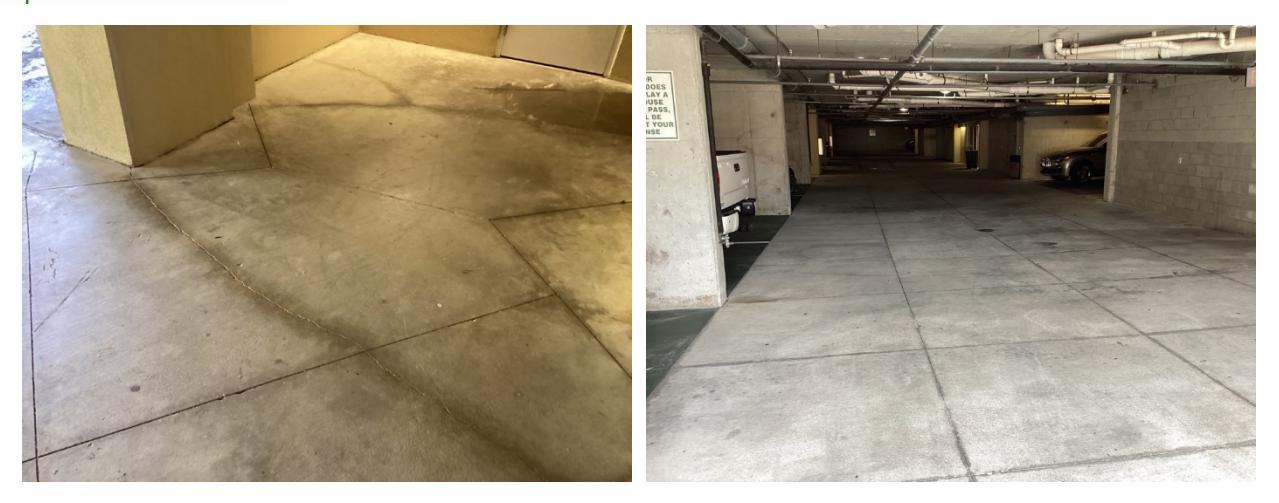
Condition: Good to fair overall with isolated cracks evident.

Concrete cracks at Tower 2 on-grade concrete

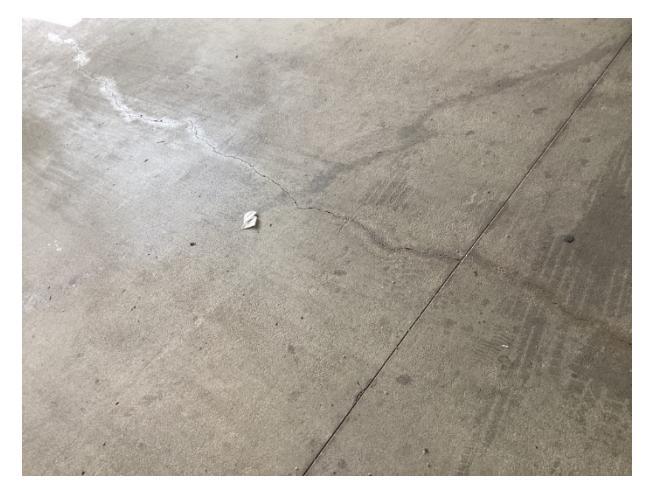
Concrete cracks

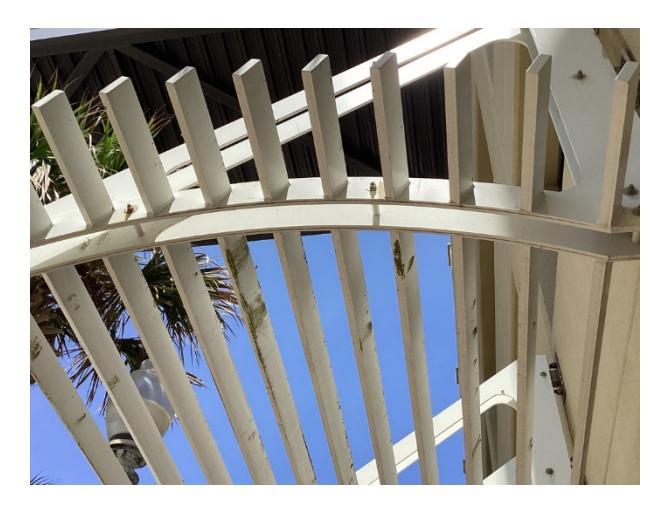
Condition: Fair overall with finish deterioration evident

Finish damage

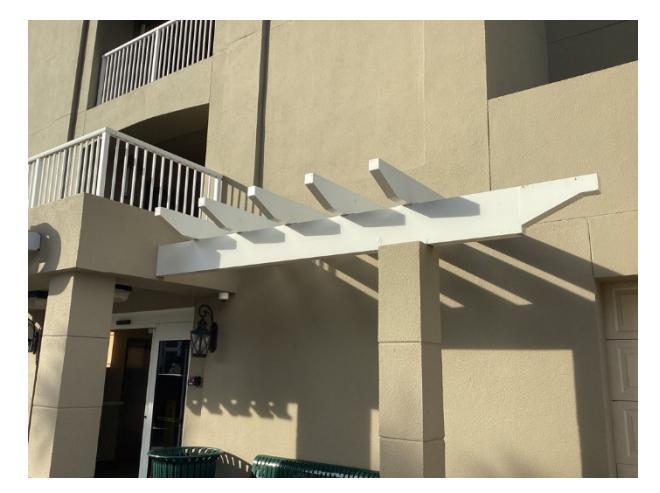
Condition: Fair overall with finish deterioration and rusted fasteners evident

Finish deterioration at pergola

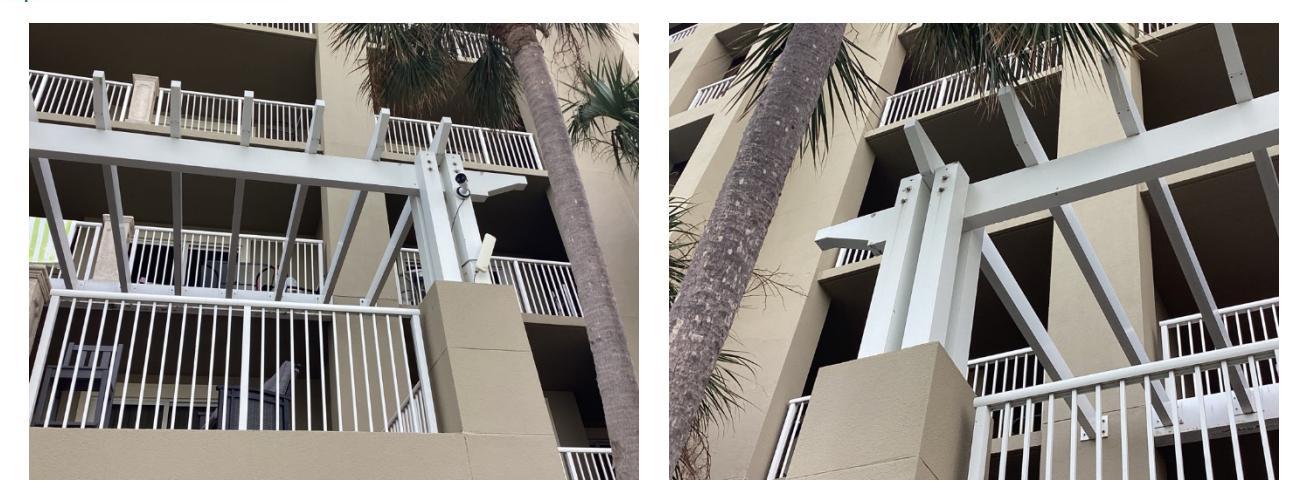
Rust stains at pergola fasteners

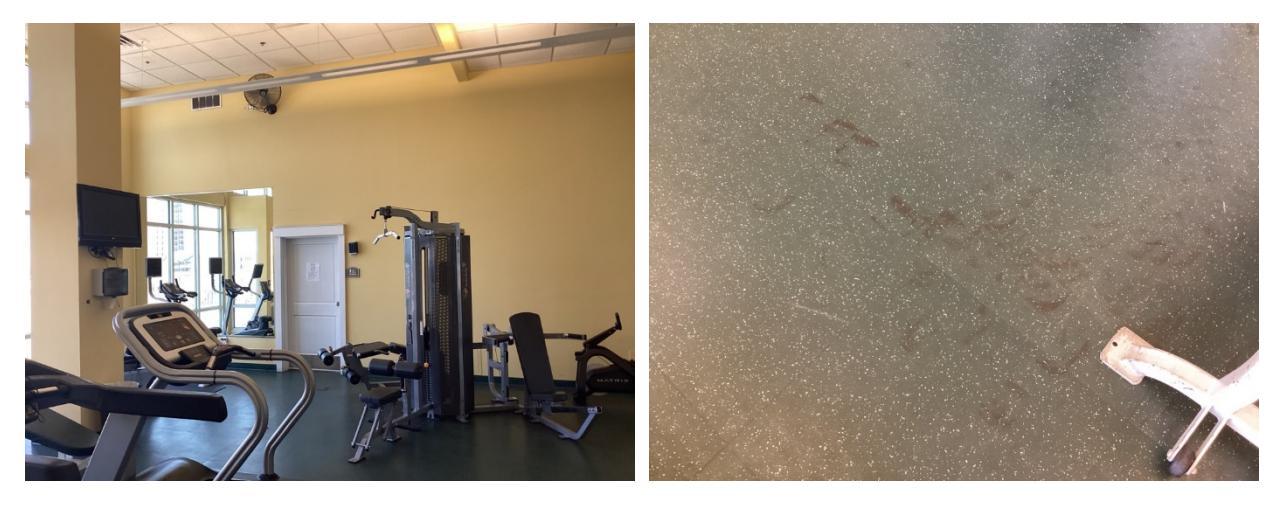
Minor floor damage

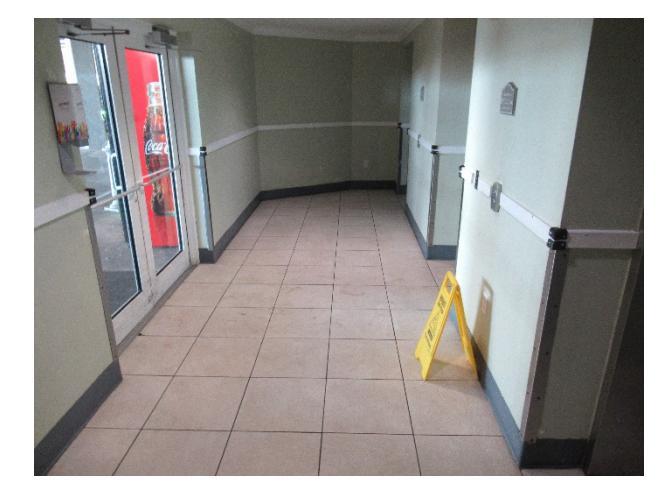
Condition: Good to fair overall with isolated, minor tile damage evident

Minor tile damage

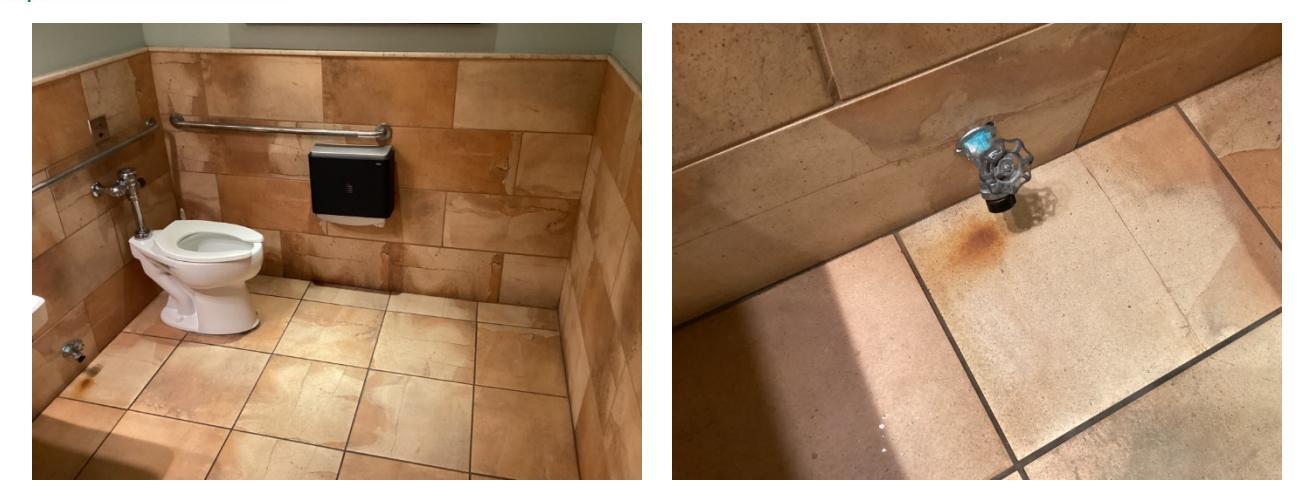
Tile crack and stain

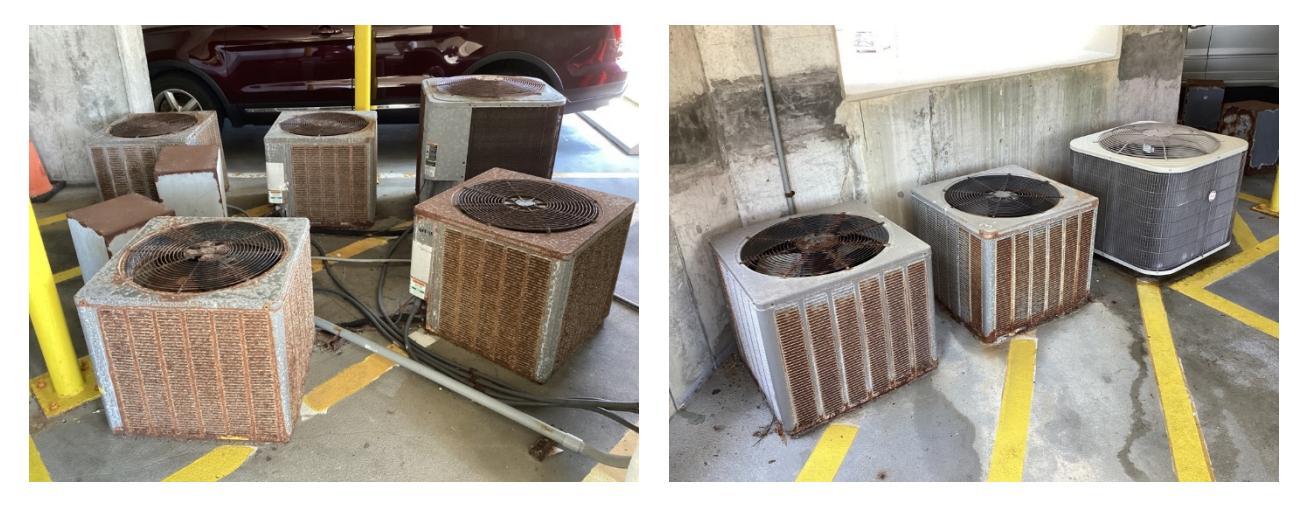
Condition: Reported satisfactory. We note extensive rust and corrosion at the units in the Tower 2 parking garage.

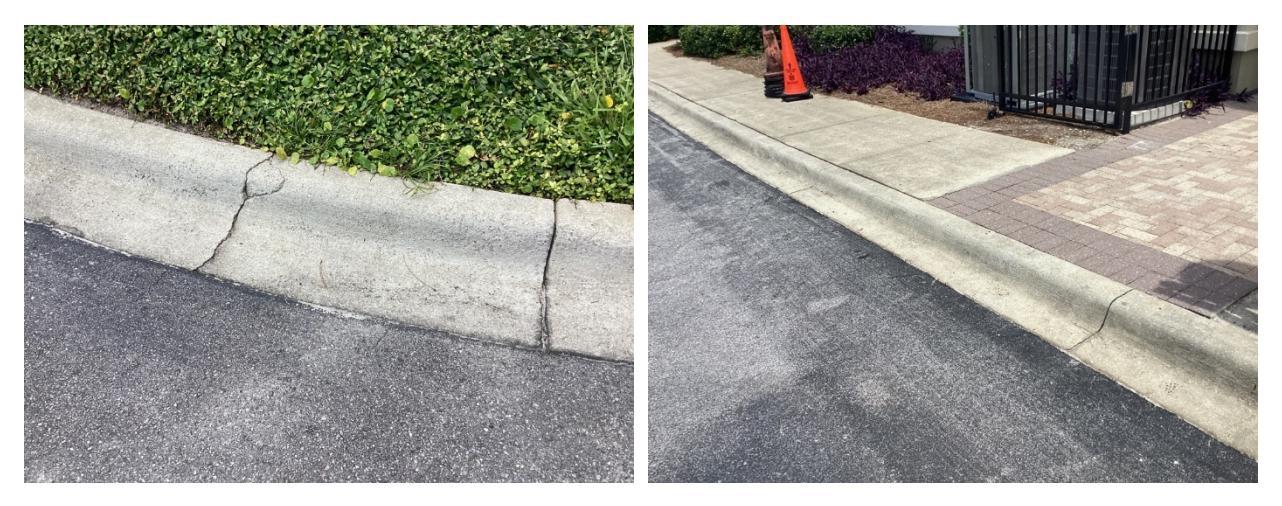
Condition: Good to fair overall with isolated cracks and spalled concrete evident.

Concrete cracks

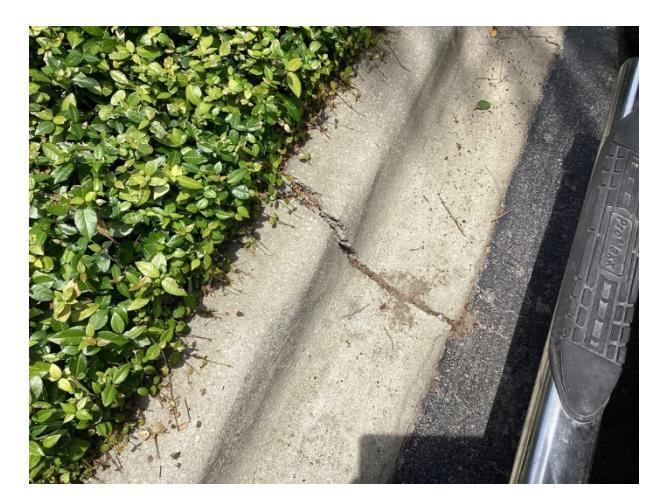
Concrete cracks

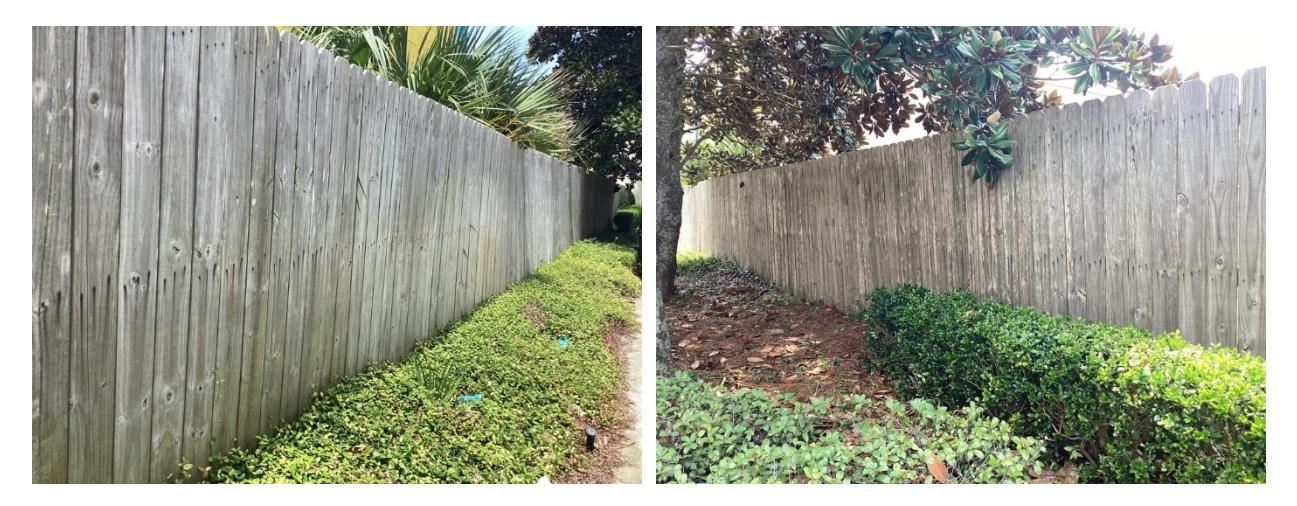
Condition: Fair overall with leaning sections evident.

Fence leaning section

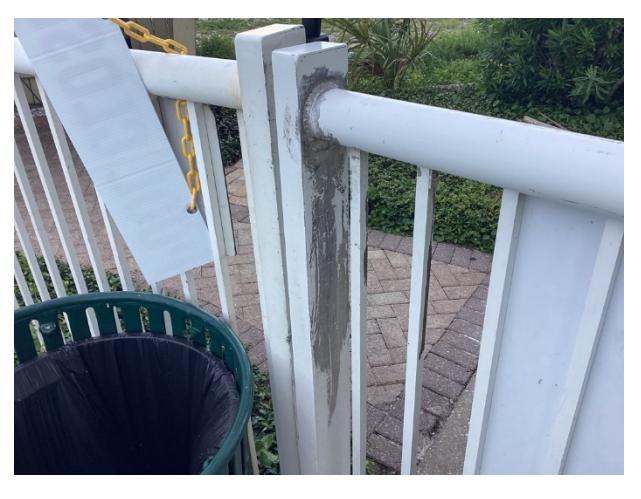
Condition: Good to fair overall with finish deterioration evident

Fence finish deterioration

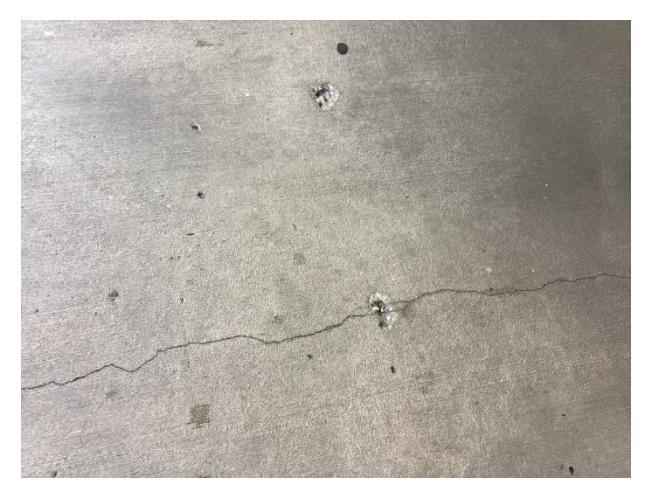
Condition: Good to fair overall with isolated cracks evident. Portions of the elevated structural concrete utilizes a protective traffic coating. We include for this cost on Line Item 7.800.

Concrete cracks and spalls

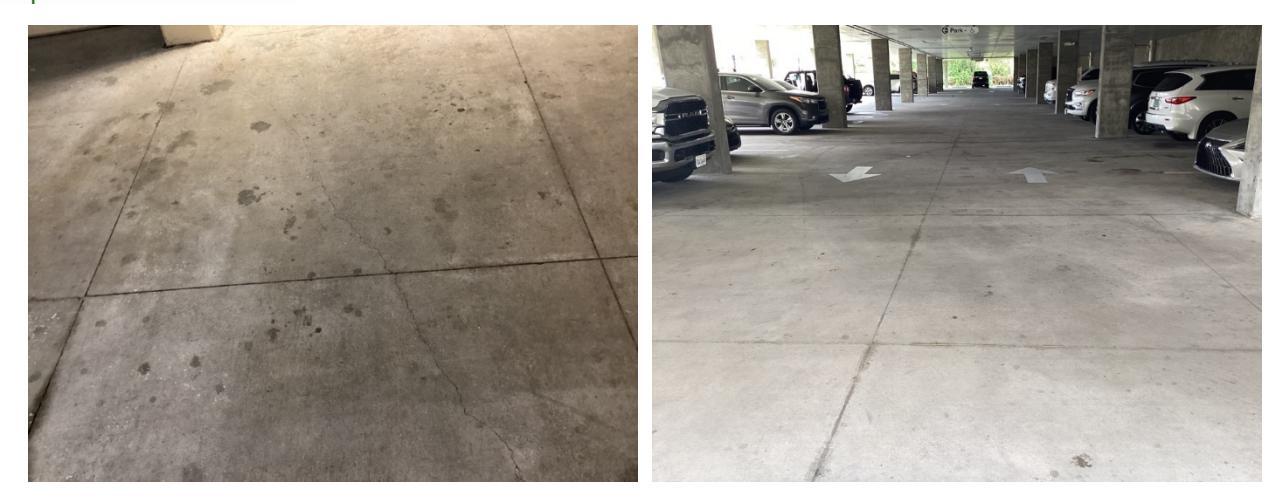
Concrete cracks

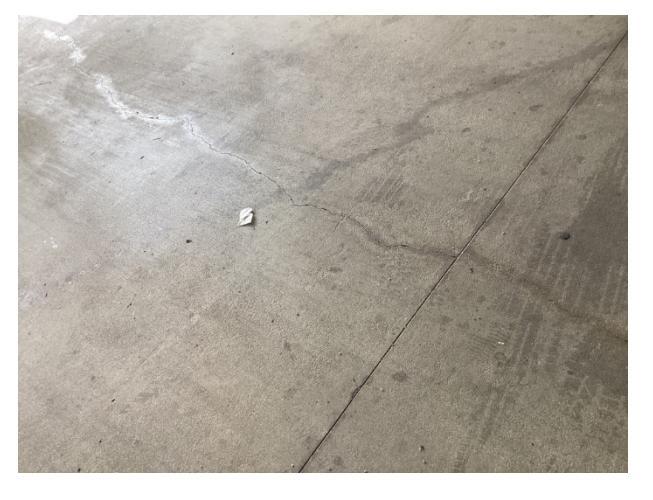
Condition: Good to fair overall with isolated cracks evident.

Concrete cracks

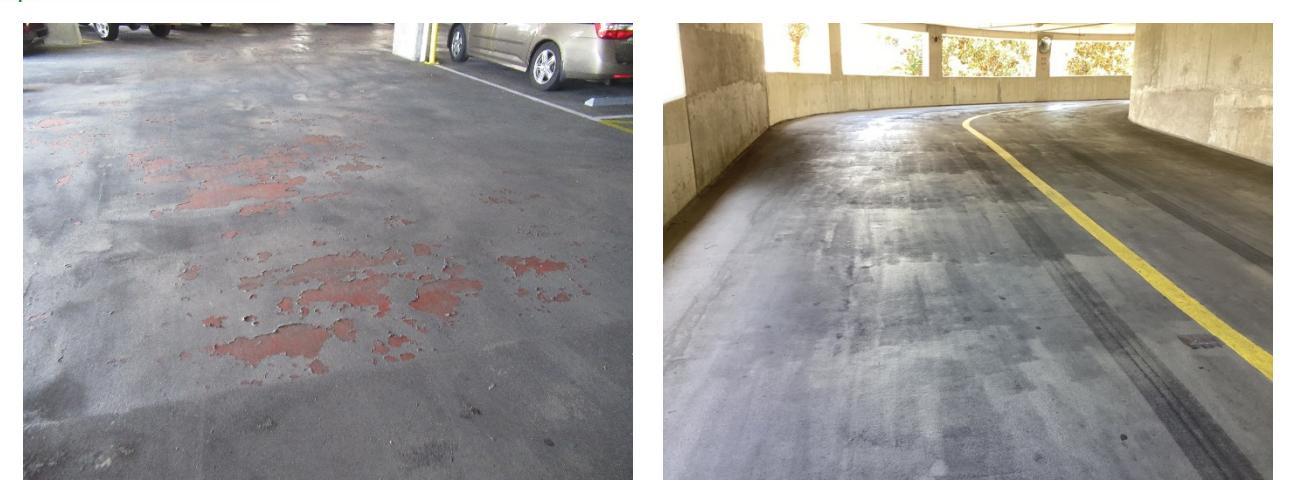
Traffic coating delamination
