## Report of Findings

**Grand Panama Beach Resort Hurricane Michael Damage Evaluation**

**Claim No: 4156891**

September 2, 2020

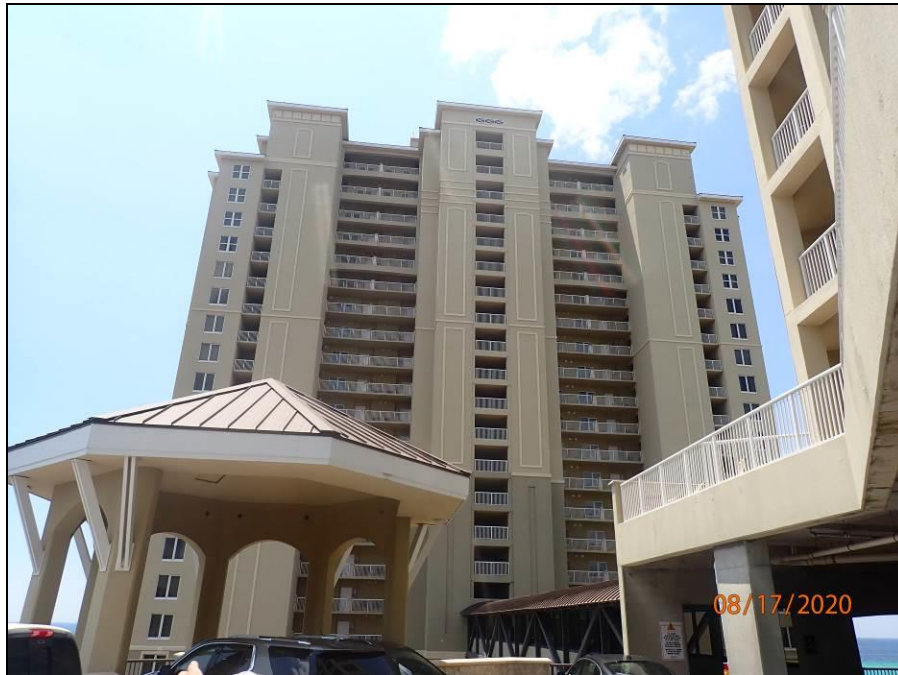
**Photograph 2**

- There was visible impact damage to the EIFS trim between the fourth and fifth floors on the exterior, north wall near the northeast corner of the building (**Photograph 2**). There was also visible impact damage to the top of the EIFS trim around the easternmost fourth-floor window on the north wall of the building.

View of the impact damage to the EIFS trim between the fourth and fifth floors on the exterior, north wall of Tower #1 (arrow). Also note impact damage to the EIFS trim above the fourth-floor window.

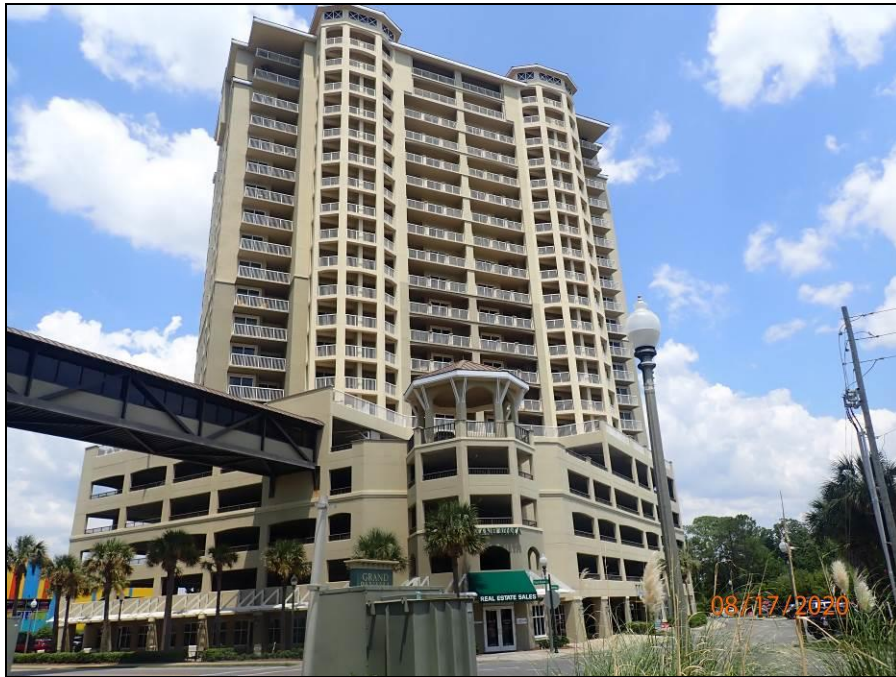
**Photograph 24**

- When viewed from the ground surface and/or the interior space of the lower parking garage, there were visible punctures, scars, and/or abrasions to the finish coat of the stucco and/or EIFS on the exterior walls of the lower parking garage of Tower #2 consistent with wind loads/forces and/or minor wind-borne debris impacts (**Photographs 24 through 26**).

View of a typical impact mark to the EIFS cladding on the exterior south wall of the fourth floor of the lower parking garage of Tower #2.

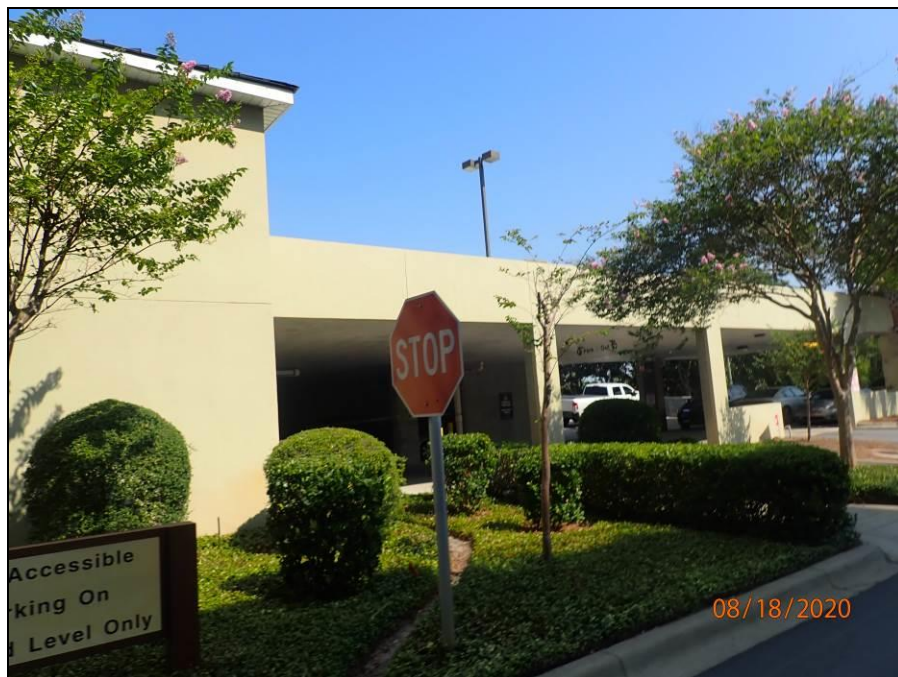
**Photograph 45**

- When viewed from the ground surface and/or the interior space of the detached parking garage, there were visible punctures, chips, scars, and/or abrasions throughout the finish coat of the stucco and/or EIFS on the exterior walls of the building, consistent with wind loads/forces and/or minor wind-borne debris impacts during the passage of Hurricane Michael (**Photographs 45 through 48**).

Close-up view of typical scars/abrasions to the stucco finish coat on the east wall of the second floor of the detached parking garage.
