FULL RESERVE STUDY

Grand Panama Beach Resort Condominium Association, Inc.

Panama City Beach, Florida

October 27, 2017

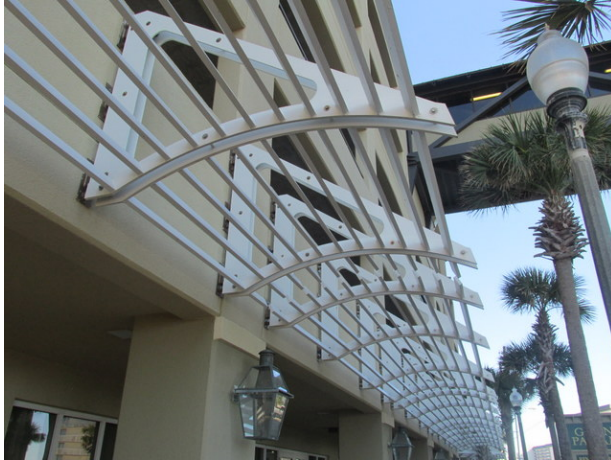
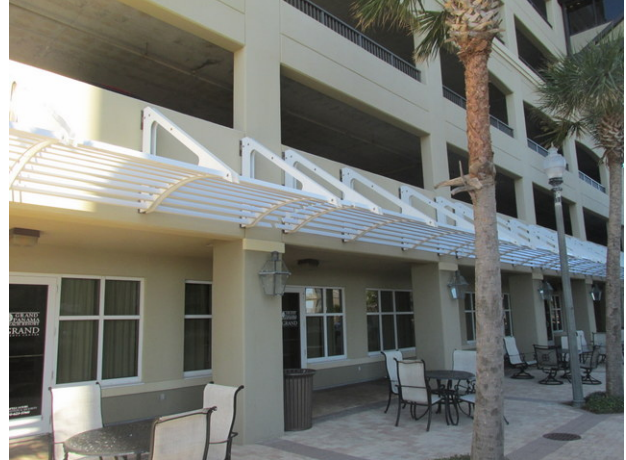
Condition: Good overall

Aluminum awning at Tower 2 facade

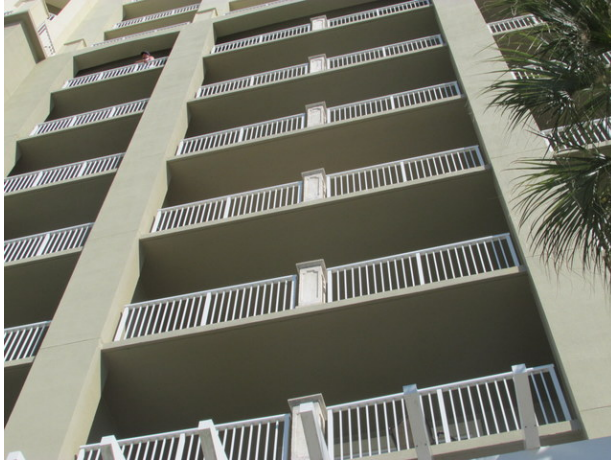
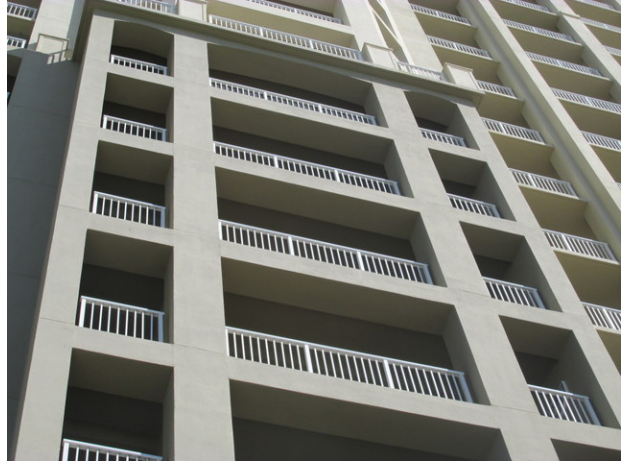
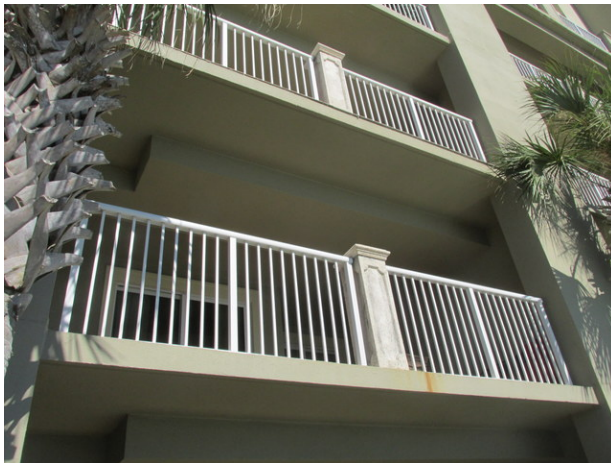
Condition: Good overall

**Concrete balconies and aluminum railings at
Tower 1**

Useful Life: Capital repairs including a close-up visual inspection, patching of delaminated concrete, routing and filling of cracked concrete, and waterproof coating applications every six- to eight-years.

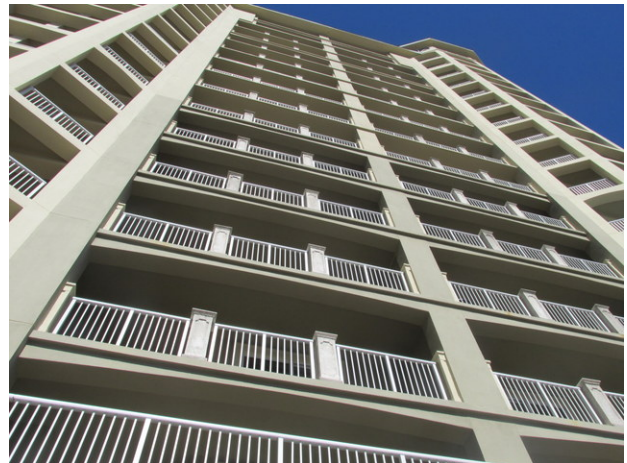
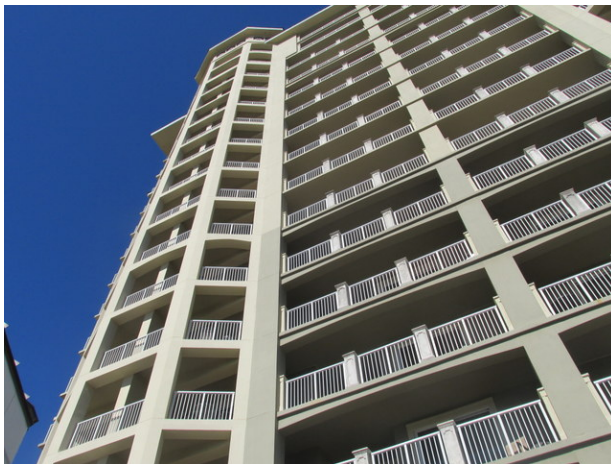
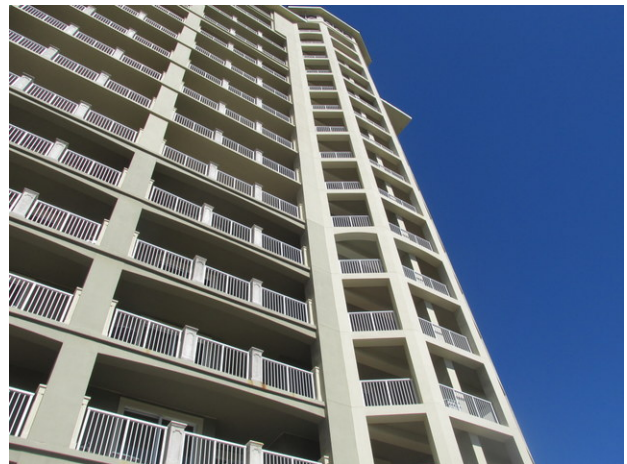
**Concrete balconies and aluminum railings at
Tower 2**

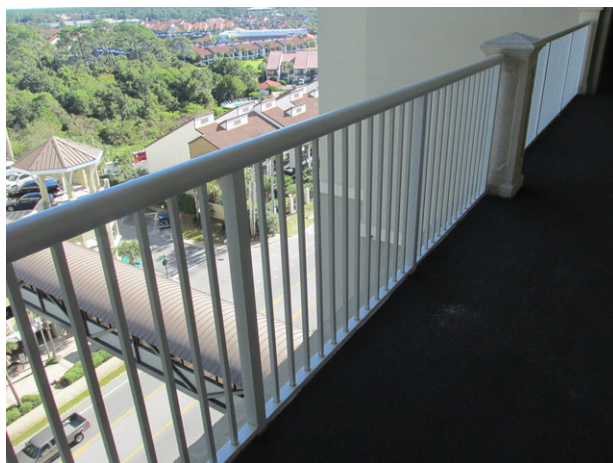
Condition: Good overall condition

Typical aluminum railing at breezeway

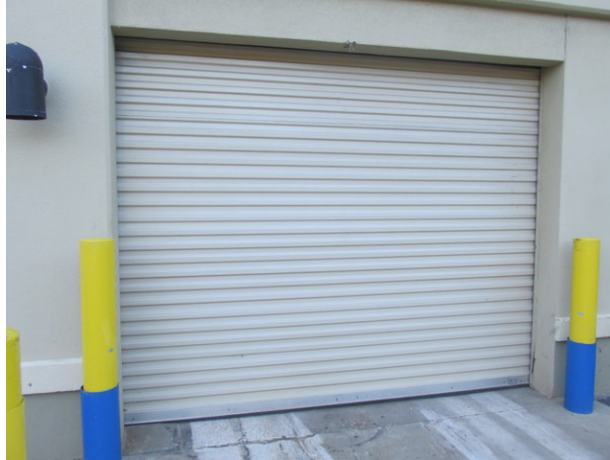
Condition: Good overall

Overhead door at Tower 2

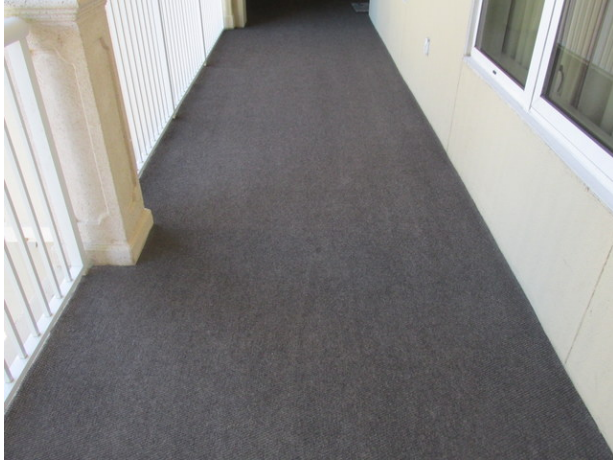
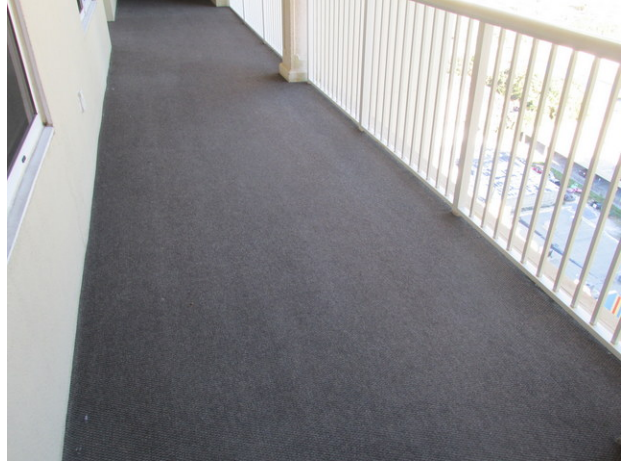
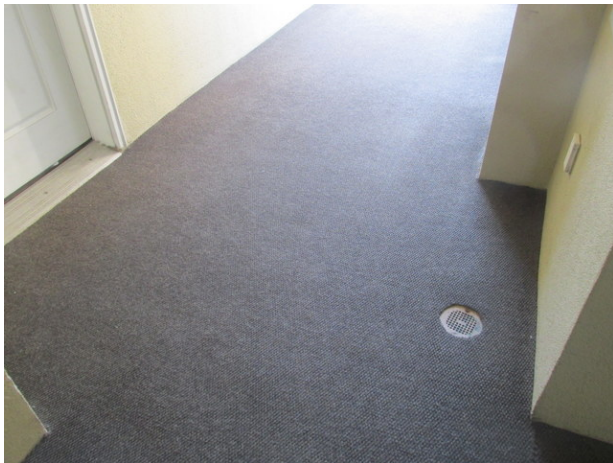
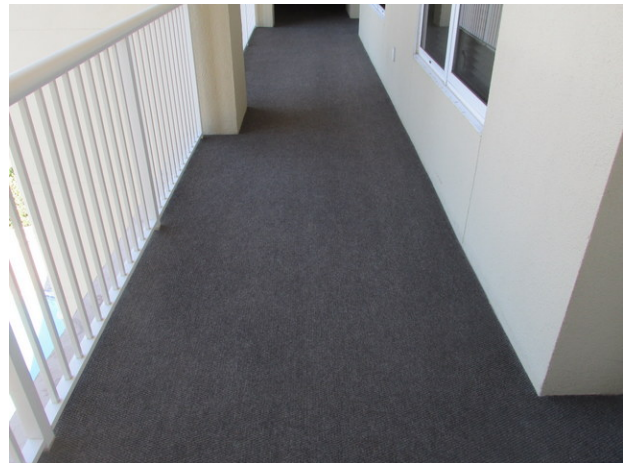
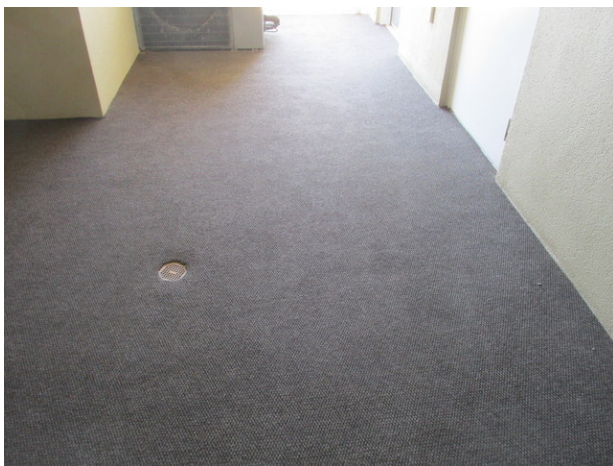
Condition: Good overall condition with isolated water stains evident

Carpet floor coverings at breezeways

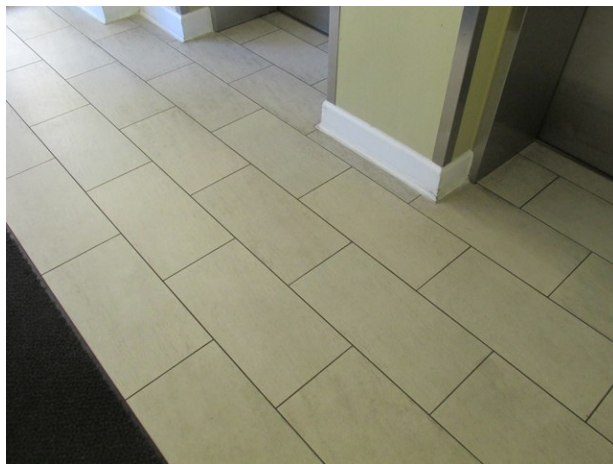
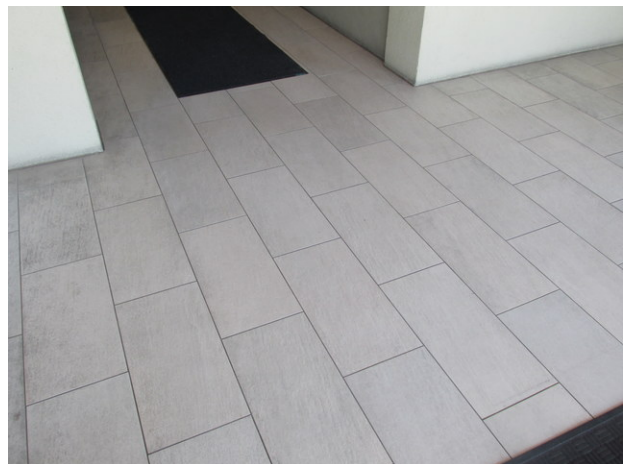
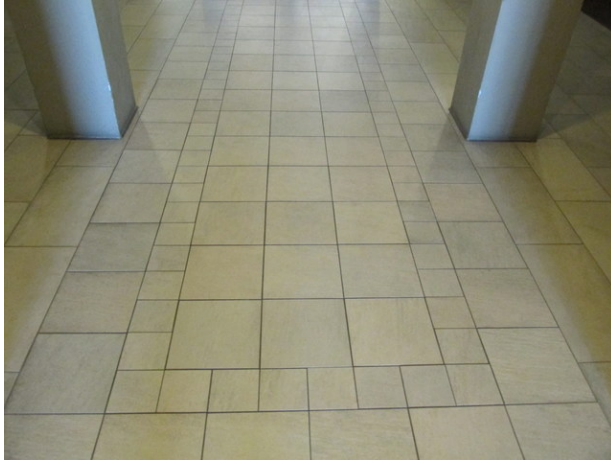
Condition: Good overall

Tile floor coverings at Tower 1 ground floor lobby

Tile floor coverings at Tower 1 ground floor

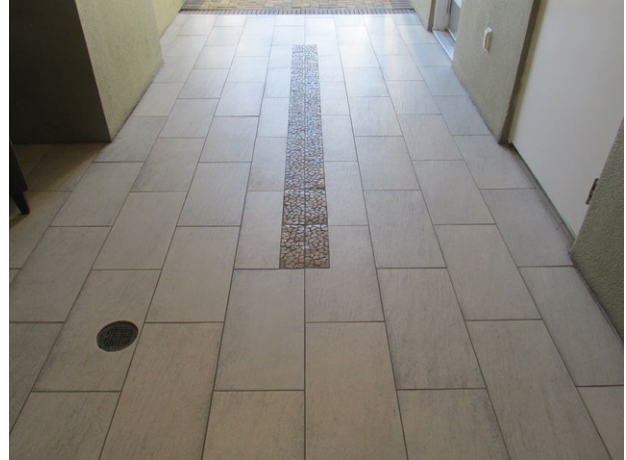
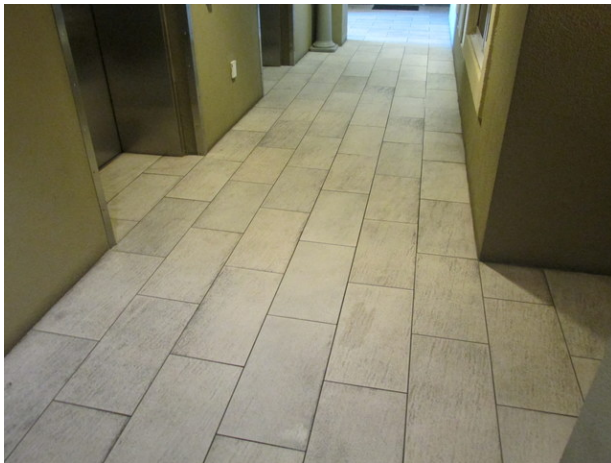
Tile floor coverings at Tower 2 6th floor breezeway

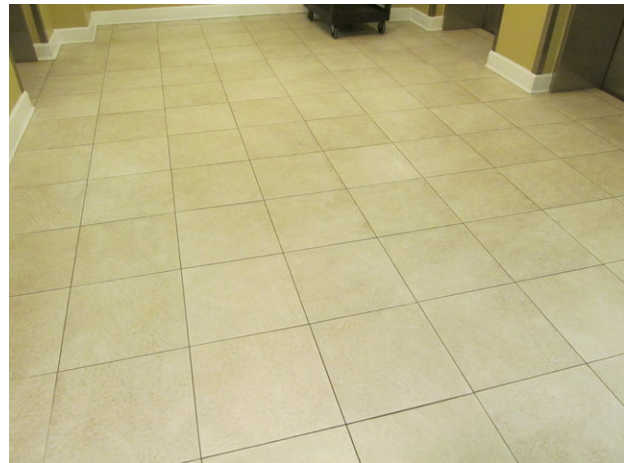
Tile floor coverings at Tower 1 garage lobby

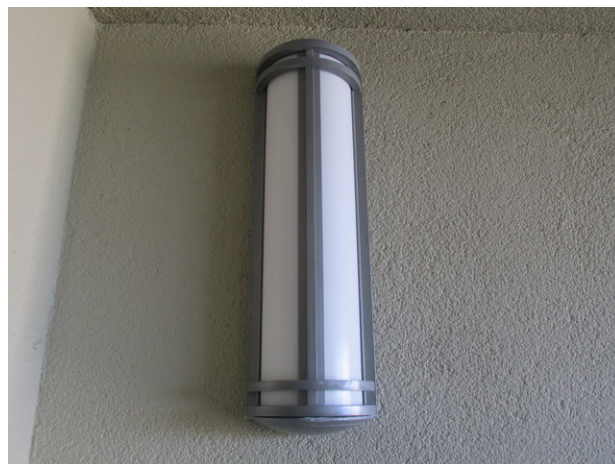
Typical wall-mounted breezeway light fixture

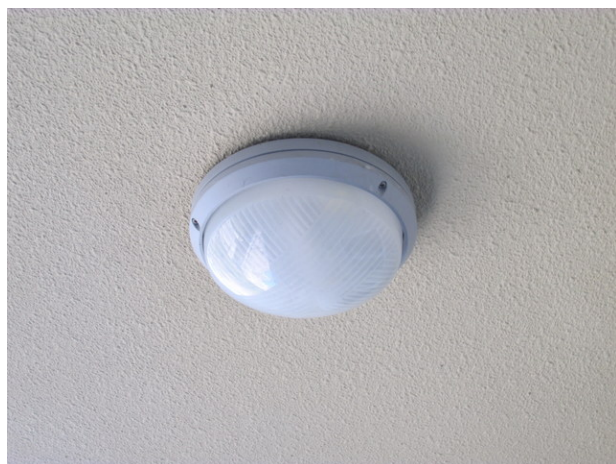
Typical ceiling-mounted breezeway light fixture

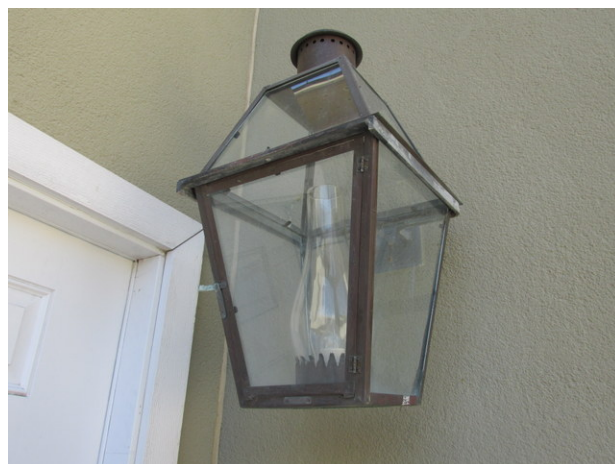
Light fixture at Tower 1 garage entrance

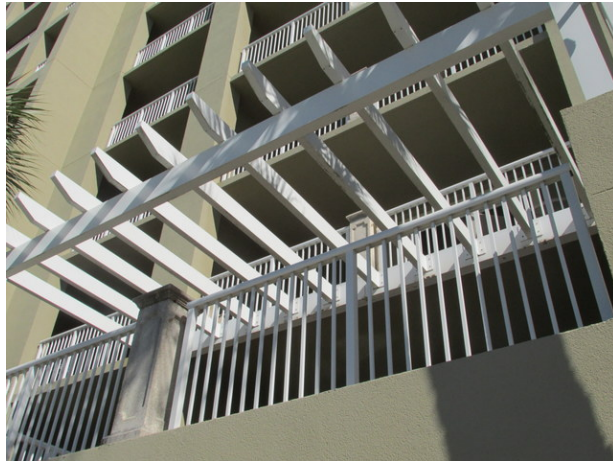
Aluminum pergola at rear of Tower 1

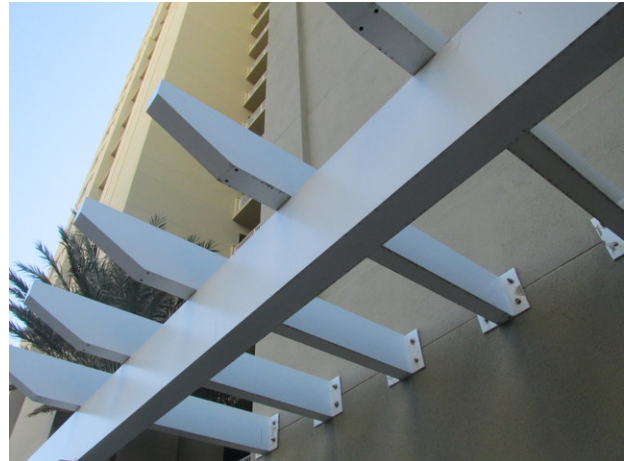
Aluminum pergola at front of Tower 1

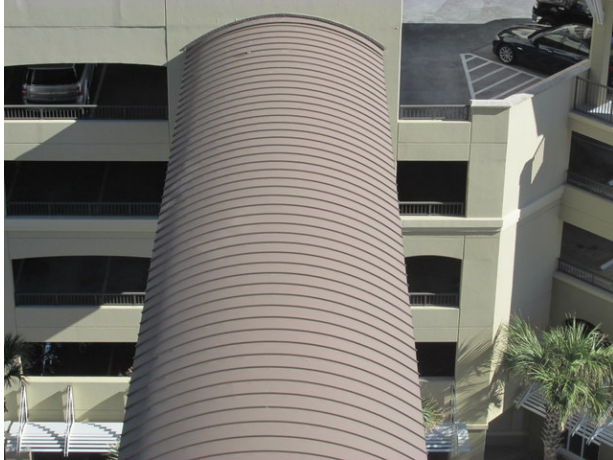
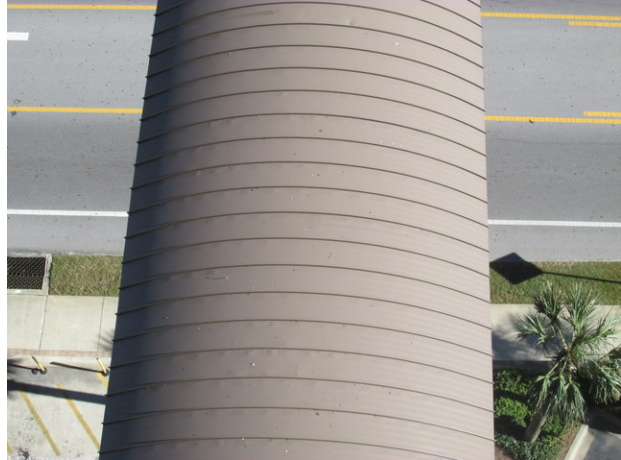
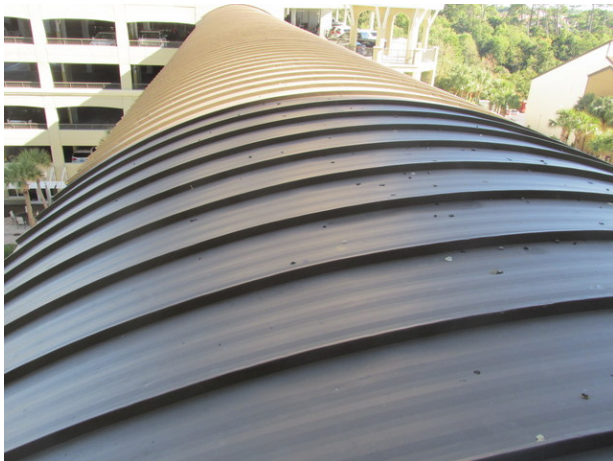
Condition: Good overall. Management does not report leaks.

Metal roof at skywalk

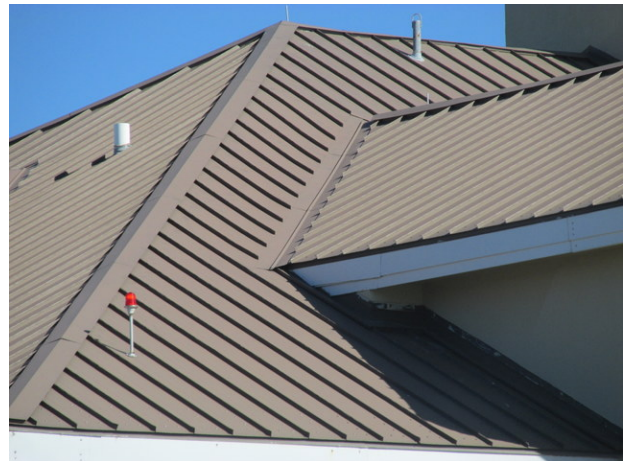
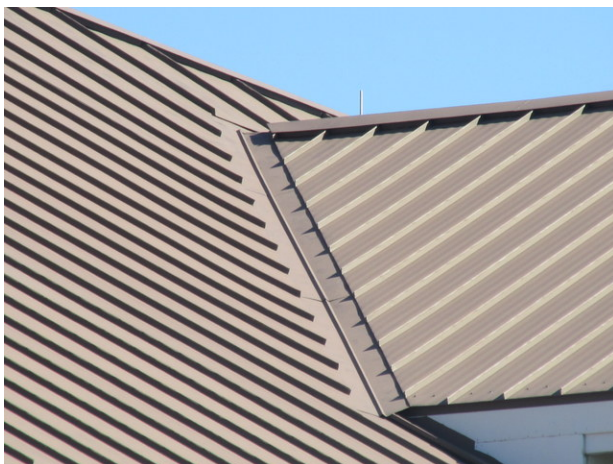
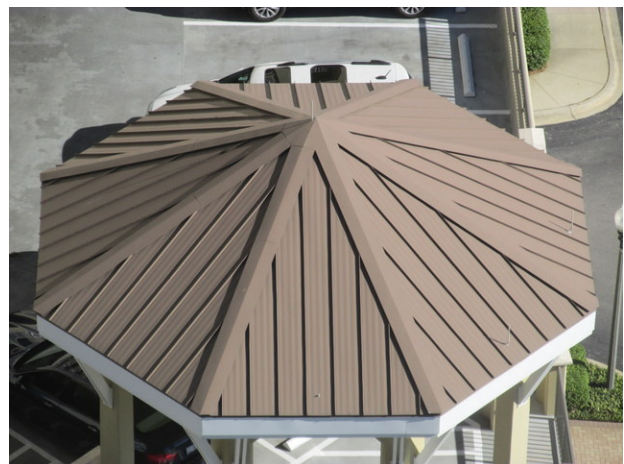
Metal roof at Tower 2

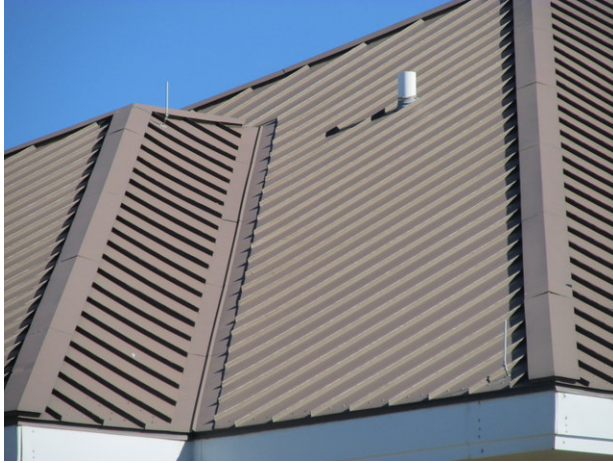
Metal roof at Tower 1

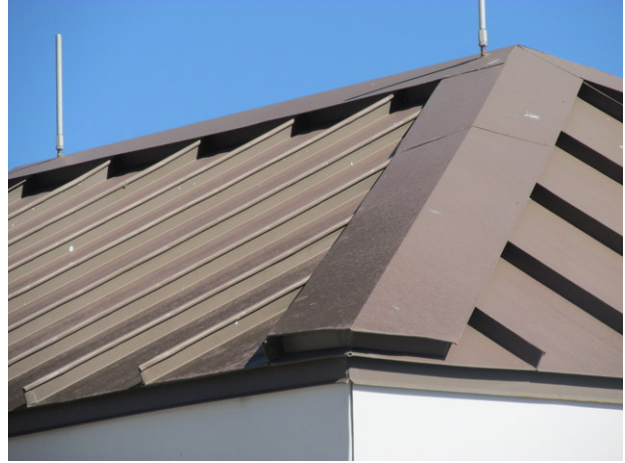
Metal roof at stairwell at Tower 2

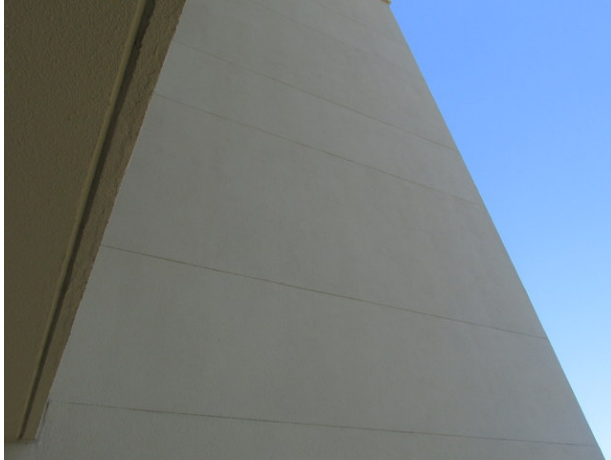
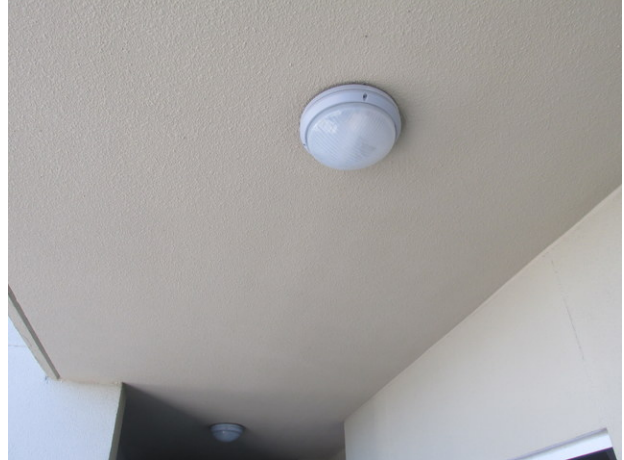
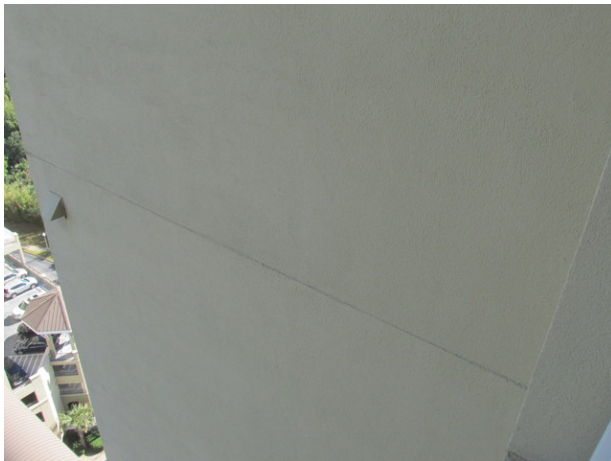
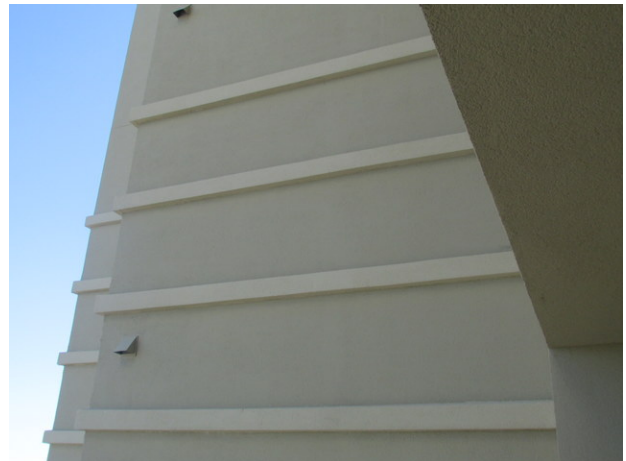
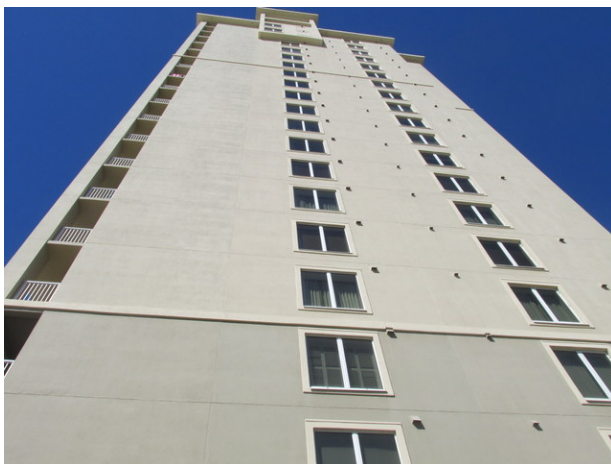
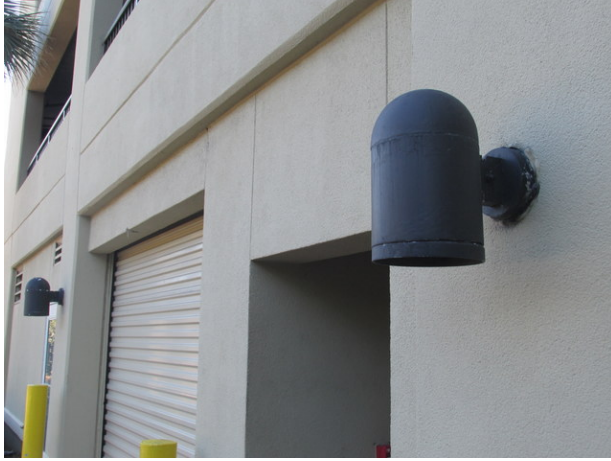
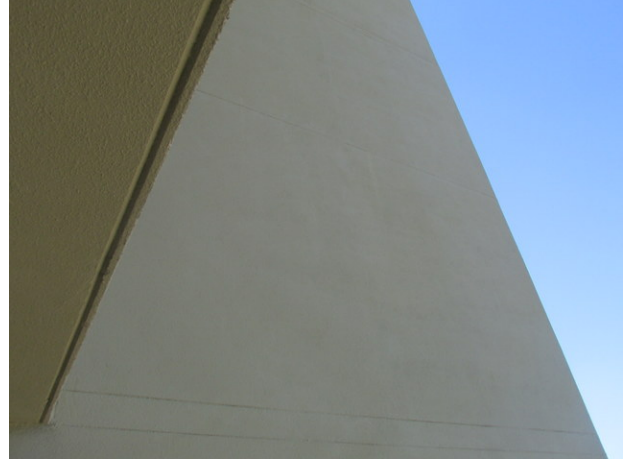
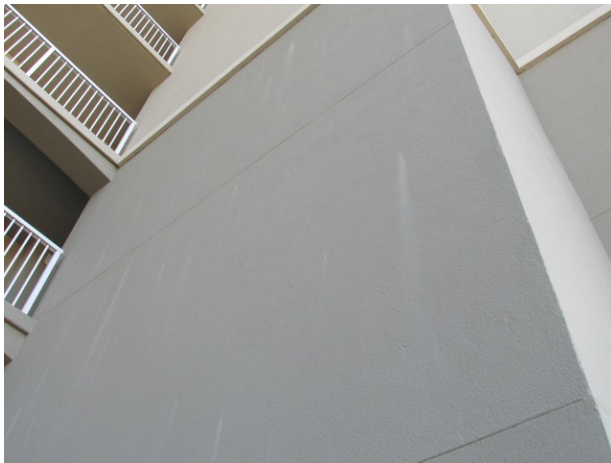
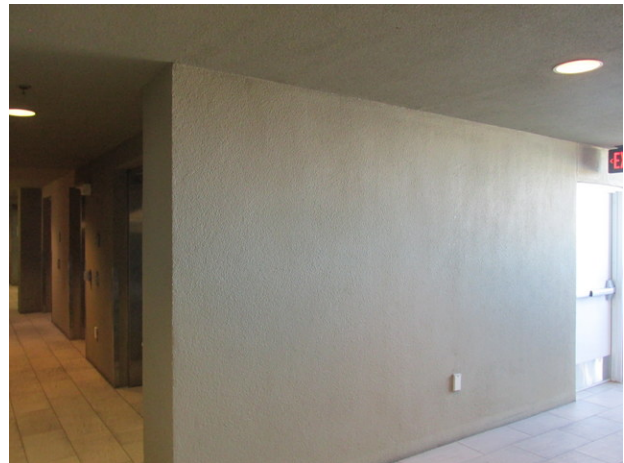
Condition: Good overall

Exterior stucco finishes

- Crack repairs as needed (Each paint product has the limited ability to cover and seal cracks but we recommend repair of all cracks which exceed the ability of the paint product to bridge.)
- Replacement of up to one percent (1%), of the stucco walls (The exact amount of area in need of replacement will be discretionary based on the actual future conditions and the desired appearance.)
- Replacement of up to fifty percent (50%) of the sealants in coordination with each paint finish application.

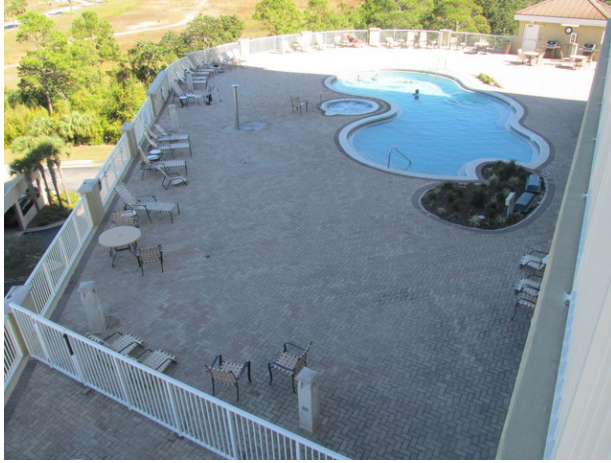
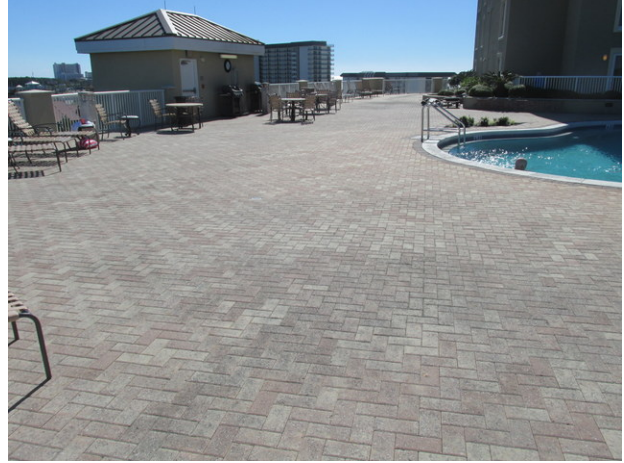
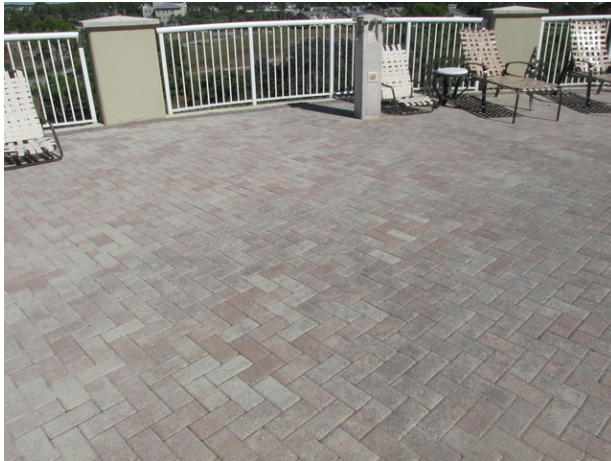
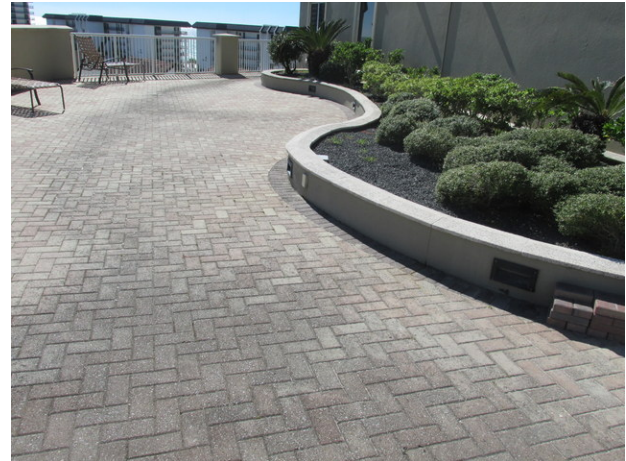
Condition: Good overall condition

Overview of plaza deck at Tower 2

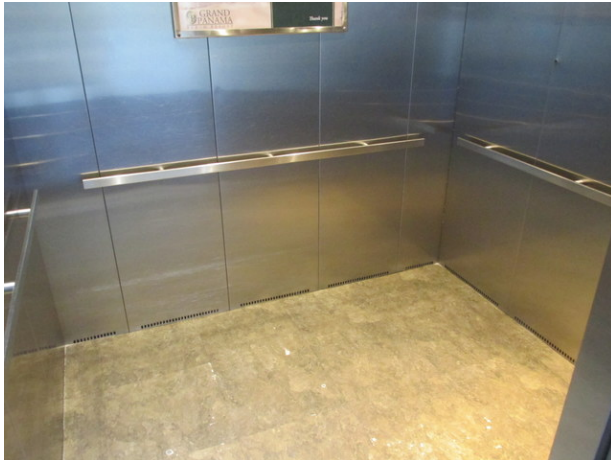
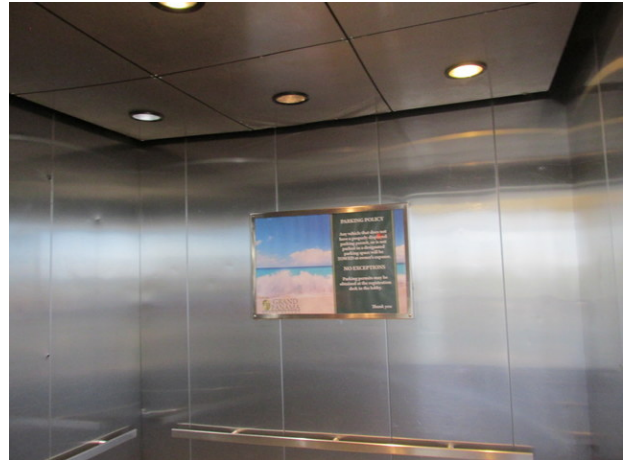
Condition: Good overall with the exception of the tile floor coverings. We note deterioration at the floor coverings. Management informs us that the Association plans to apply epoxy floor coverings at the cabs in 2018.

Elevator cab finishes

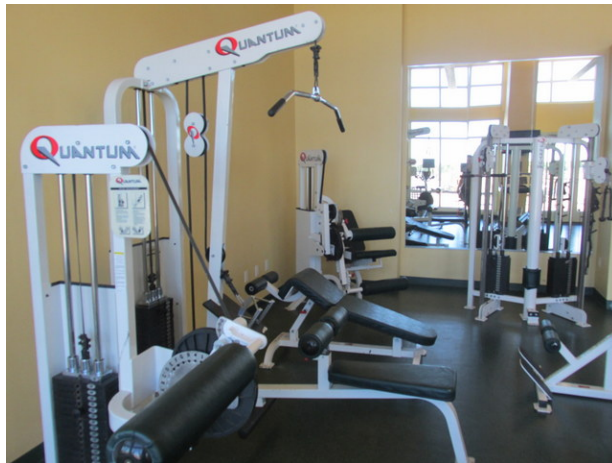
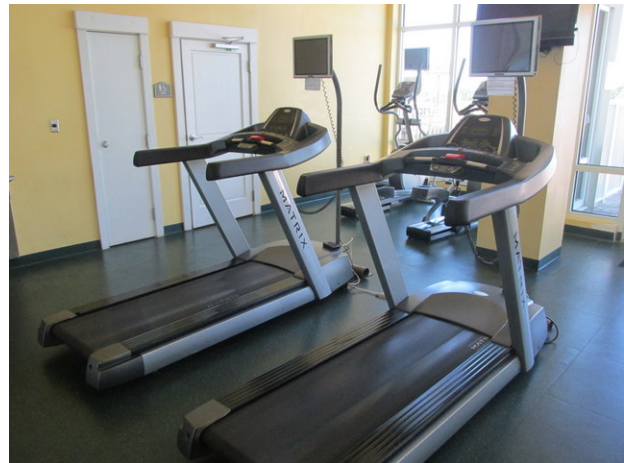
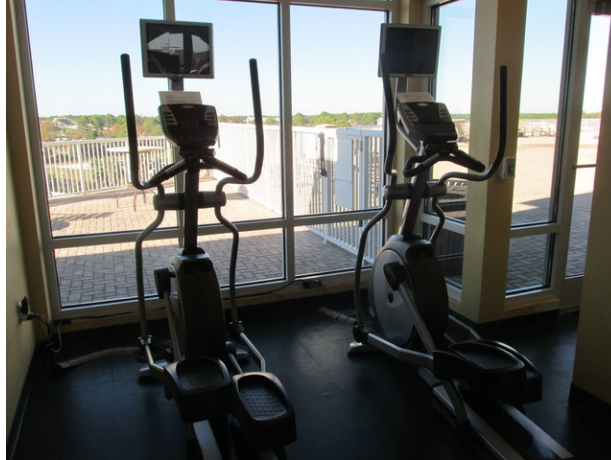
Conditions: Good reported operational condition

Exercise equipment

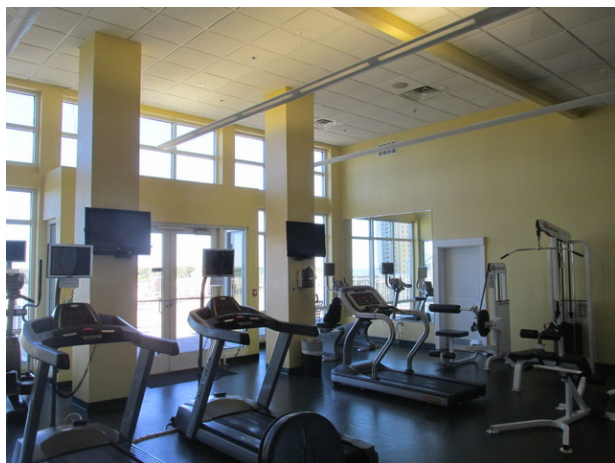
Exercise room finishes and fixtures

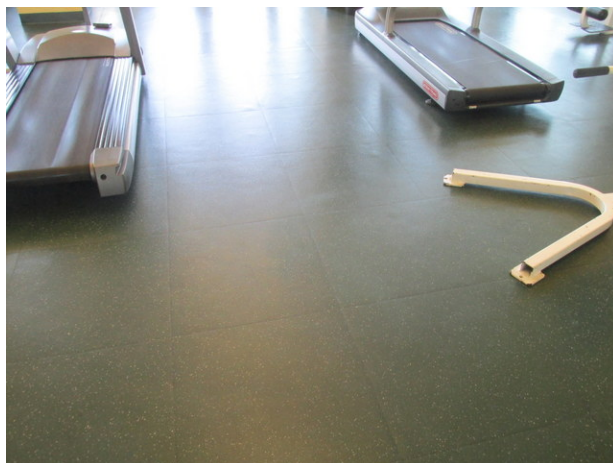
Floor coverings at exercise room

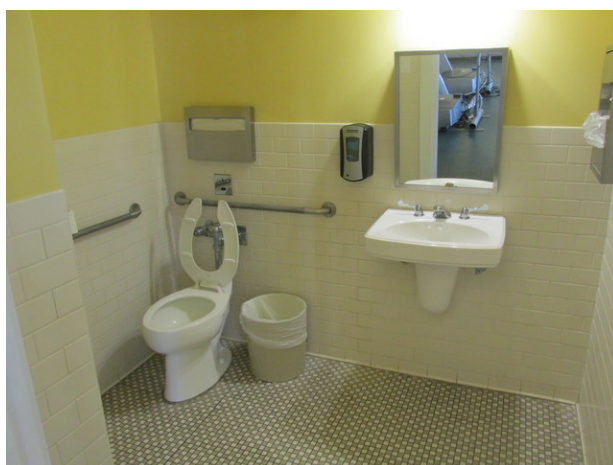
Rest room finishes and fixtures at exercise room

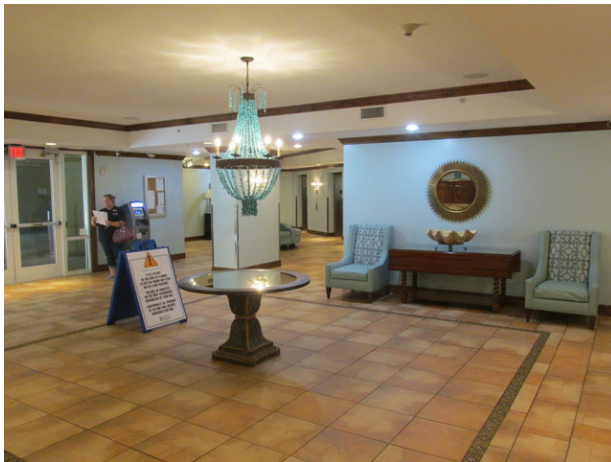
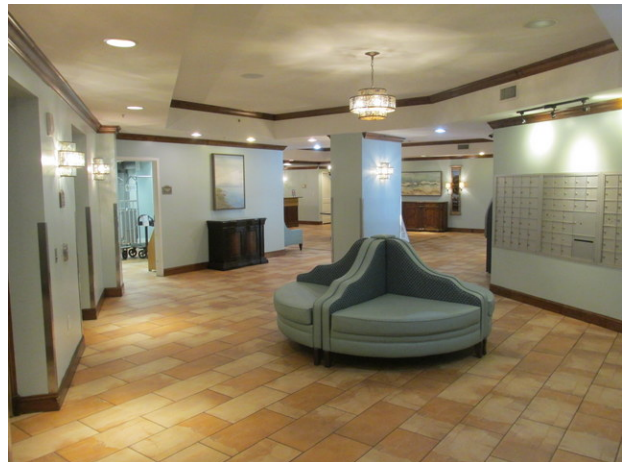
Condition: Good overall condition

Lobby finishes and fixtures

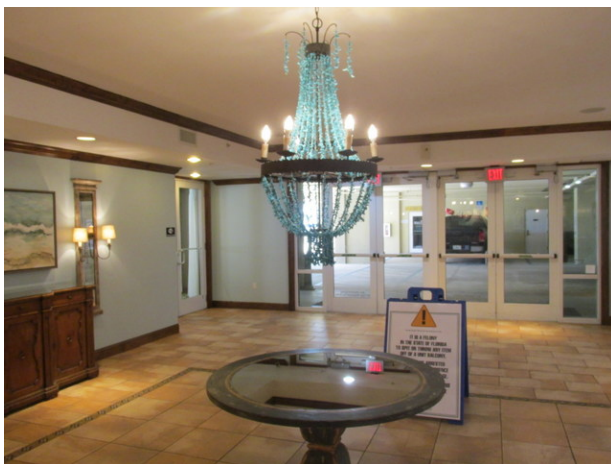
Lobby finishes and fixtures

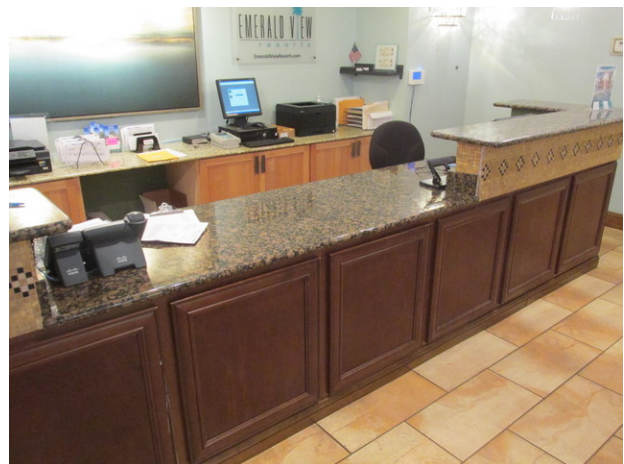
Lobby finishes and fixtures

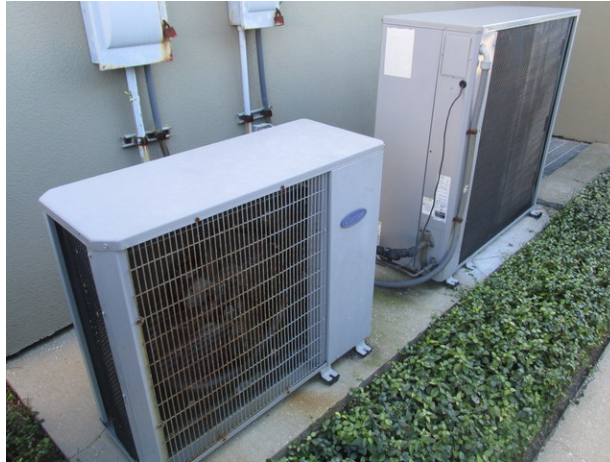
Condition: Reported in satisfactory operational condition

Split system condensing units

Expenditure Detail Notes: Expenditure timing and costs are depicted in the **Reserve Expenditures** table in Section 3. The condensing unit may require replacement prior to replacement of the related interior forced air unit. For purposes of this Reserve Study, we assume coordination of replacement of the interior forced air unit, evaporator coil, refrigerant lines and exterior condensing unit. We include a phased replacement of the systems.

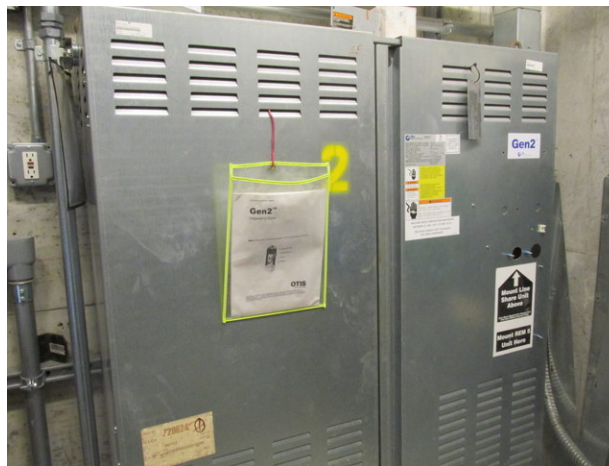
Condition: Reported satisfactory and service interruptions are reportedly infrequent.

Elevator equipment

Expenditure Detail Notes: Expenditure timing and costs are depicted in the **Reserve Expenditures** table in Section 3. We anticipate replacement of the following traction elevator system components:

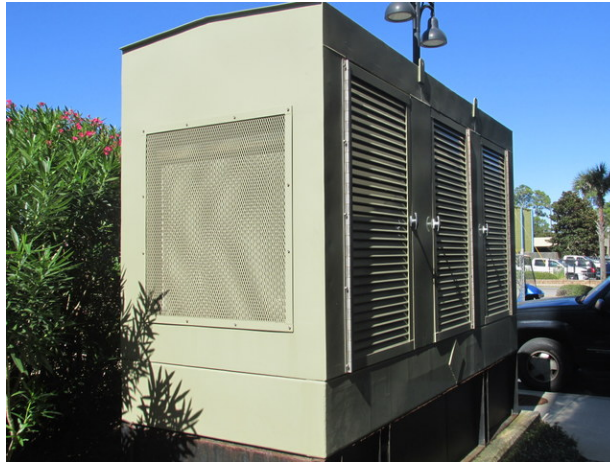
Condition: Reported in satisfactory operational condition

Emergency generator at Tower 1

Expenditure Detail Notes: Expenditure timing and costs are depicted in the **Reserve Expenditures** table in Section 3. Our estimate of cost includes replacement of the transfer switches.

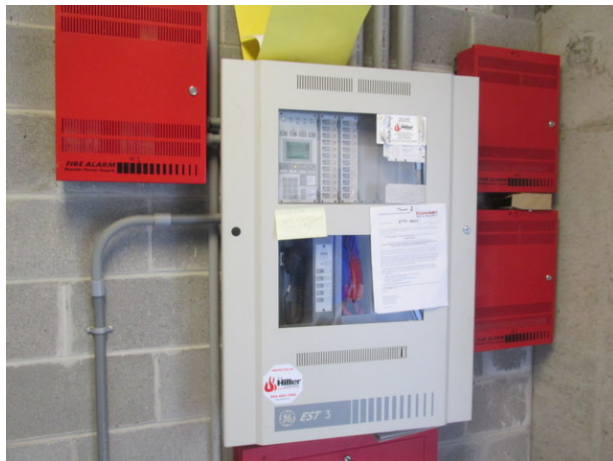
Conditions: Reported satisfactory. We note isolated emergency fixtures with deteriorated finishes. The Association should replace deteriorated fixtures as needed and fund this activity through the operating budget.

Life safety system control panel

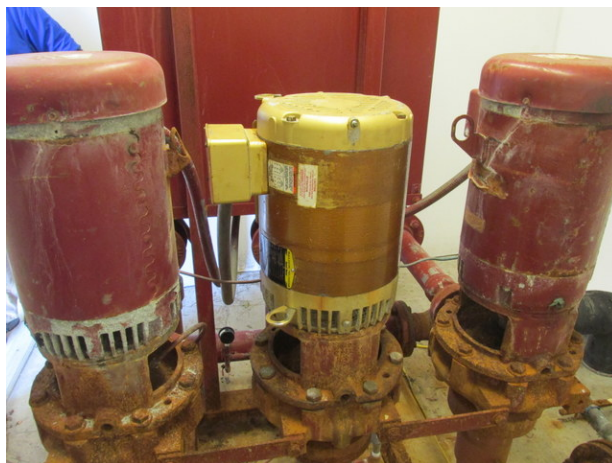
Conditions: Reported in satisfactory operational condition.

Domestic water booster pumps at Tower 1

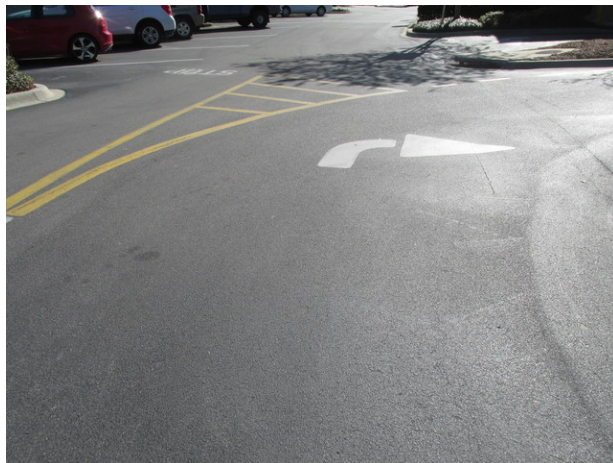
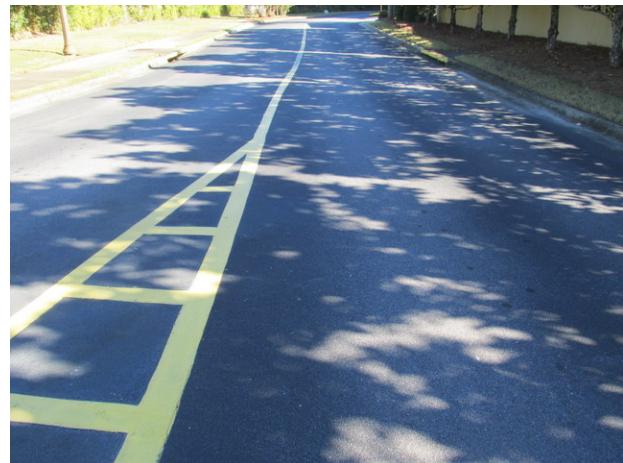
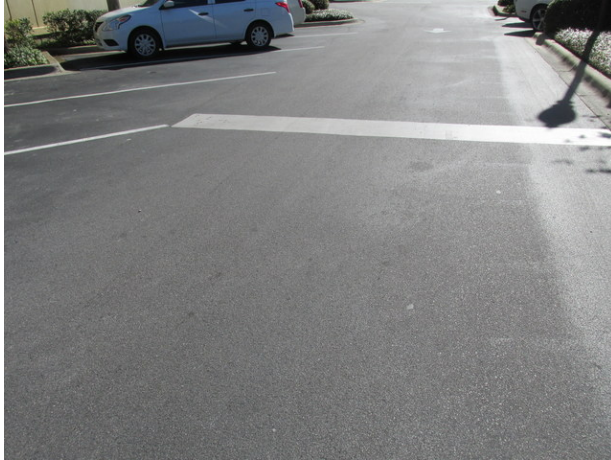
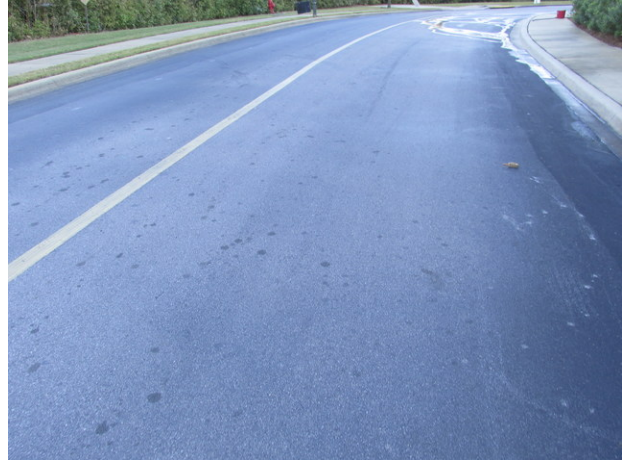
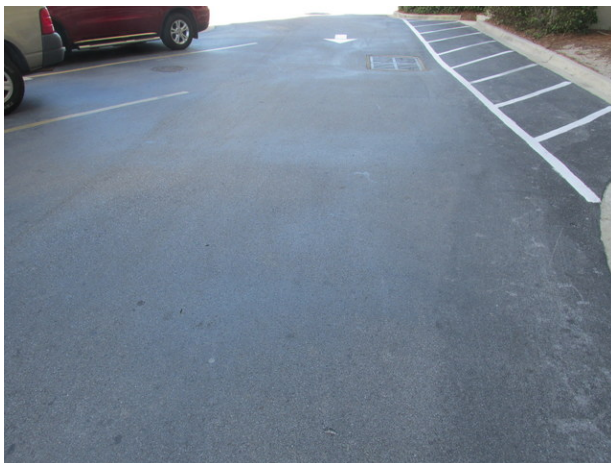
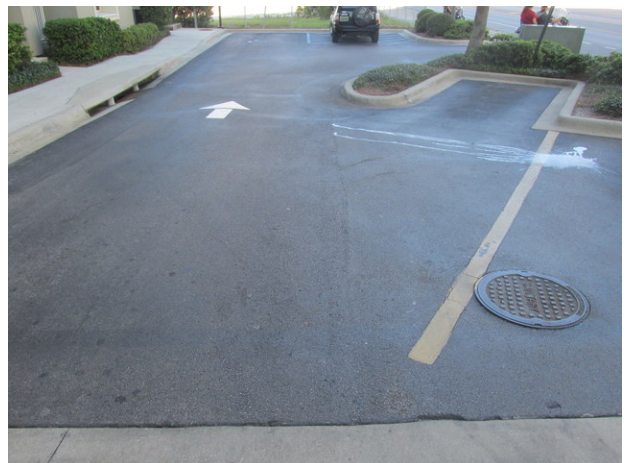
Condition: Good overall condition. We note isolated concrete deterioration and exposed rebar at a catch basin at the Tower 2 parking area.

Asphalt pavement at Tower 2 parking area

Expenditure Detail Notes: Expenditure timing and costs are depicted in the **Reserve Expenditures** table in Section 3. Our cost for milling and overlayment includes area patching of up to ten percent (10%) and capital repairs to the nine catch basins.

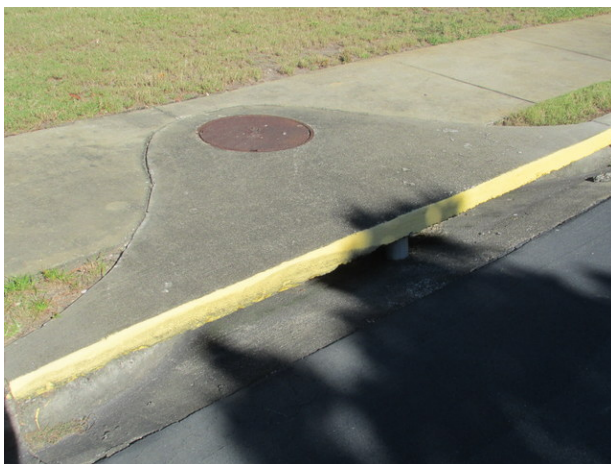
Catch basin

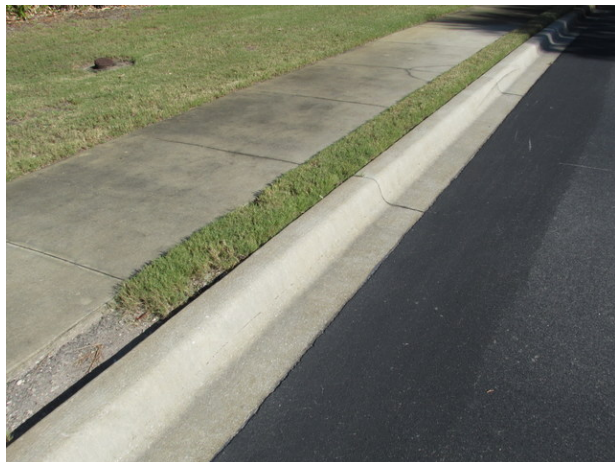
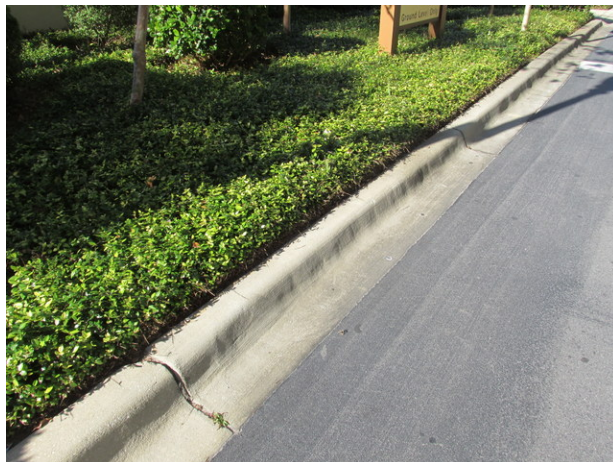
Condition: Good overall

Concrete curb and gutter

Expenditure Detail Notes: Expenditure timing and costs are depicted in the **Reserve Expenditures** table in Section 3. We estimate that up to 550 linear feet of curbs and gutters, or approximately twenty percent (20.2%) of the total, will require replacement during the next 30 years.

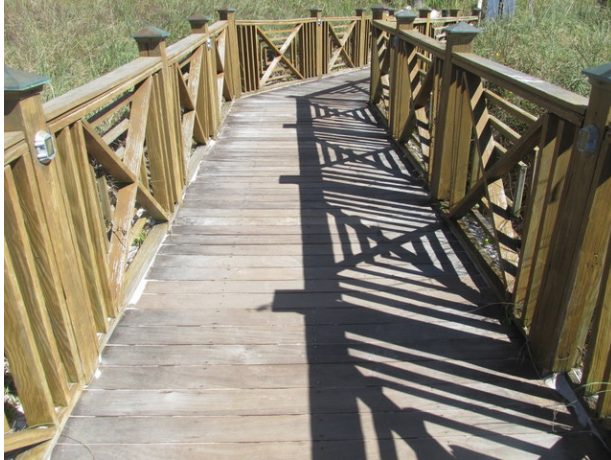
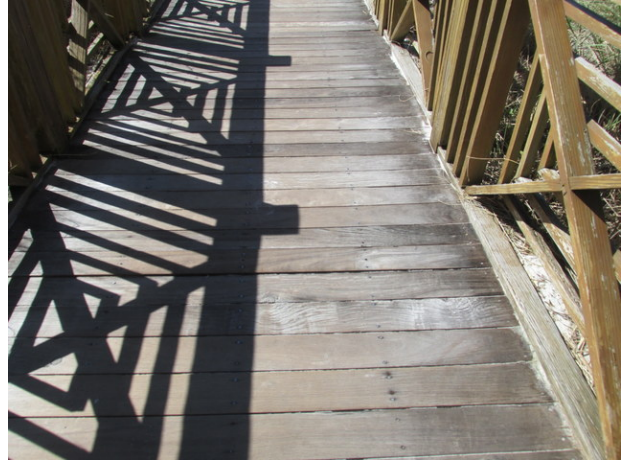
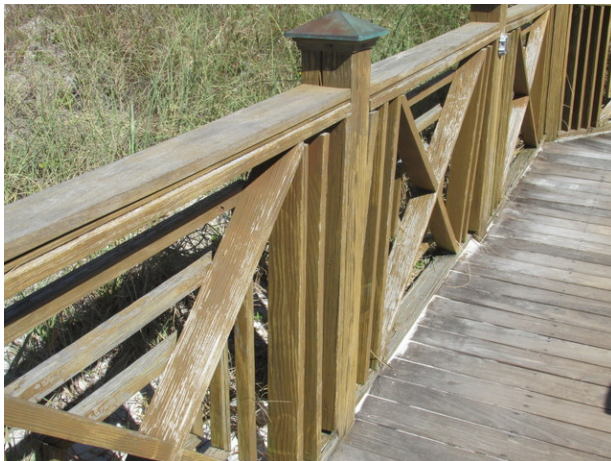
Condition: Good overall condition

Wood decking and railings at dune walkover
