FULL RESERVE STUDY

Grand Panama Beach Resort Condominium Association, Inc.

Panama City Beach, Florida

October 27, 2017

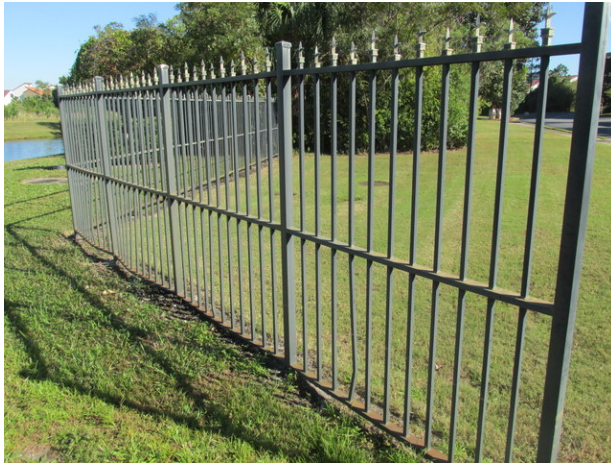
Condition: Good to fair overall. We note isolated damage and finish deterioration.

Aluminum fence adjacent to gate house

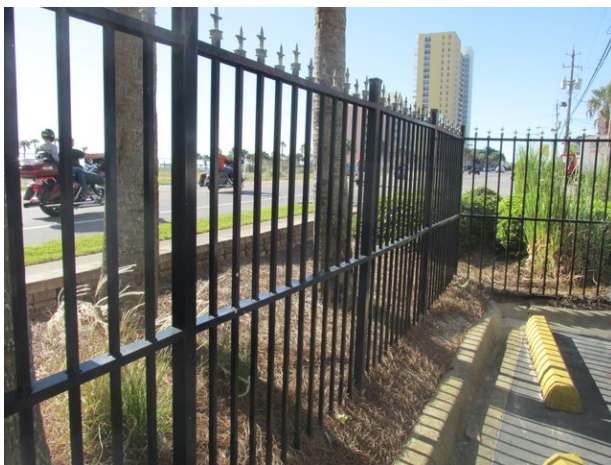
Aluminum fence at Tower 2 parking area

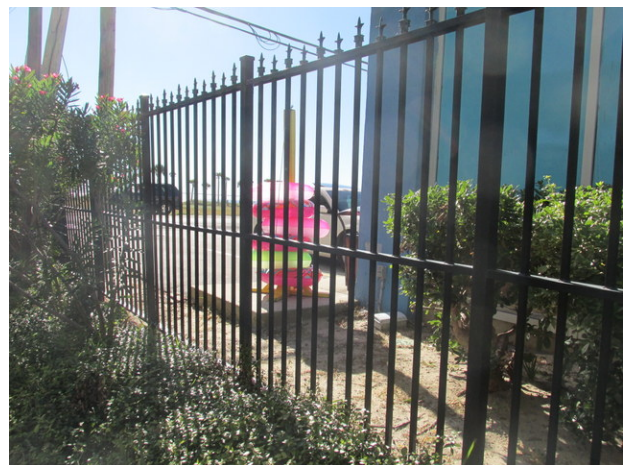
Aluminum fence at Tower 2 parking area

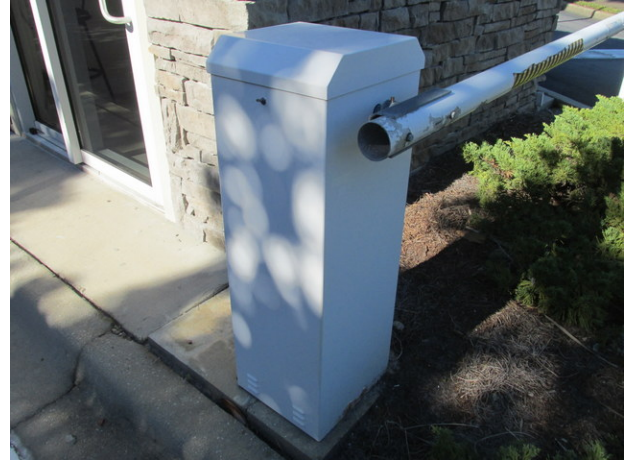
Condition: The operators were not in operation at the time of our inspection.

Swing-arm gate operator at gate house

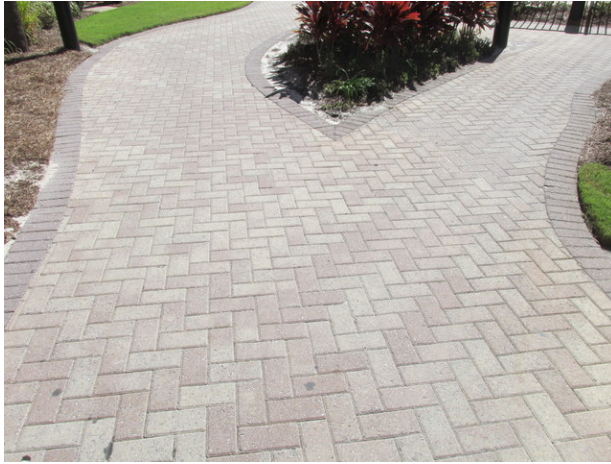
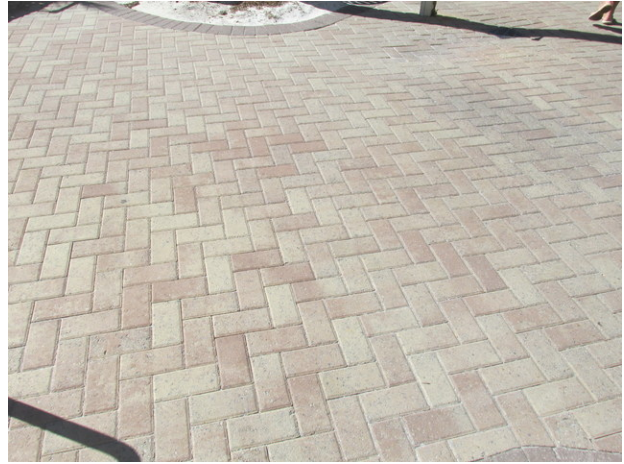
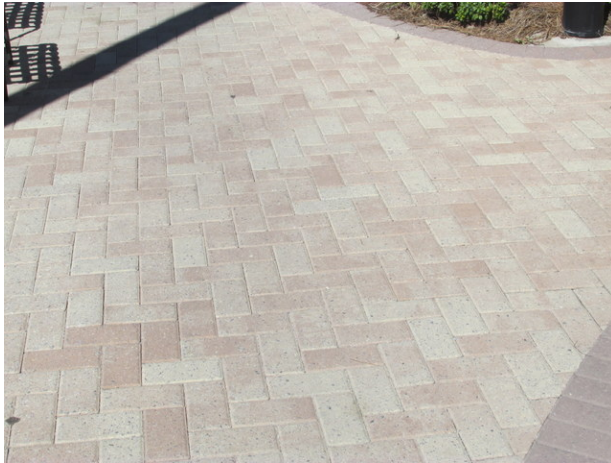
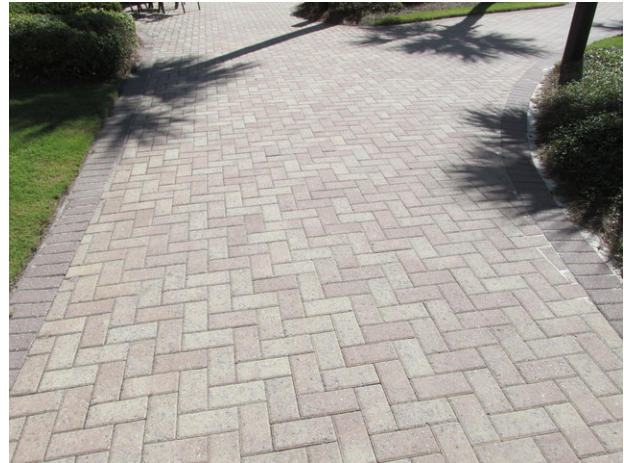
Condition: Error! Not a valid link. overall with no visible deterioration evident

Pavers at Tower 1 pool area

Expenditure Detail Notes: Expenditure timing and costs are depicted in the **Reserve Expenditures** table in Section 3. We suggest the Association conduct interim resetting and replacement of minor areas of pavers as normal maintenance, funded from the operating budget.

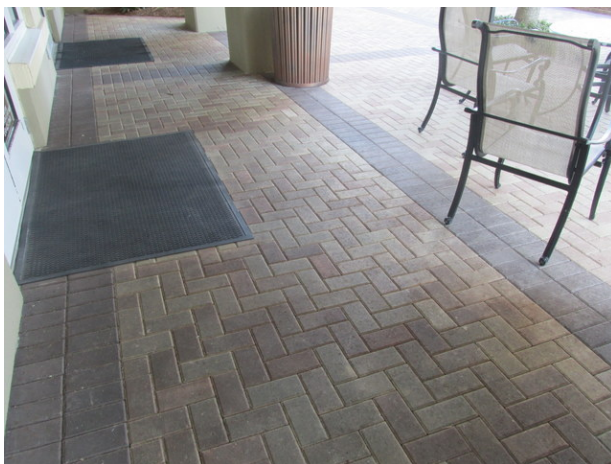
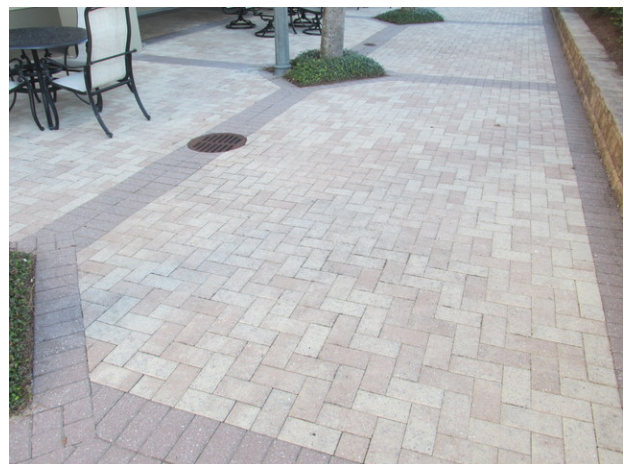
Pavers at front of Tower 2

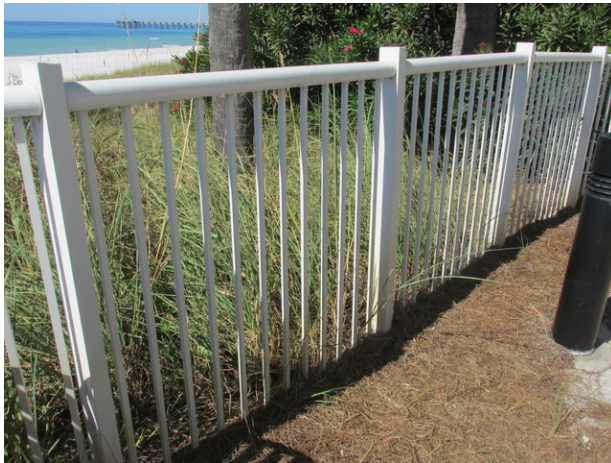
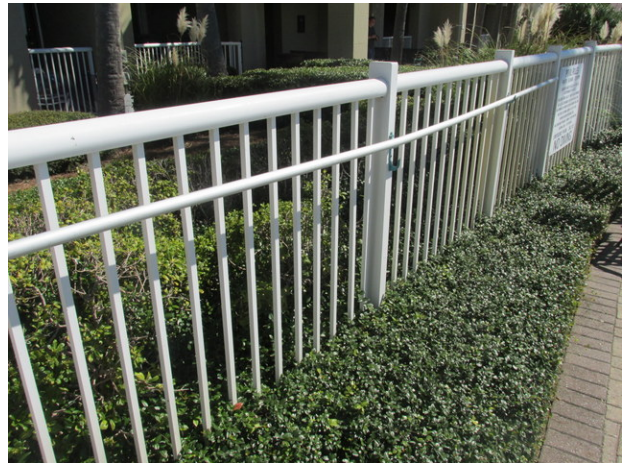
Condition: Good overall condition

Aluminum fence at Tower 1 pool area

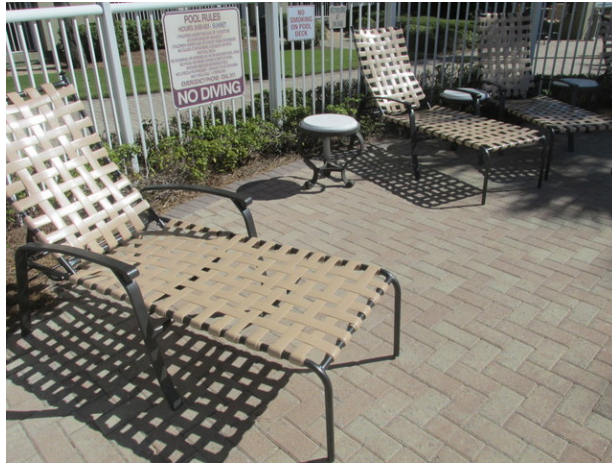
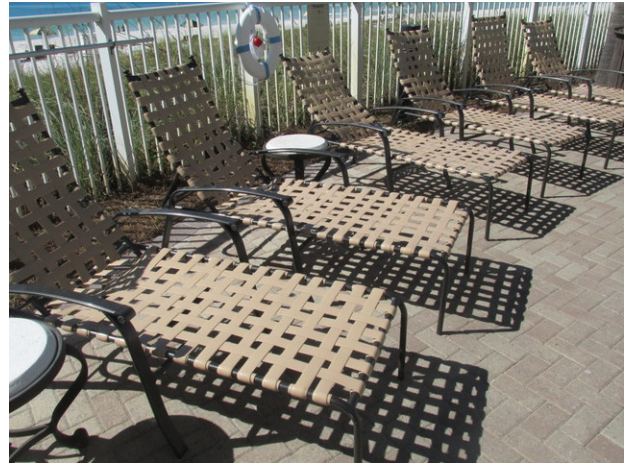
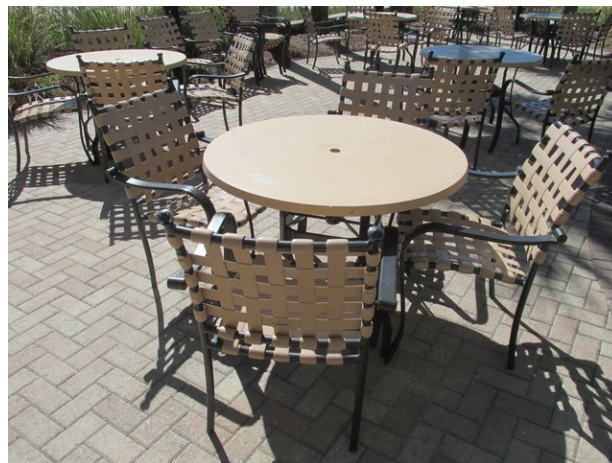
Condition: Good overall

Pool furniture at Tower 1 pool

Expenditure Detail Notes: Expenditure timing and costs are depicted in the **Reserve Expenditures** table in Section 3. We recommend interim re-strapping, refinishing and other repairs to the furniture as normal maintenance to maximize its useful life.

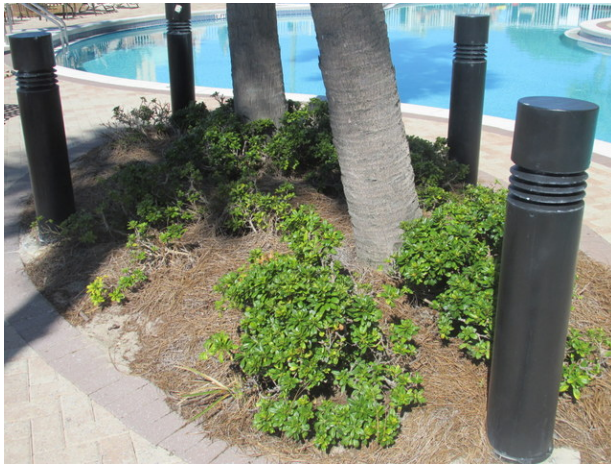
Condition: We note several bollards with deteriorated finishes. The Association should apply finishes to the bollards on an as-needed basis and fund this activity through the operating budget.

Bollard-type light fixtures at Tower 1 pool area

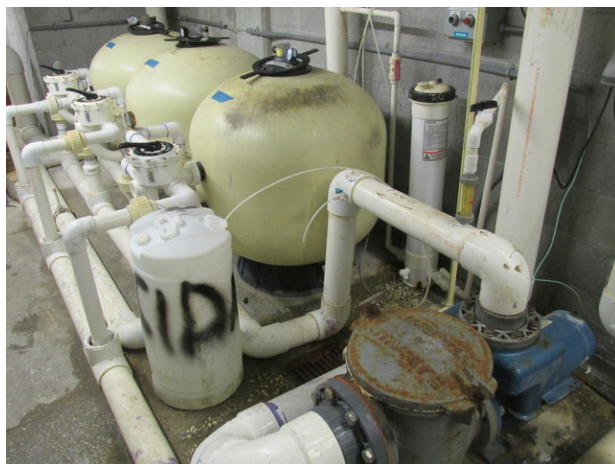
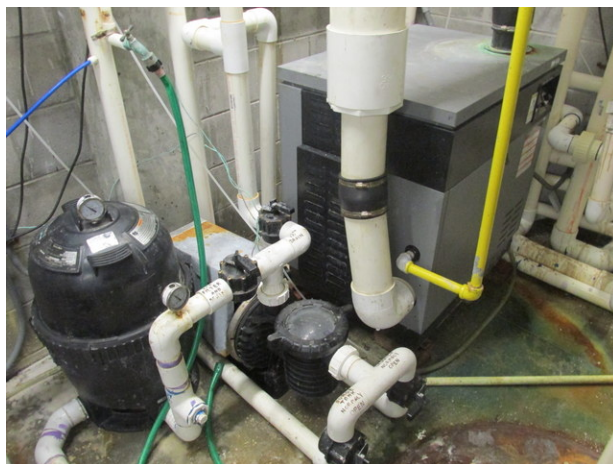
Condition: Reported in satisfactory operational condition

Pool mechanical equipment

Expenditure Detail Notes: Expenditure timing and costs are depicted in the **Reserve Expenditures** table in Section 3. Failure of the pool mechanical equipment as a single event is unlikely. We consider interim replacement of motors and minor repairs as normal maintenance.

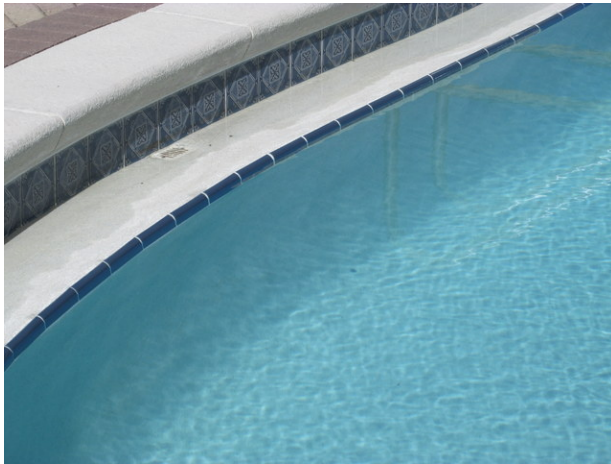
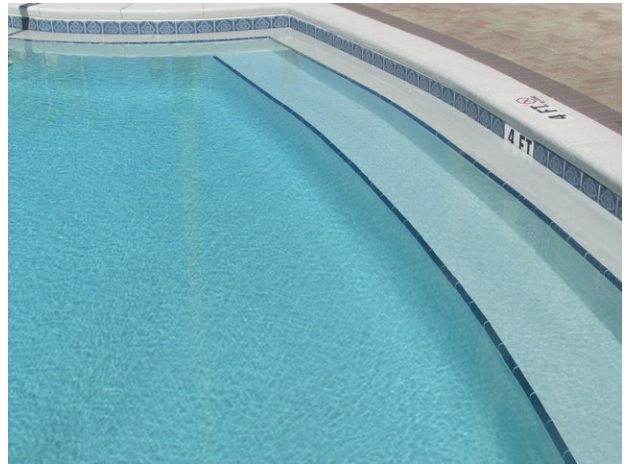
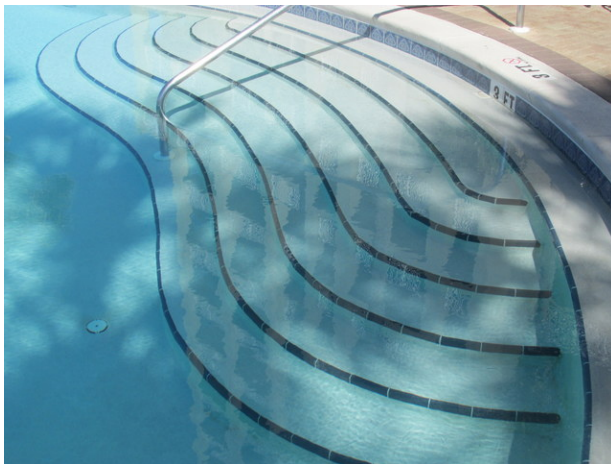
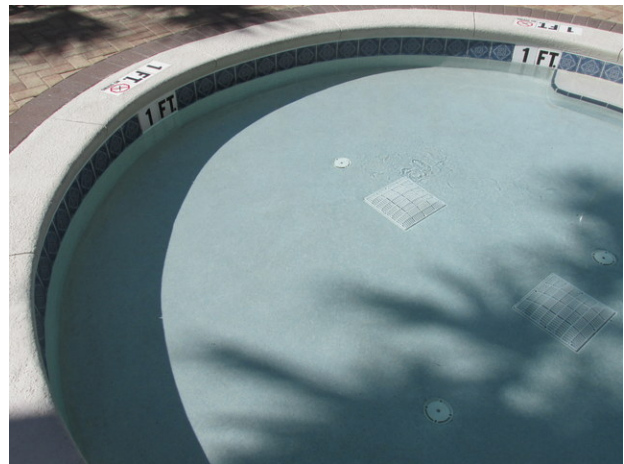
Condition: Good overall condition

Pool plaster finish and tile at Tower 1 pool

Pool plaster finish and tile at Tower 1 spa

Component Detail Notes: Removal and replacement provides the opportunity to inspect the pool structures and to allow for partial repairs of the underlying concrete surfaces as needed. To maintain the integrity of the pool structures, we recommend the Association budget for the following:

- Removal and replacement of the plaster finishes
- Partial replacements of the scuppers and coping as needed
- Replacement of tiles as needed
- Replacement of joint sealants as needed
- Concrete structure repairs as needed

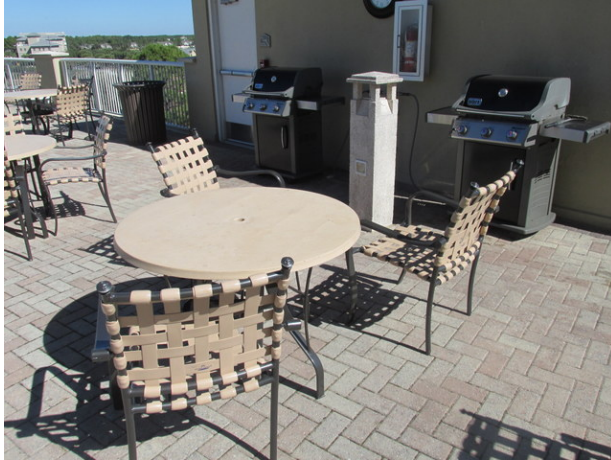
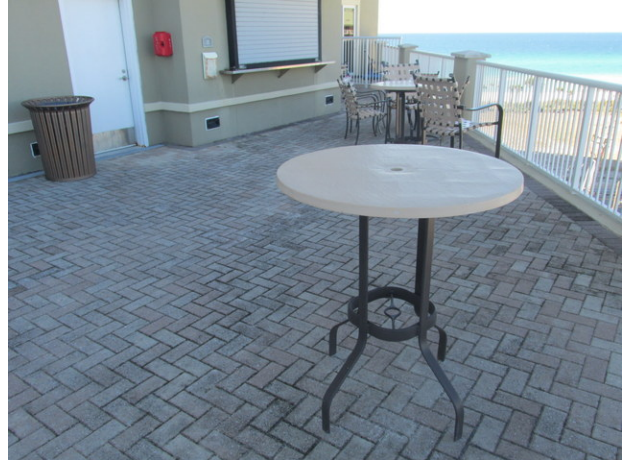
Condition: Good overall

Furniture at Tower 2 pool area

Expenditure Detail Notes: Expenditure timing and costs are depicted in the **Reserve Expenditures** table in Section 3. We recommend interim re-strapping, refinishing and other repairs to the furniture as normal maintenance to maximize its useful life.

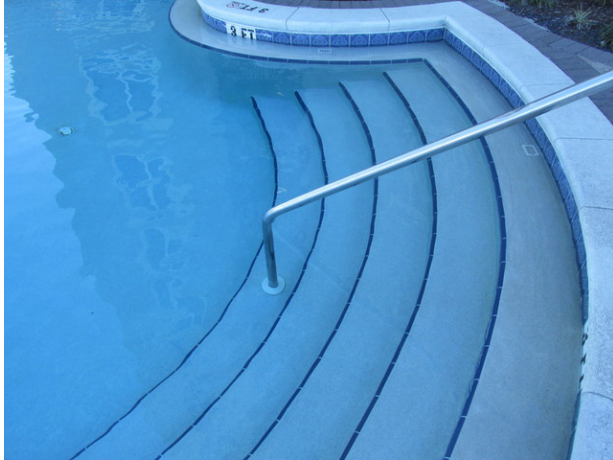
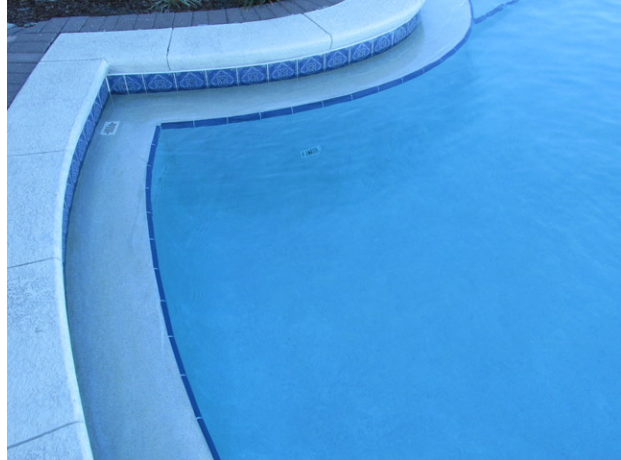
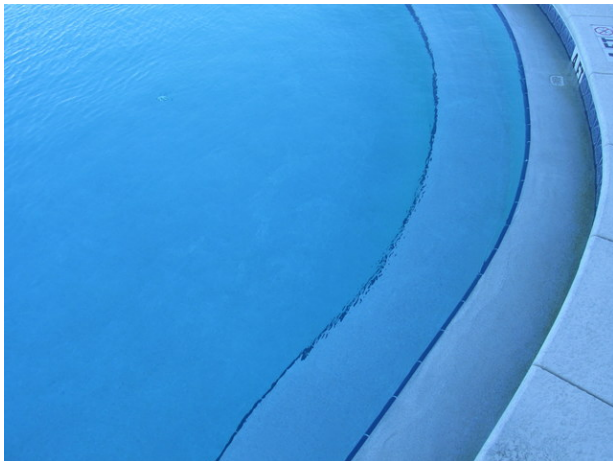
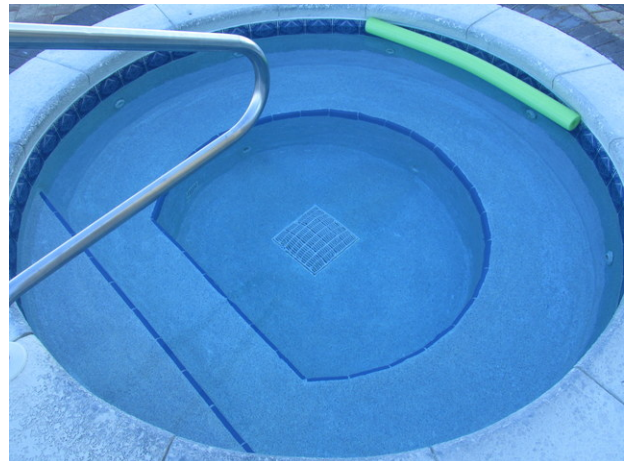
Condition: Good overall condition

Pool plaster finish and tile at Tower 2 pool

Pool plaster finish and tile at Tower 2 spa

Component Detail Notes: Removal and replacement provides the opportunity to inspect the pool structures and to allow for partial repairs of the underlying concrete surfaces as needed. To maintain the integrity of the pool structures, we recommend the Association budget for the following:

- Removal and replacement of the plaster finishes
- Partial replacements of the scuppers and coping as needed
- Replacement of tiles as needed
- Replacement of joint sealants as needed
- Concrete structure repairs as needed

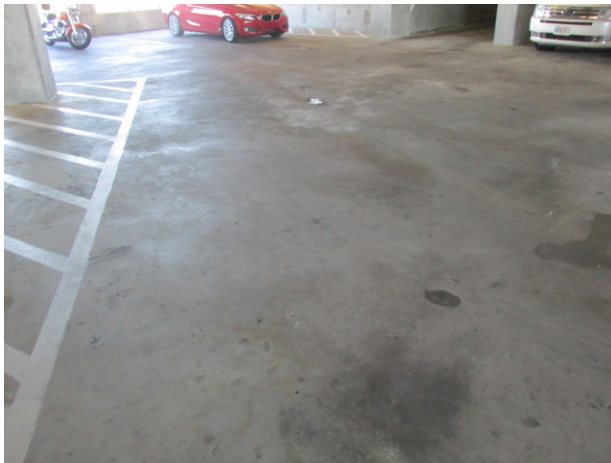
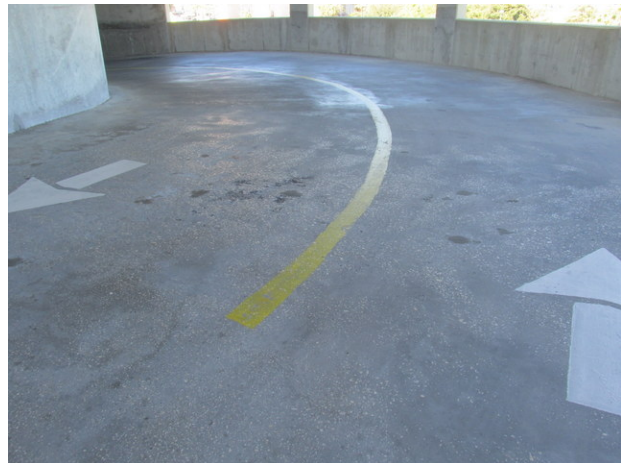
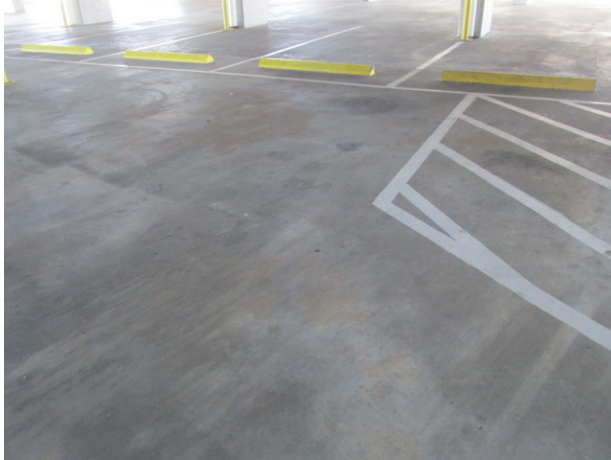
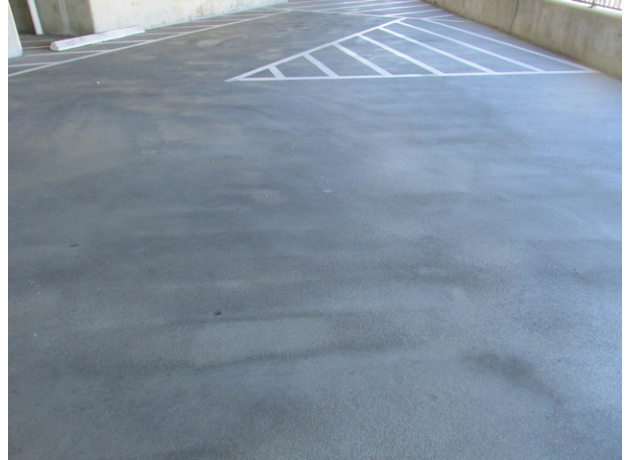
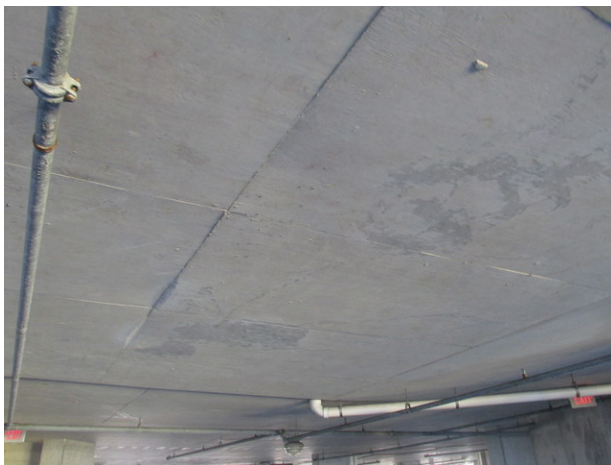
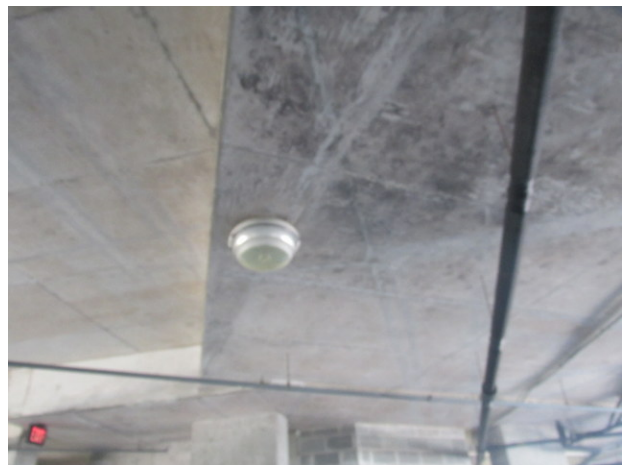
Condition: Good overall with no visible deterioration evident. The elevated structural concrete at Level 2 of the Tower 2 garage utilizes a protective traffic coating.

Elevated concrete at Tower 2 garage

- Complete inspection of the garage concrete
- Partial depth concrete replacement of a limited amount of the surface area of the concrete floors
- Partial depth concrete replacement of a limited amount of the surface area of the elevated structural concrete ceilings
- Remediation of structural concrete columns and beams as needed
- Crack repairs on all surfaces as needed

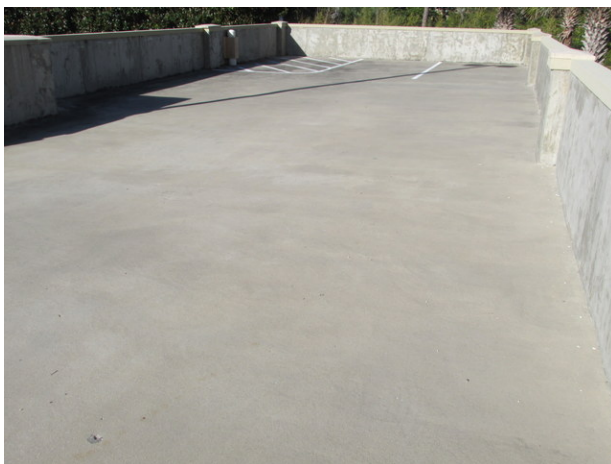
Elevated concrete at separate garage structure

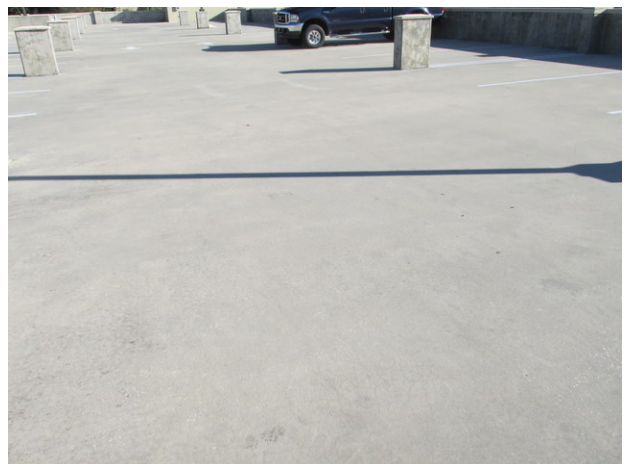
Elevated concrete at separate garage structure

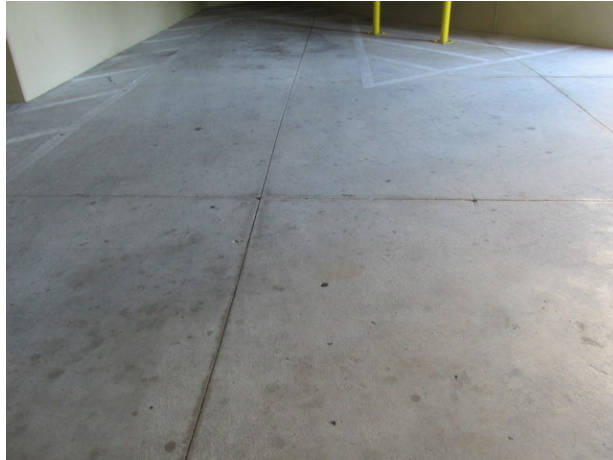
On-grade concrete at Tower 2 garage

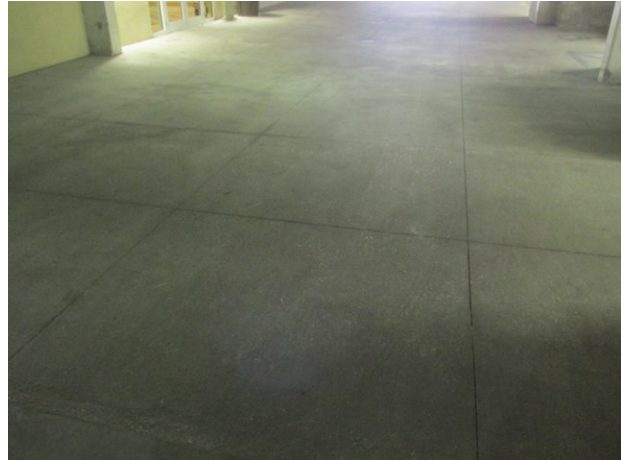
On-grade concrete at Tower 1 garage

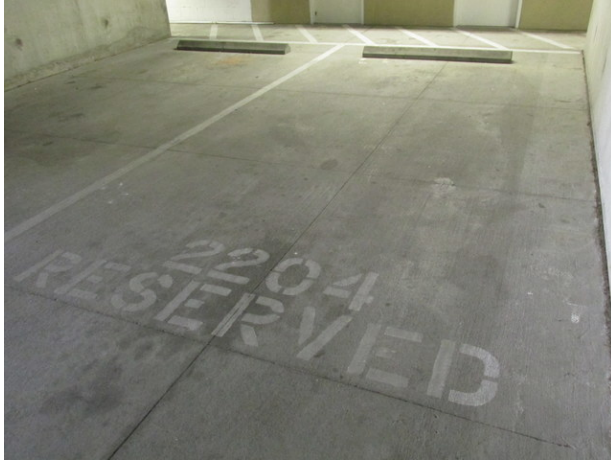
On-grade concrete at Tower 1 garage

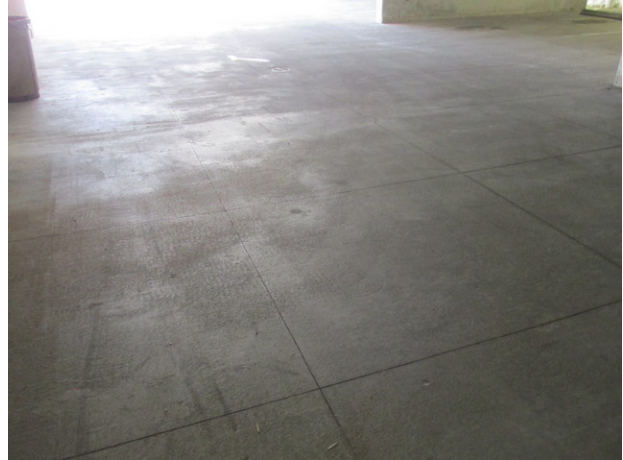
On-grade concrete at Tower 1 garage

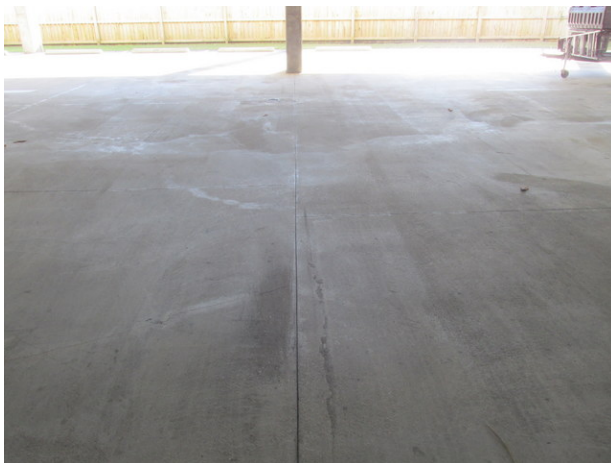
On-grade concrete at separate garage structure

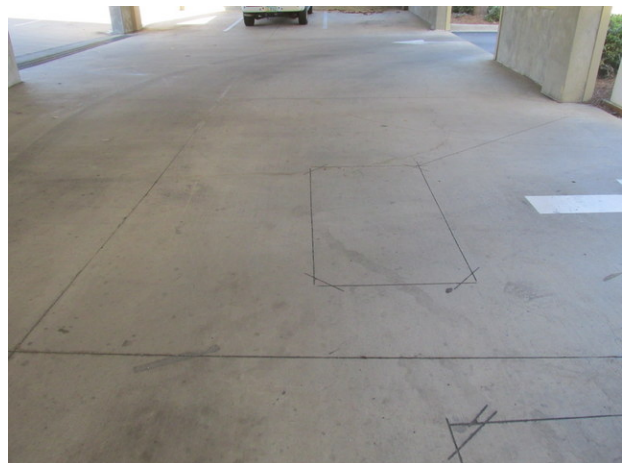
Condition: Good overall

On-grade concrete at separate garage structure

- Complete inspection of the floor
- Selective cut out and replacement of up to three percent (3.3%), or 1,515 square feet, of the on-grade concrete
- Crack repairs as needed

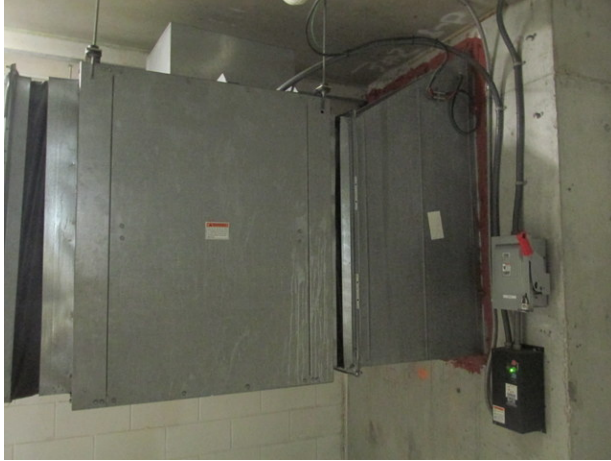
Exhaust fan at Tower 1 garage

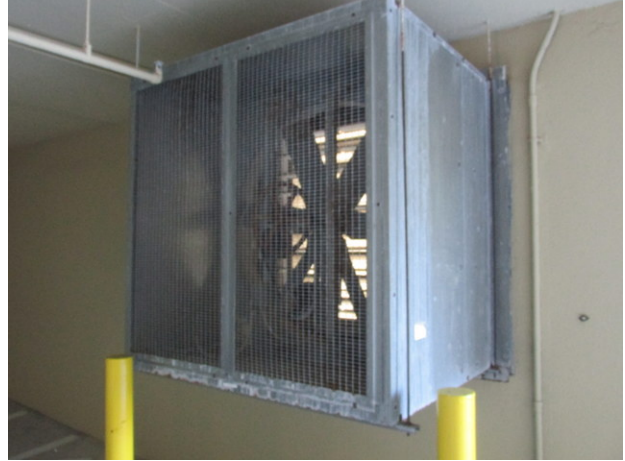
Condition: Reported satisfactory

Exhaust fan at Tower 2 garage

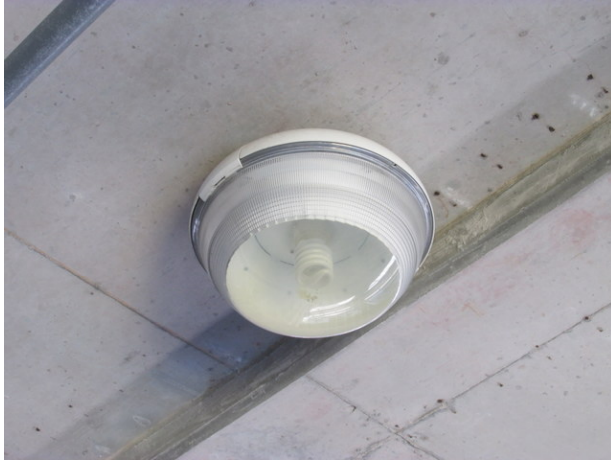
Typical light fixture at garages at Towers 1 and 2

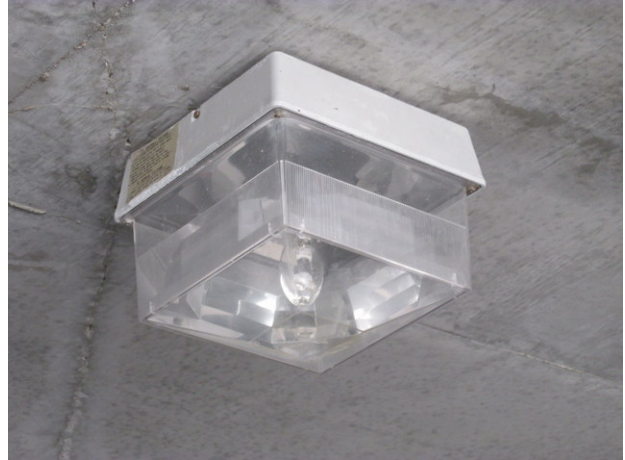
Condition: Good overall condition. We note missing fixtures and covers at the separate garage structure.

Typical light fixture at separate garage structure

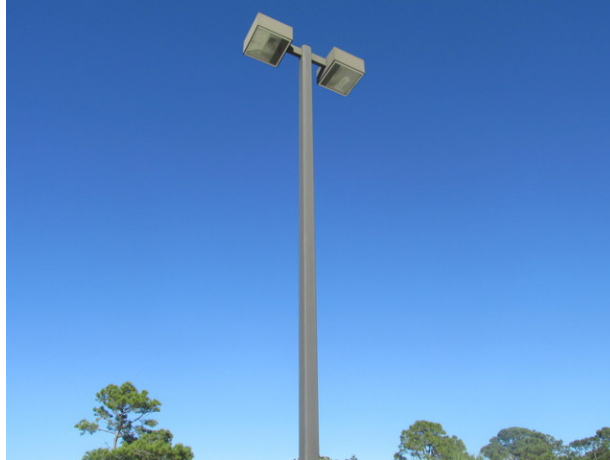
Condition: Good overall condition

Light pole and fixtures at separate garage structure
