Grand Panama Beach Resort Condominium Association, Inc.

August 1, 2023 • Panama City Beach, FL

Grand Panama Beach Resort Condominium Association, Inc. Panama City Beach, Florida

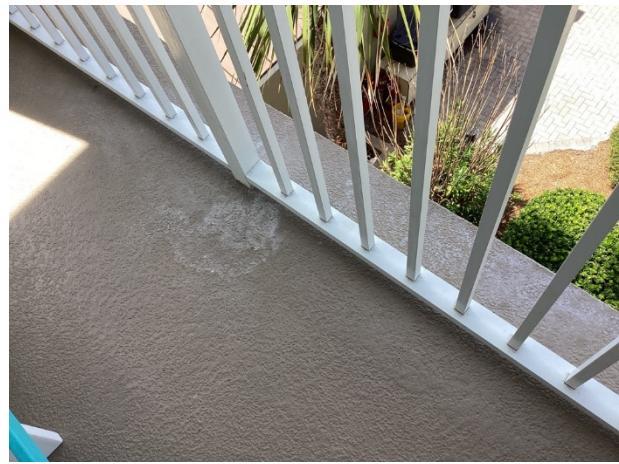
Minor surface stain

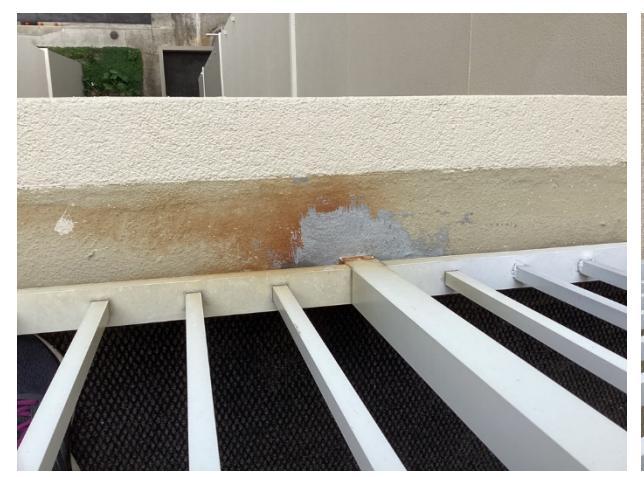
Condition: Good to fair overall. We note previous repairs at the embedded posts.

Previous repair

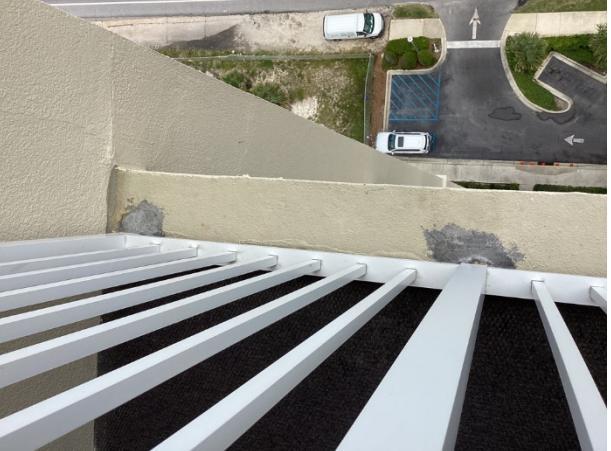
Previous repairs

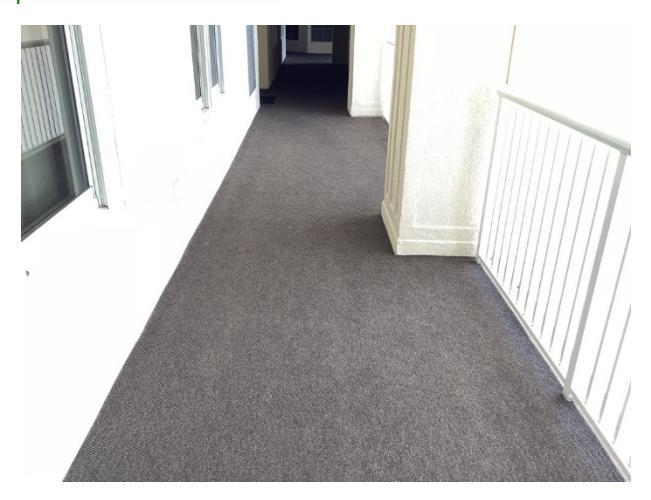
Condition: Fair overall with carpet stains, rust at the condensing units and moisture evident. We note carpet at the breezeways. Carpet conceals concrete deterioration, retains water and inhibits drainage. Water trapped by the carpet can result in accelerated concrete deterioration. Therefore, we do not recommend the use of carpet on breezeways surfaces.

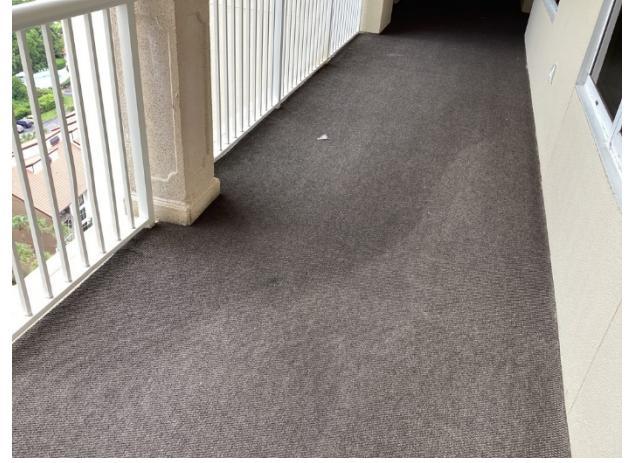
Carpet discoloration at wet areas

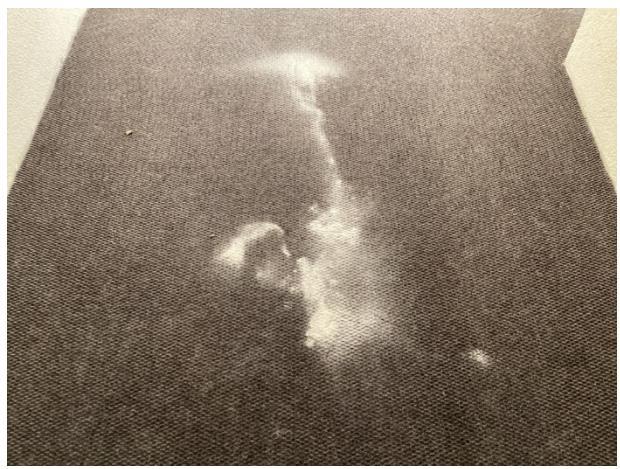
Sand at breezeway carpet

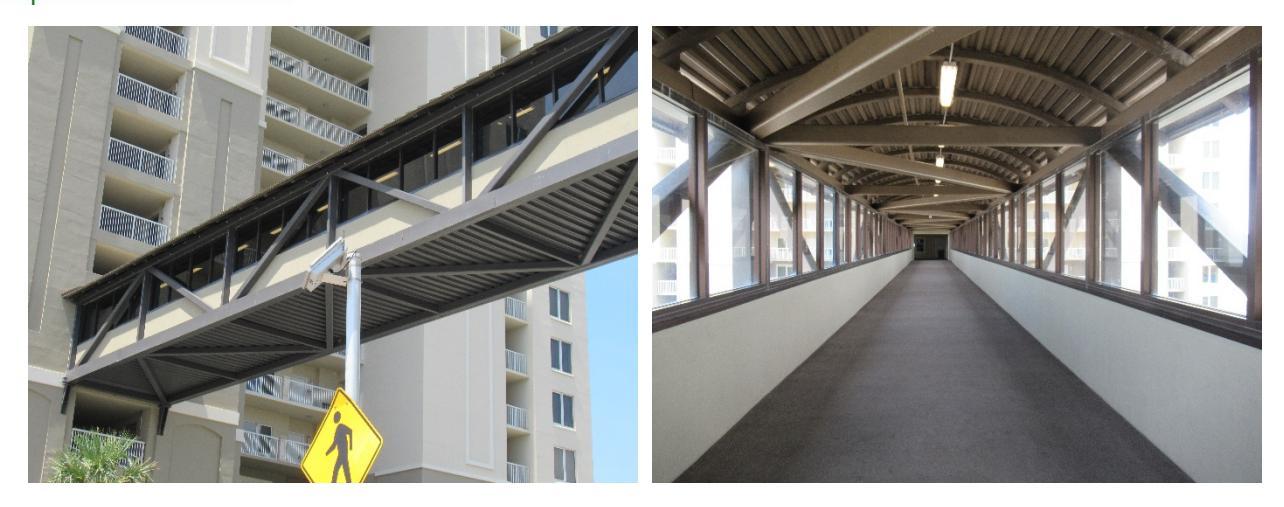
Condition: Good to fair overall with isolated finish deterioration evident.

Skywalk overview

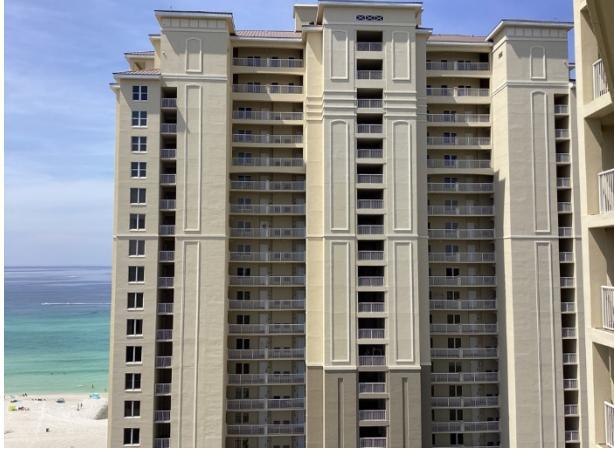
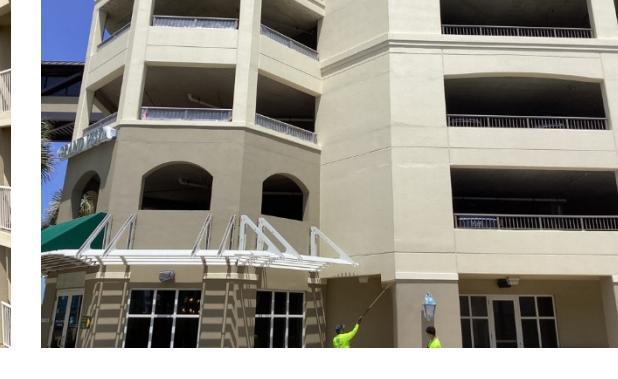
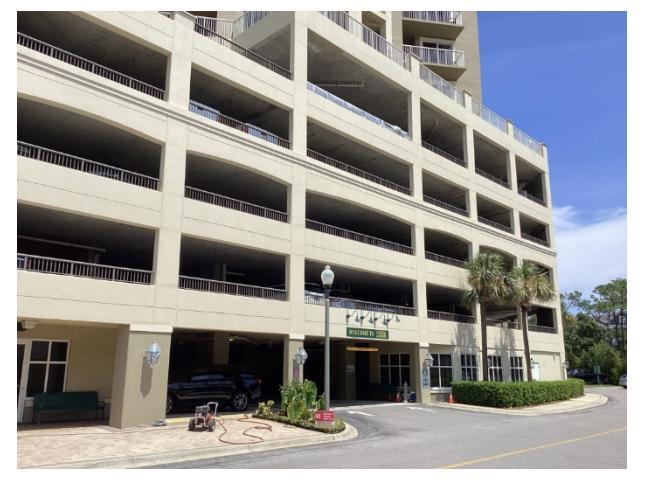
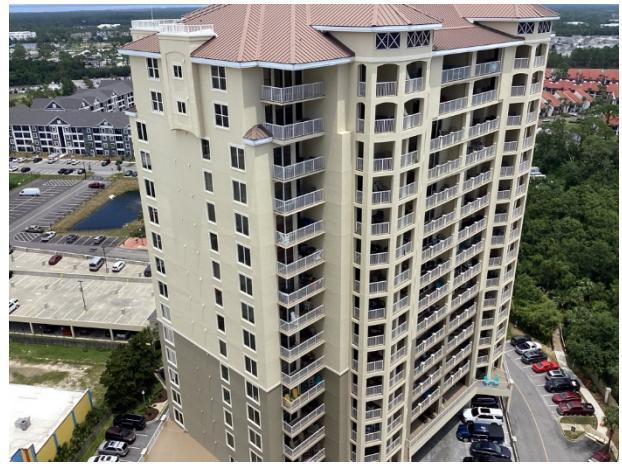
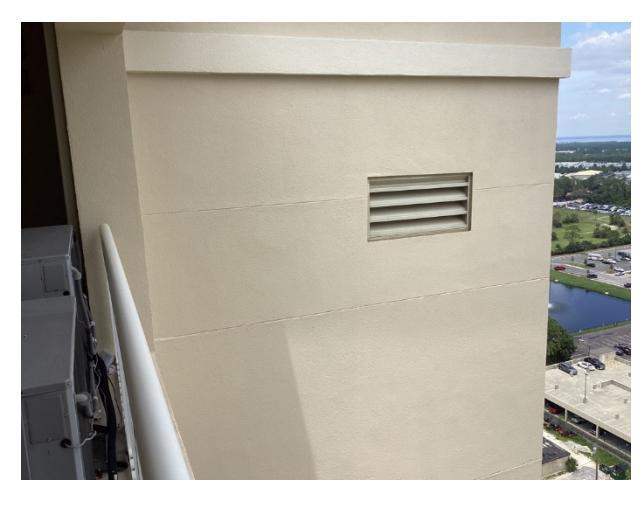
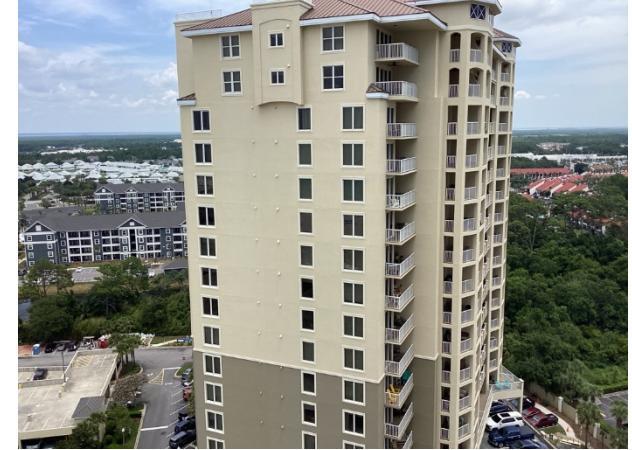
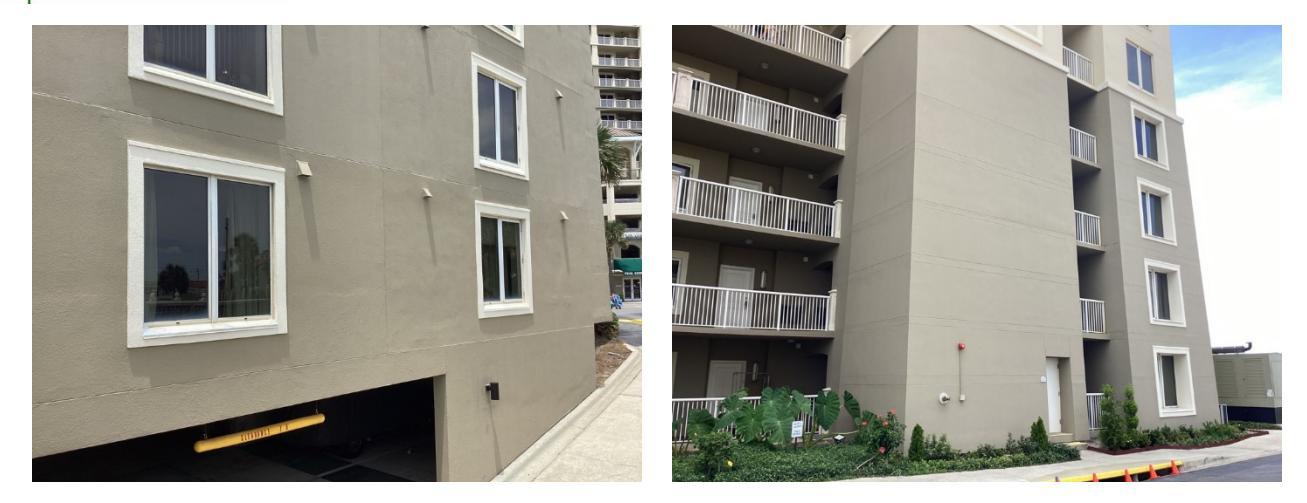
Condition: Good overall

Stucco wall finishes

Useful Life: We recommend inspections, repairs and paint finish applications every 8-to 10-years.

- Complete inspection of the stucco
- Crack repairs as needed (Each paint product has the limited ability to cover and seal cracks but we recommend repair of all cracks which exceed the ability of the paint product to bridge.)
- Replacement of up to one percent (1%), of the stucco walls (The exact amount of area in need of replacement will be discretionary based on the actual future conditions and the desired appearance.)
- Replacement of up to thirty-three percent (33%) of the sealants in coordination with each paint finish application.

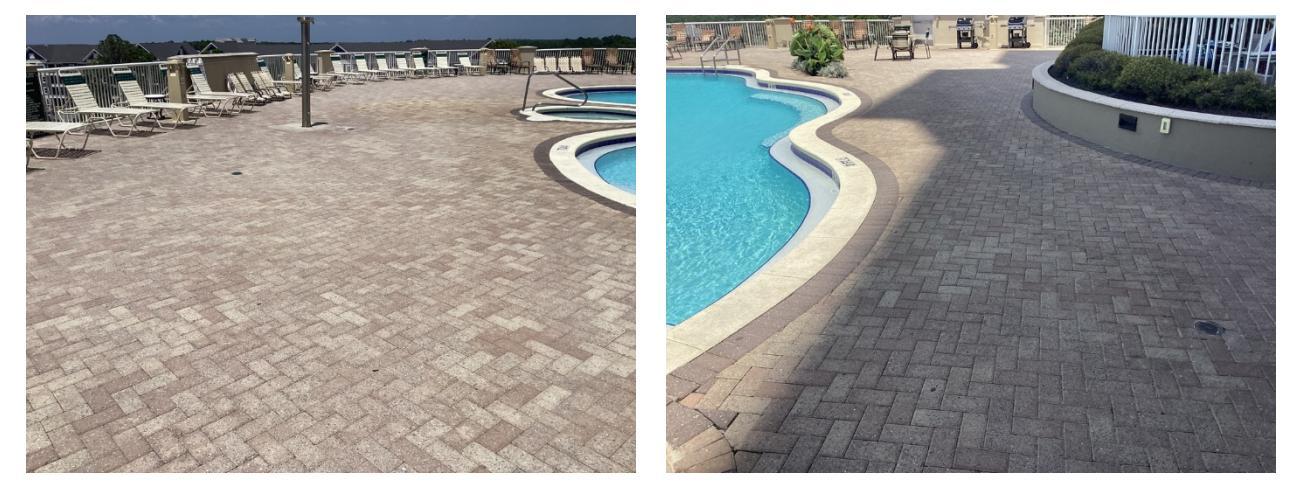
Condition: Good overall condition and Management does not report a recent history of water infiltration issues. We note isolated paver discoloration at the planter weep holes and isolated displaced pavers.

Plaza deck overview

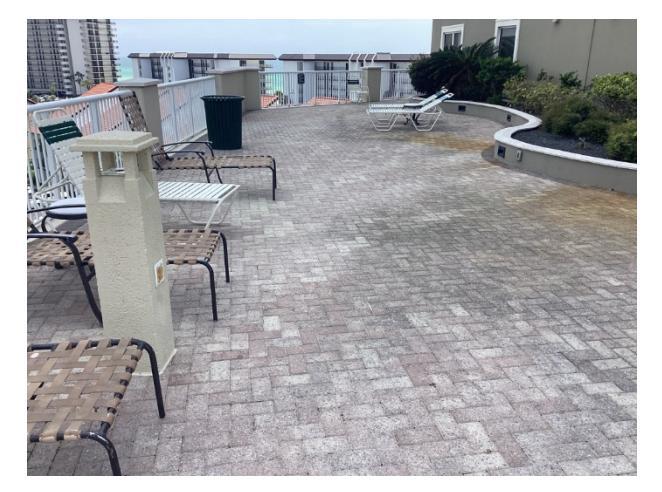
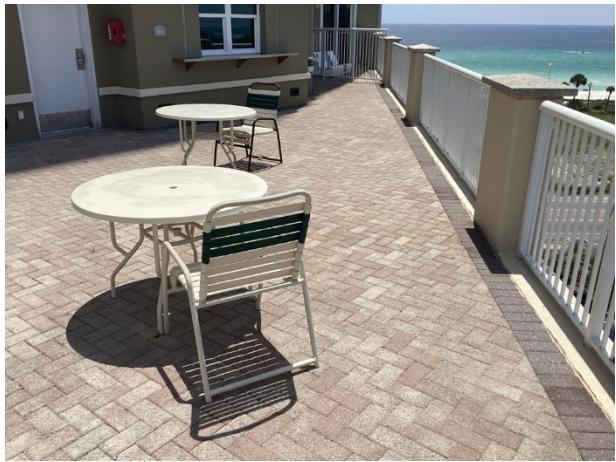
Plaza deck overview

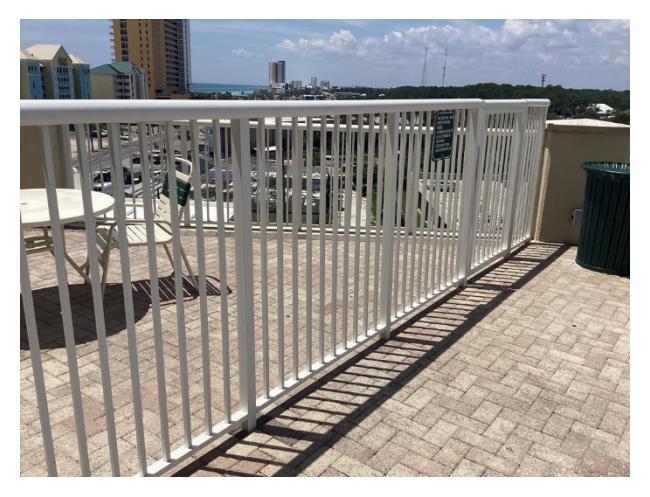
Plaza deck railings

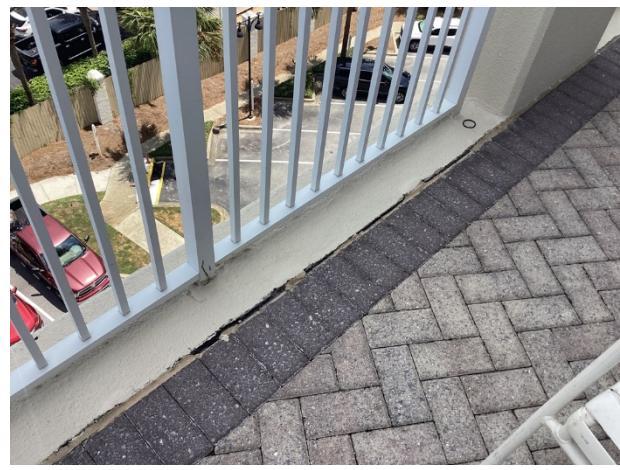
Sealant deterioration

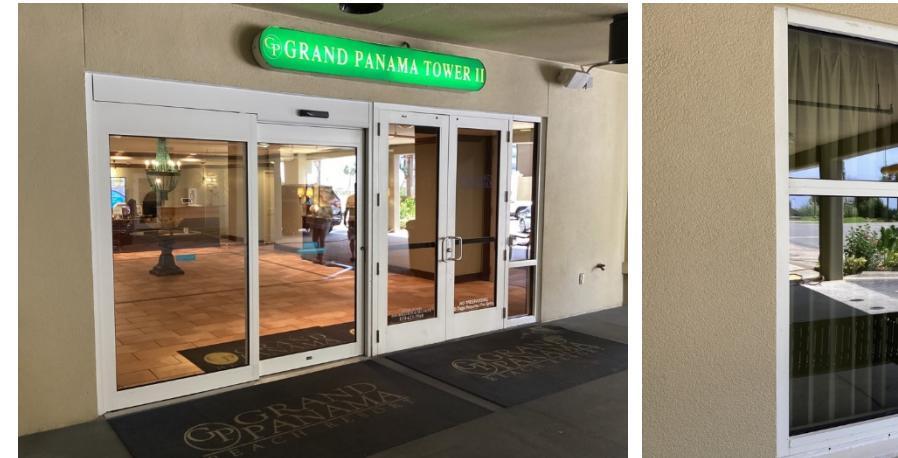
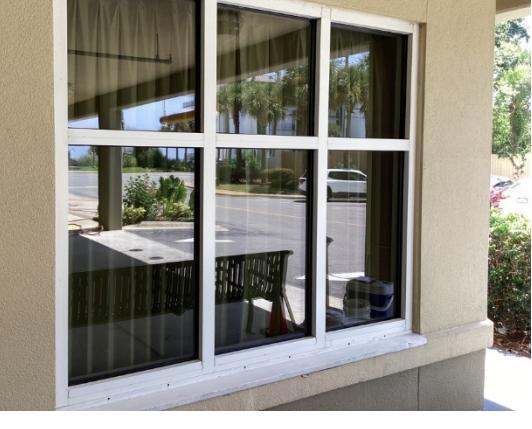
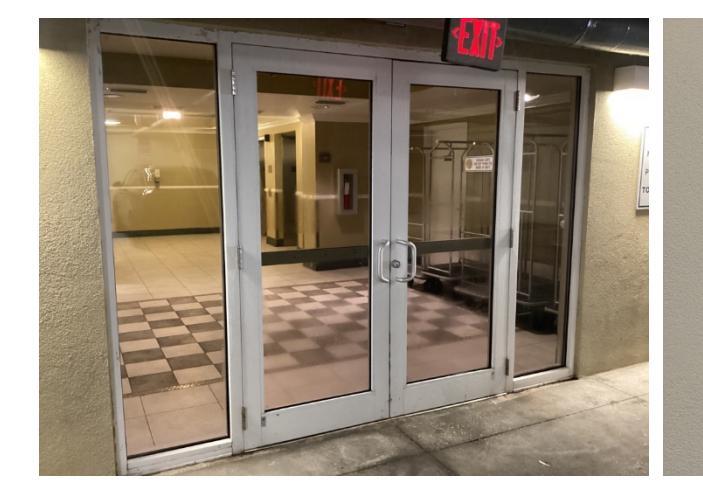
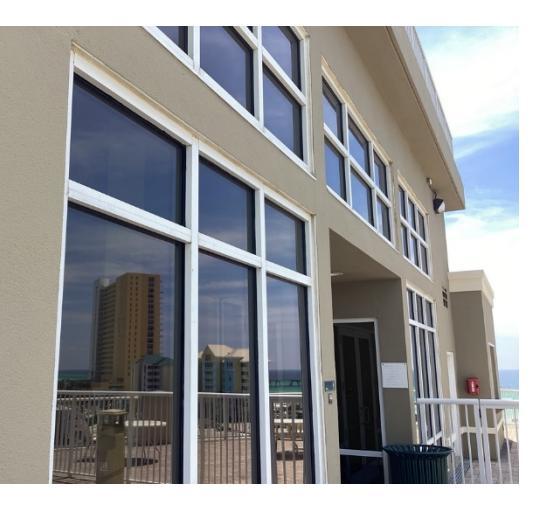
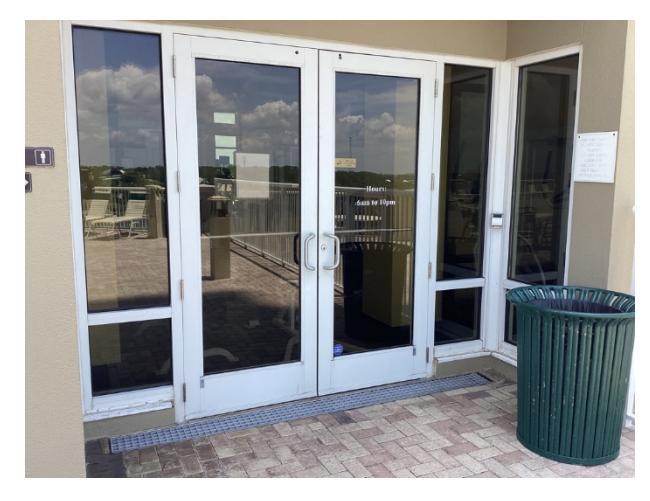
Condition: Good overall

Common windows and doors

Common windows

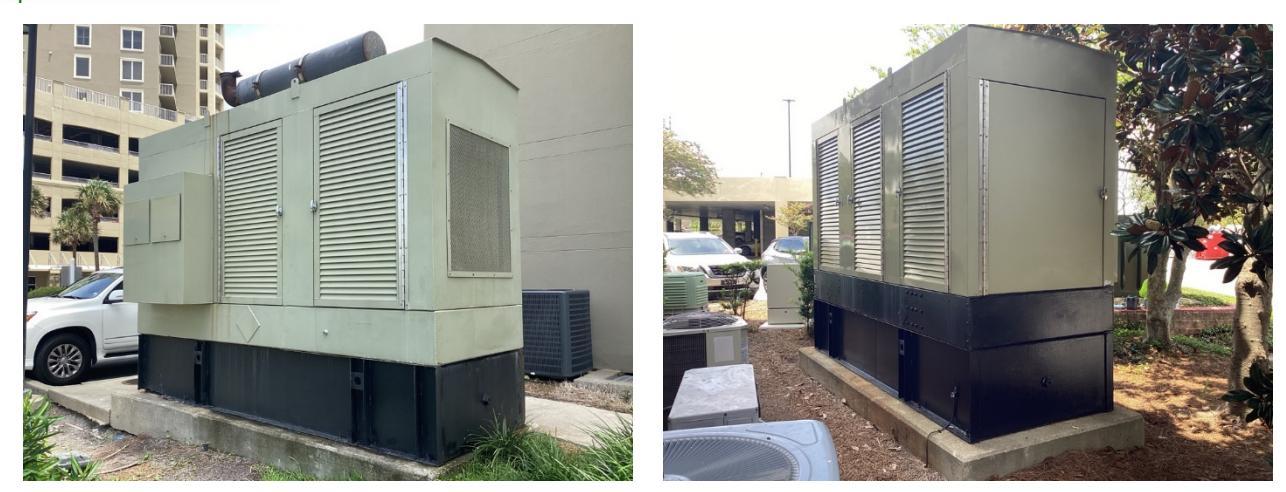
Condition: Reported satisfactory without operational deficiencies

Generator at Tower 1

Generator at Tower 2

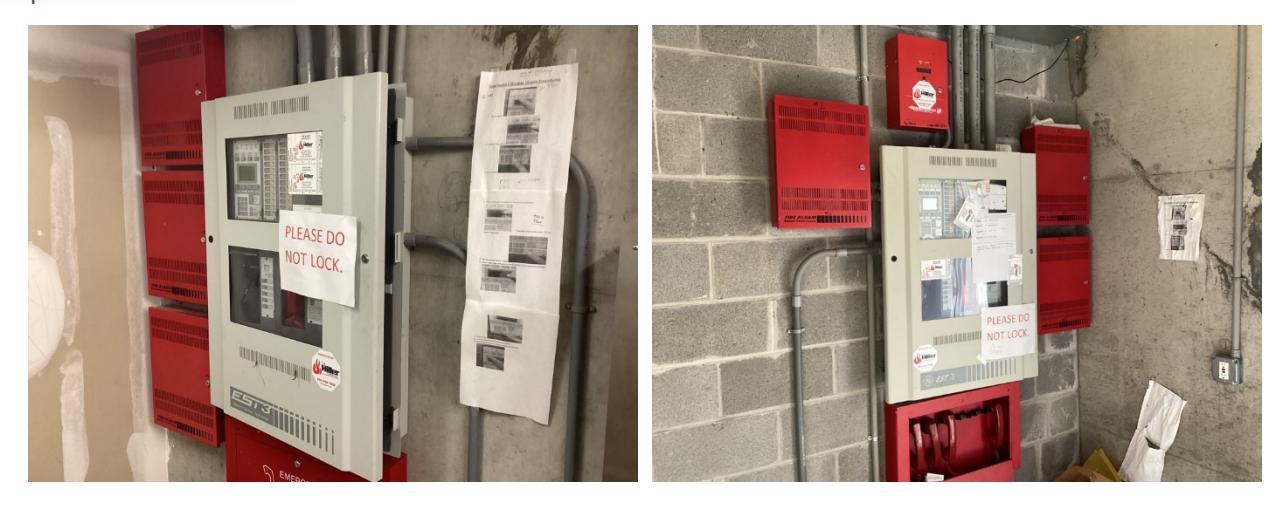
Conditions: Reported satisfactory without operational deficiencies.

Control panel at Tower 1

Control panel at Tower 2

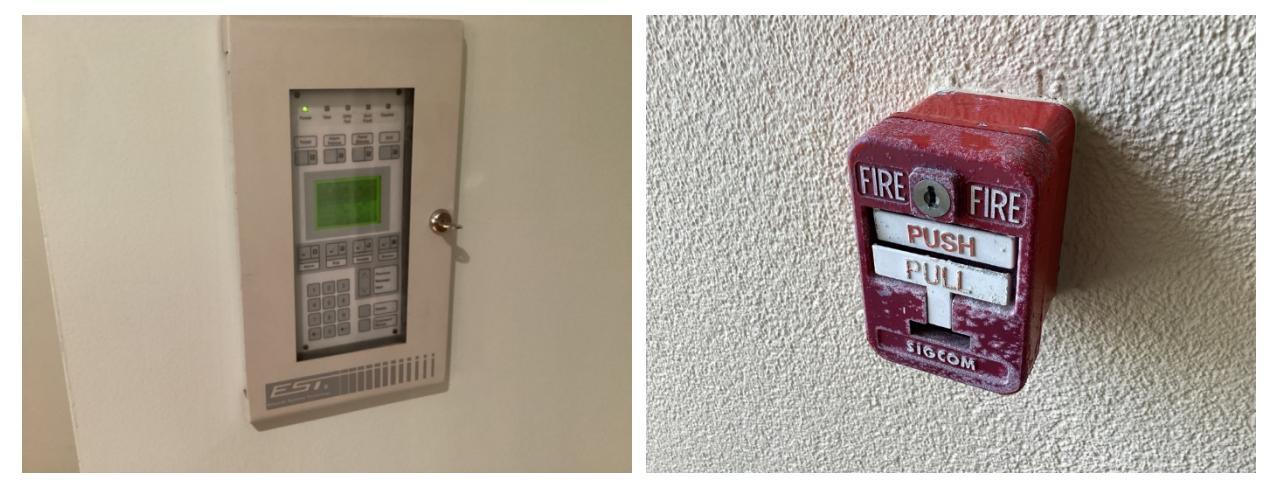
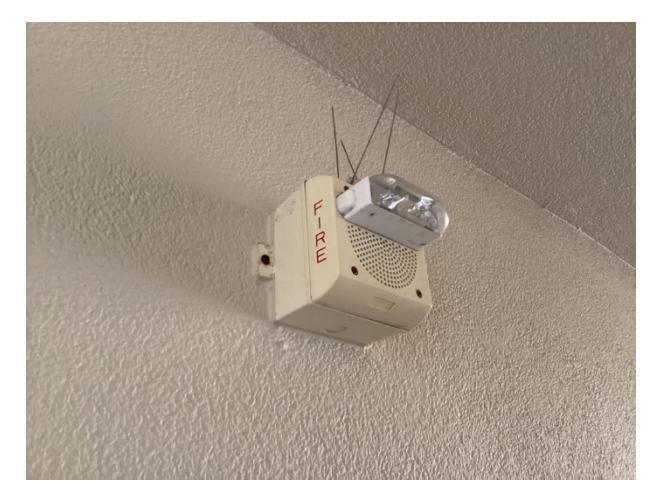
Secondary panel

Emergency devices

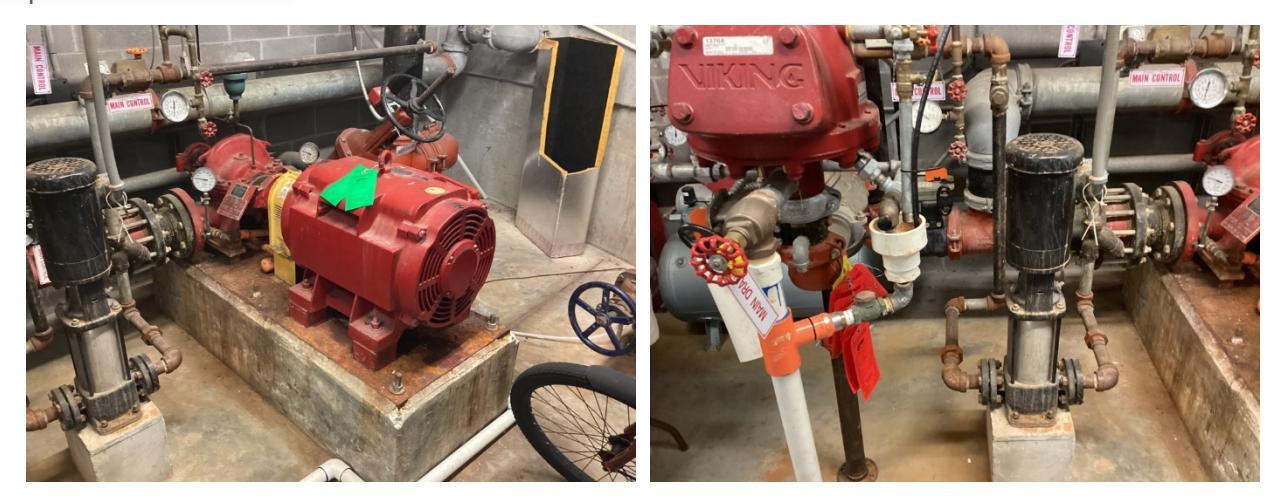
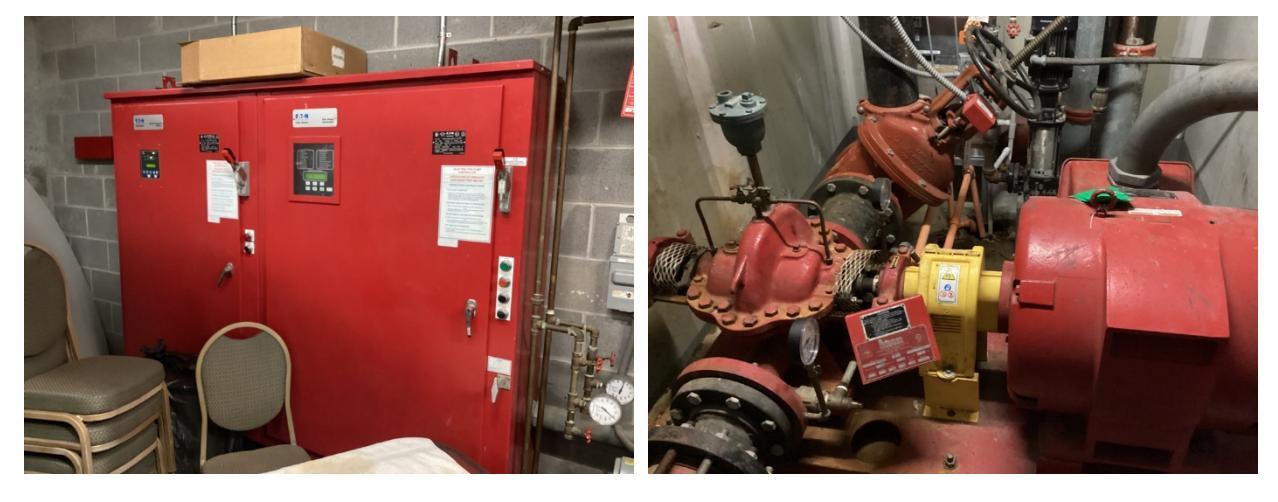
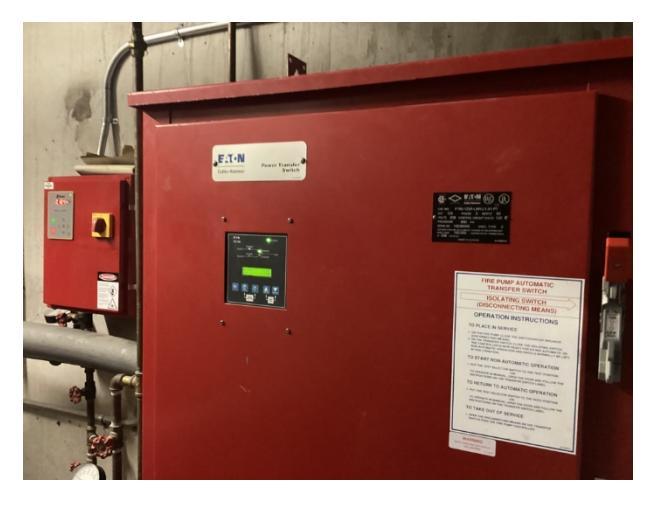
- The fire suppression pump was last inspected on March 23, 2023.
- The inspection tag color is acceptable
- The Association does not report a history of leaks.

Fire suppression pump

Jockey pump

Fire suppression pump controls

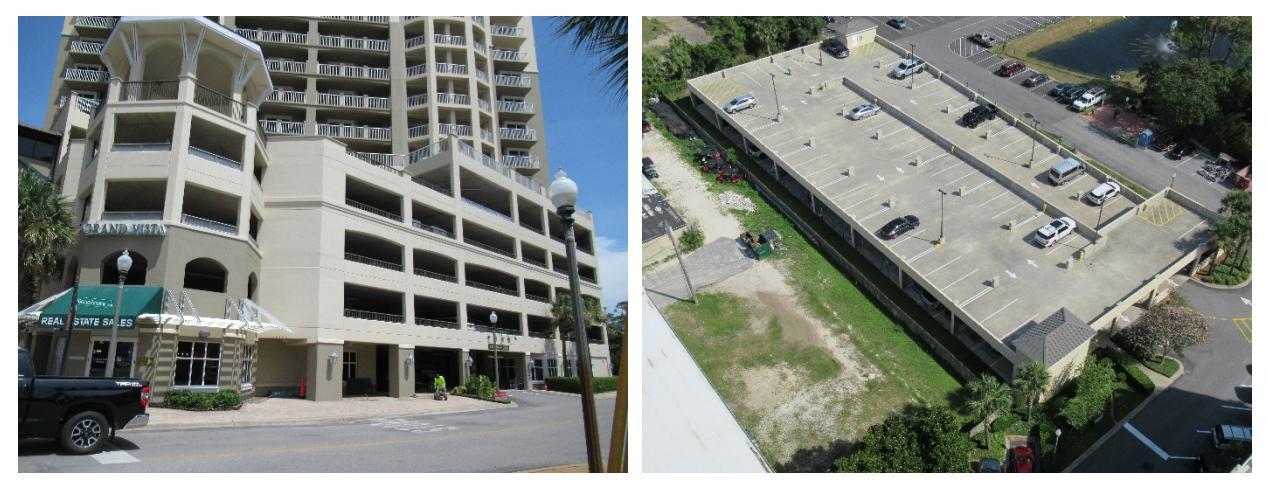
Tower 2 garage overview

Detached garage overview

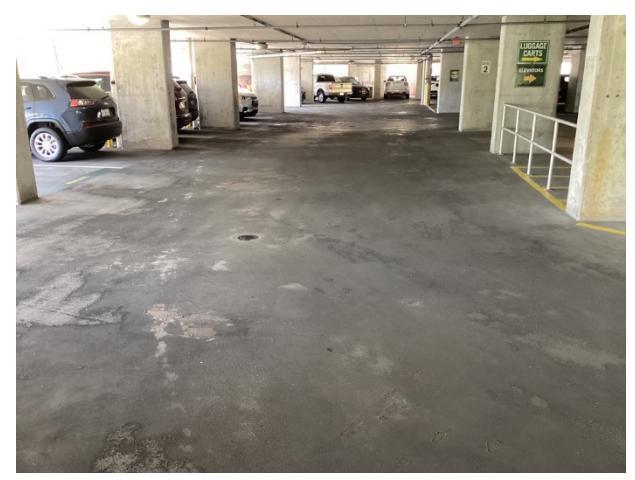
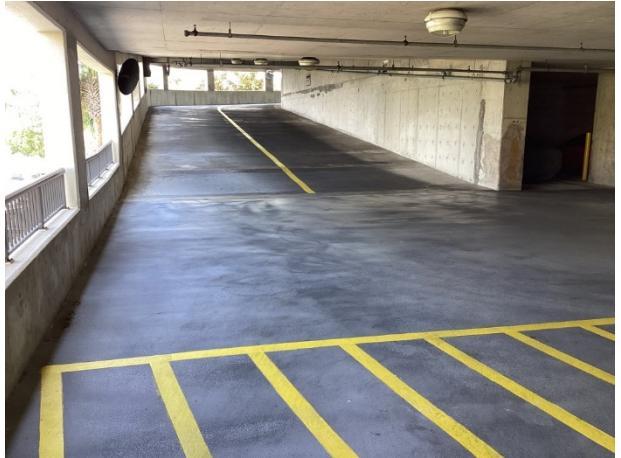
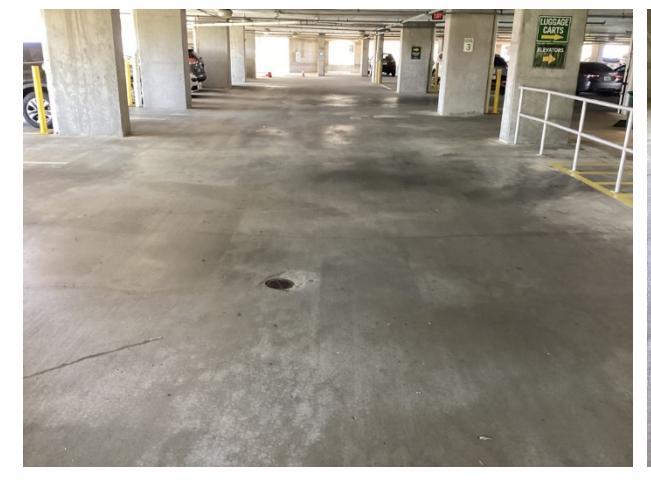
Elevated garage floor overview at Tower 2

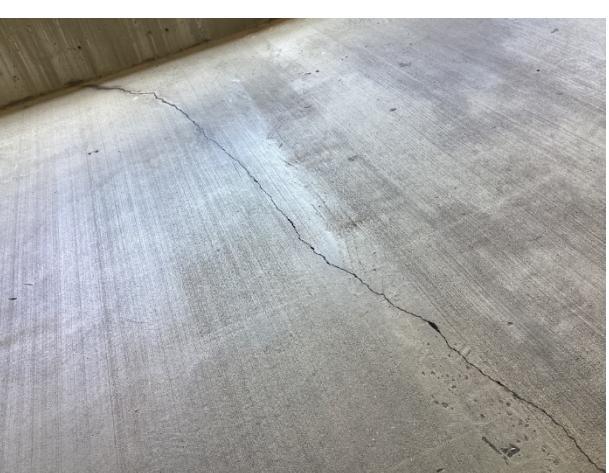
Concrete cracks

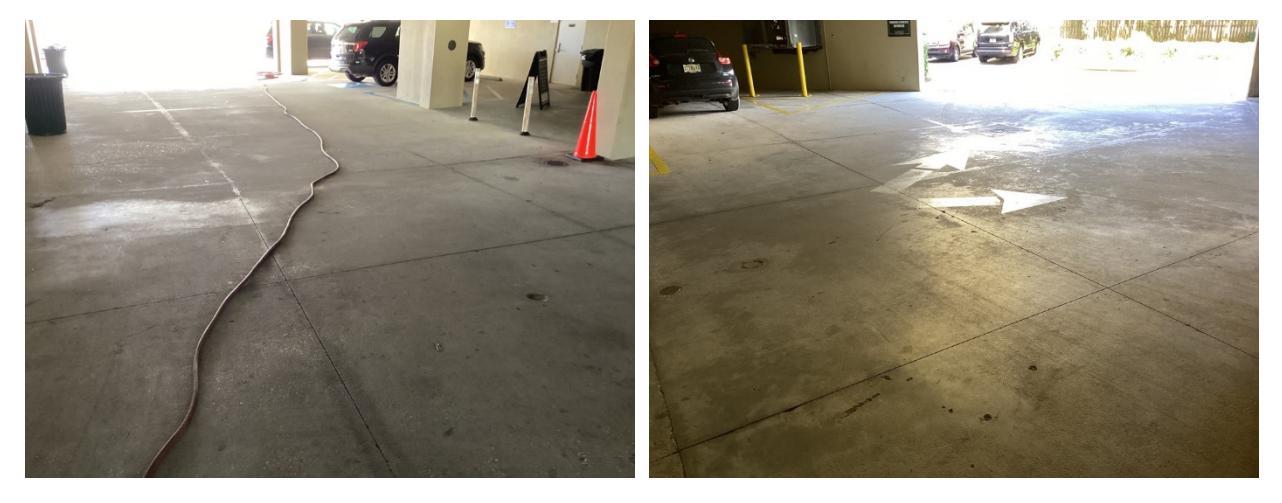
Condition: Good to fair overall with isolated cracks evident.

On-grade garage floor overview at Tower 2

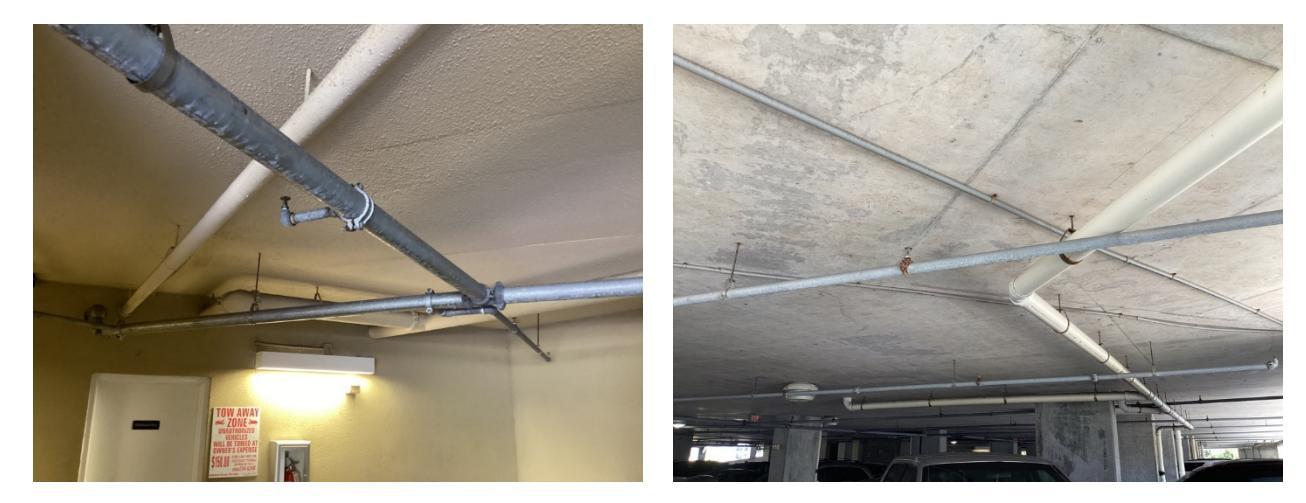
Condition: Good overall

Fire suppression system

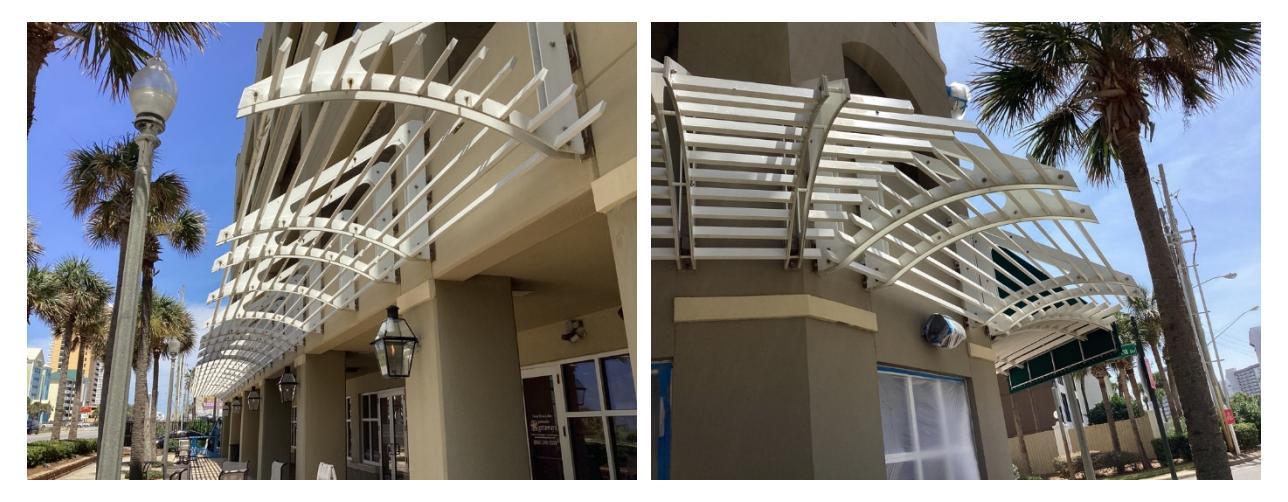
Condition: Fair overall with finish deterioration evident

Awnings overview

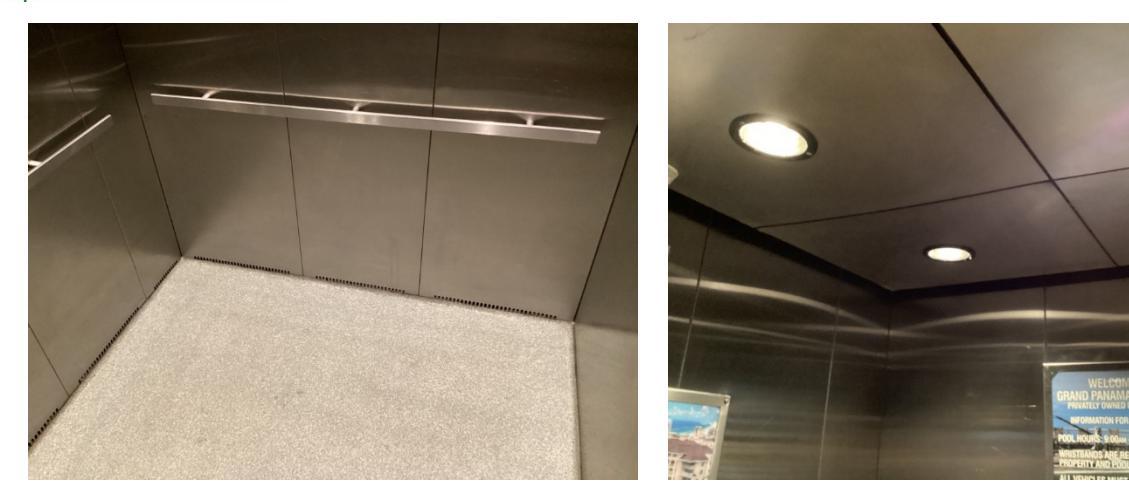
Elevator cab finishes

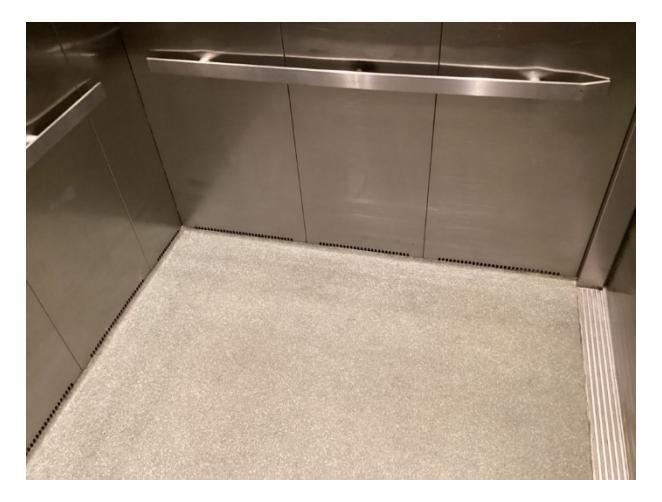
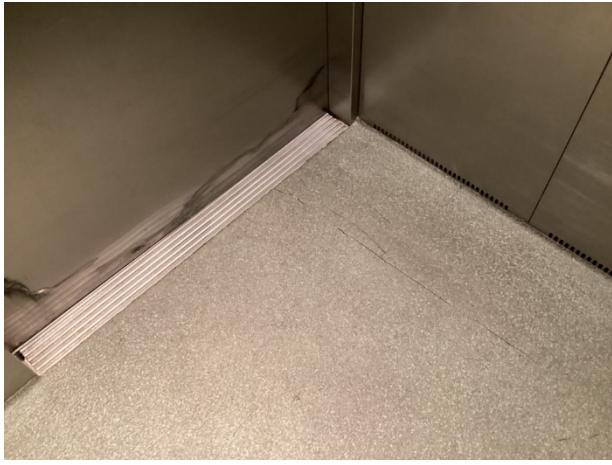
Elevator cab finishes

Damage at cab finishes

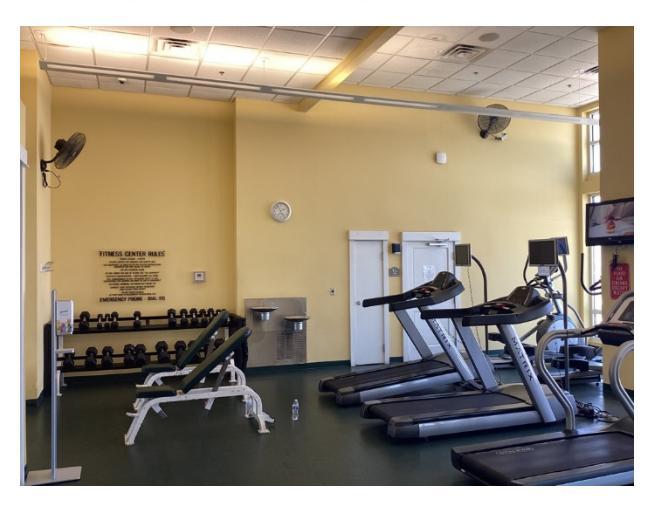
- Cardiovascular equipment: Original and reported in good condition
- Strength training equipment: Original and reported in good condition

Typical exercise equipment

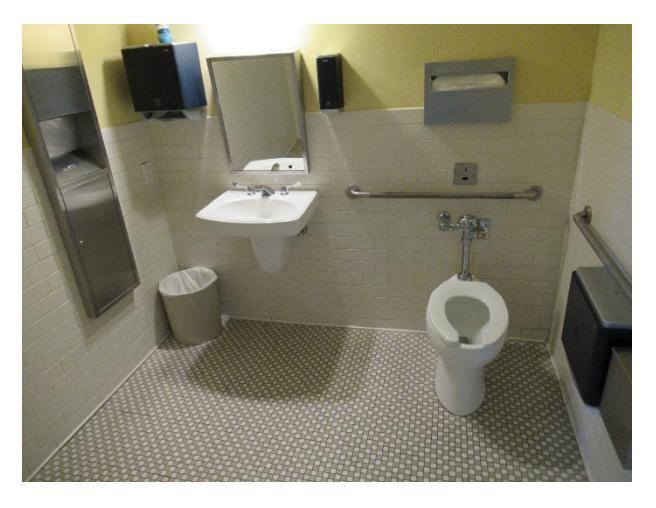
Minor floor damage

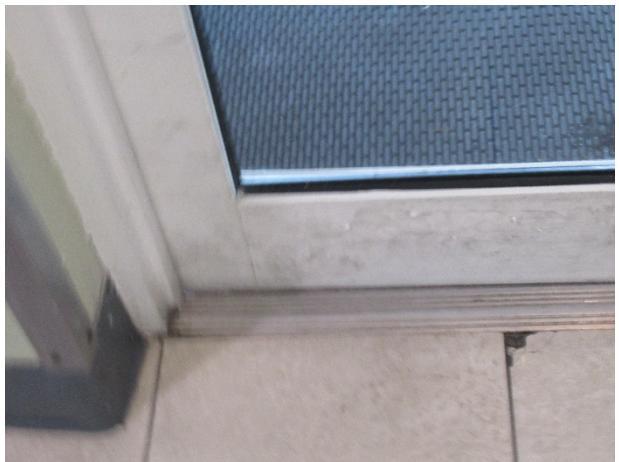
Condition: Good to fair overall with isolated, minor tile damage evident

Typical tile floor covering at Tower 2 elevator lobby

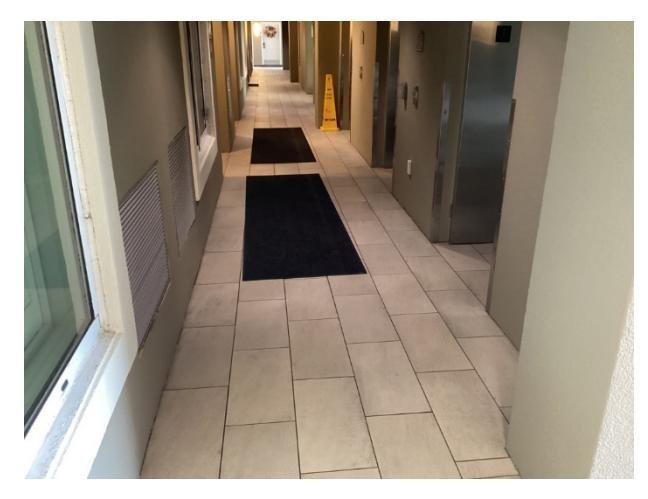
Minor tile damage

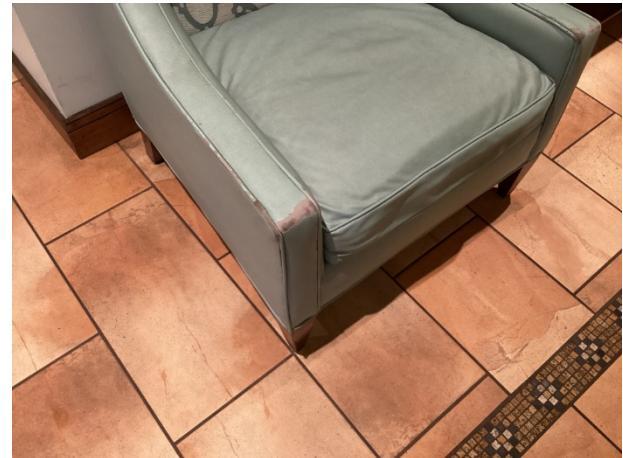
Condition: Good to fair overall with finish deterioration evident at the furnishings and floor coverings

Furnishing deterioration

Expenditure Detail Notes: Expenditure timing and costs are depicted in the **Reserve Expenditures** table in Section 3. The complete renovation should include replacement of all components listed above and the partial renovations should include the following:

- Application of paint finish to all surfaces
- Replacement of up to fifty percent (50%) of the furnishings

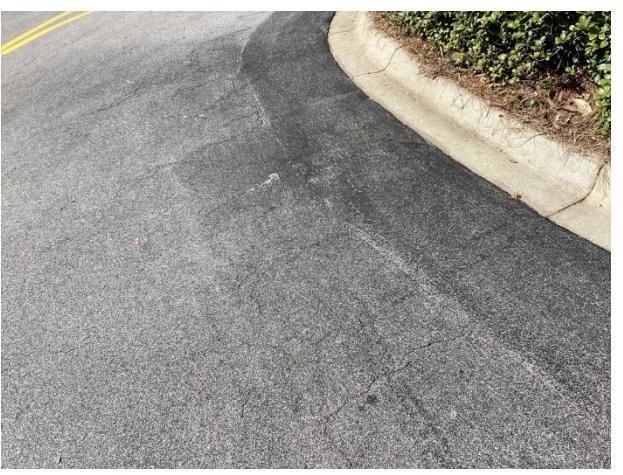
Condition: Good to fair overall with isolated cracks and patches evident.

Pavement cracks

Component Detail Notes: Patch repairs are conducted at areas exhibiting settlement, potholes, or excessive cracking. These conditions typically occur near high traffic areas, catch basins, and pavement edges. The contractor should only apply seal coat applications after repairs are completed. These activities minimize the damaging effects of vehicle fluids, maintain a uniform and positive appearance, and maximize the useful life of the pavement.

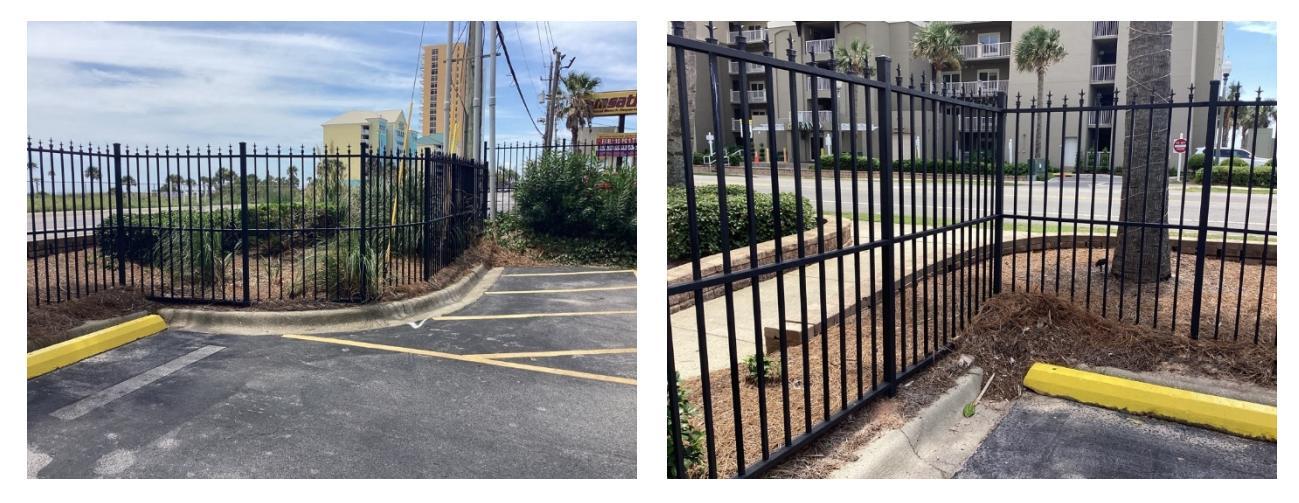
Condition: Fair overall with finish deterioration evident.

Aluminum fence

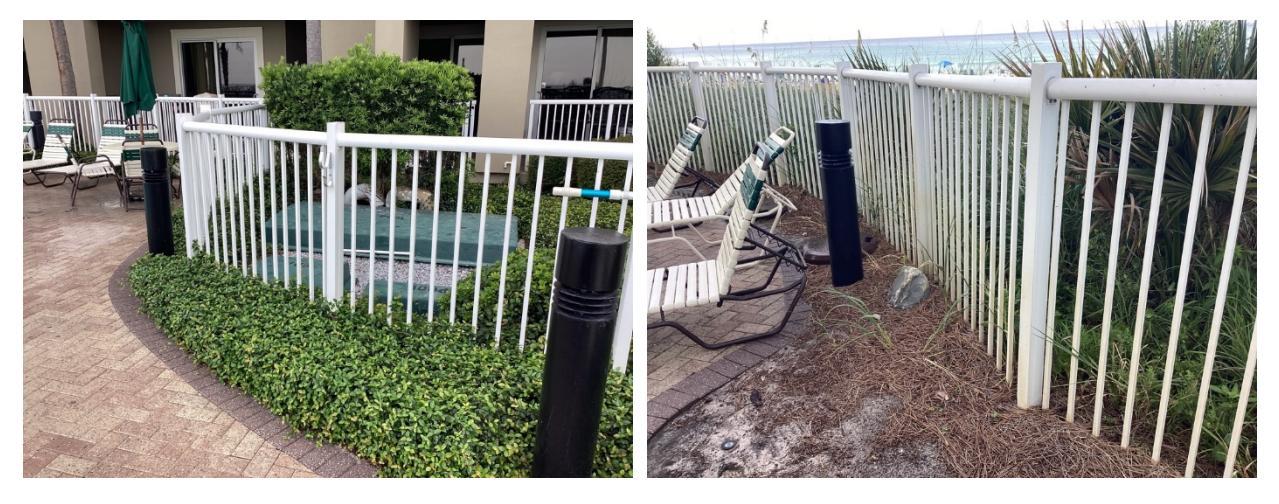
Condition: Good to fair overall with finish deterioration evident

Aluminum pool fence

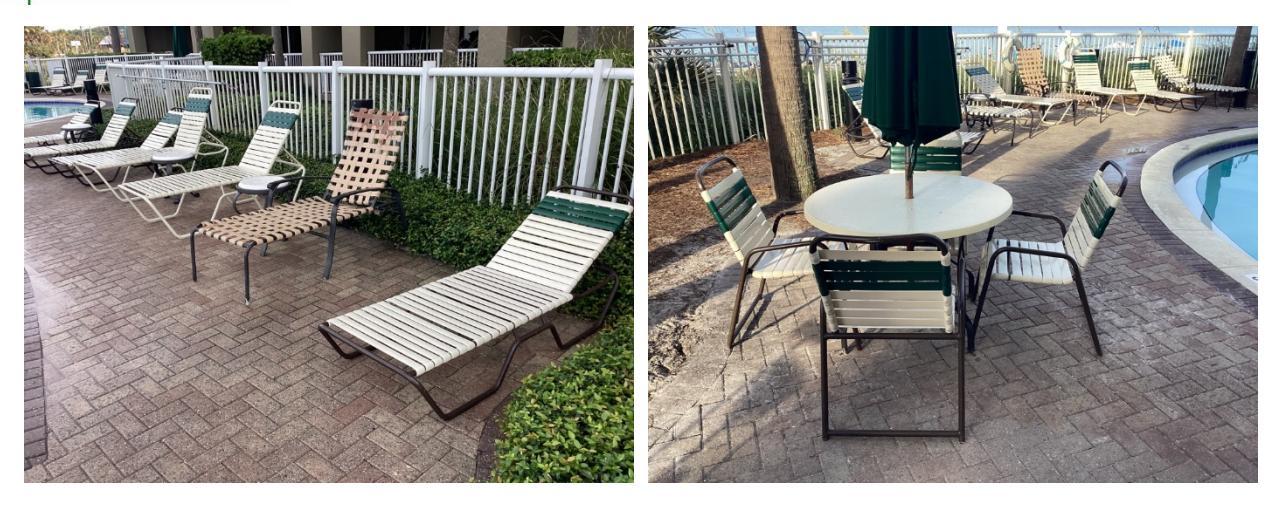
Condition: Fair to poor overall

Pool furniture

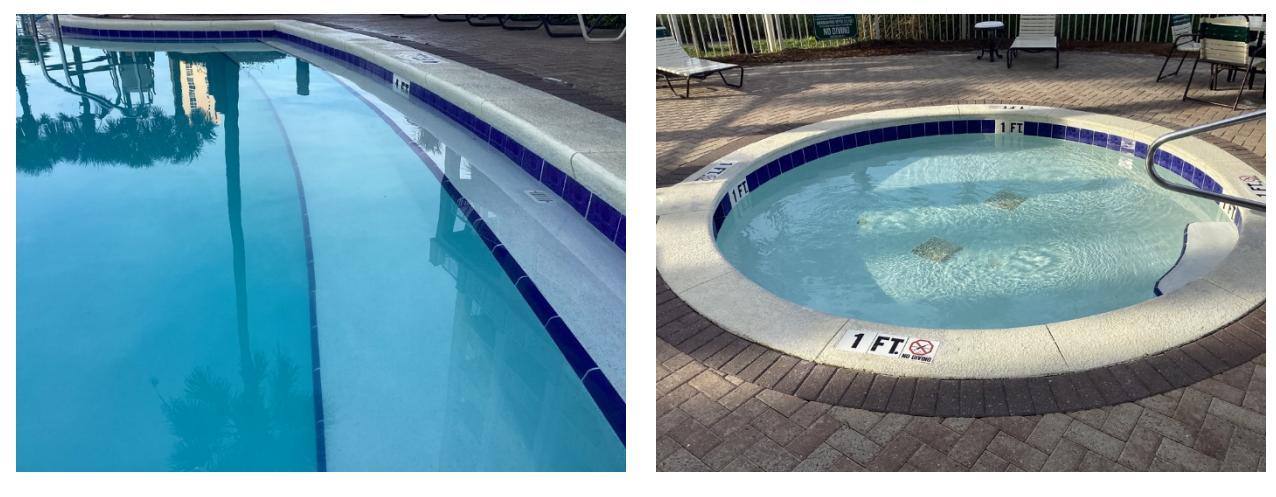
Pool plaster overview

Pool plaster finish with tile perimeter

- Inspect and patch areas of significant plaster delamination, coping damage and structure cracks
- Inspect main drain connection and anti-entrapment covers, pressure test circulation piping and valves
- Test handrails and safety features for proper operation

- Removal and replacement of the plaster finishes
- Partial replacements of the scuppers and coping as needed
- Replacement of tiles as needed
- Replacement of joint sealants as needed
- Concrete structure repairs as needed
