Grand Panama Beach Resort Condominium Association, Inc.

August 1, 2023 • Panama City Beach, FL

Grand Panama Beach Resort Condominium Association, Inc. Panama City Beach, Florida

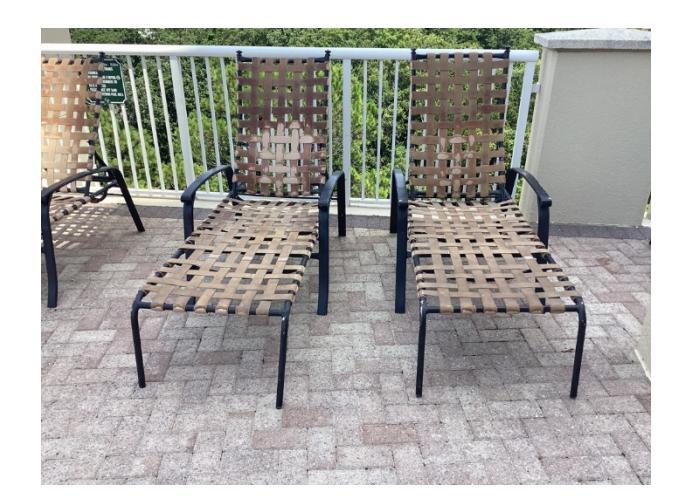
Condition: Fair overall

Furniture damage

Expenditure Detail Notes: Expenditure timing and costs are depicted in the **Reserve Expenditures** table in Section 3. We recommend interim re-strapping, refinishing, cushion replacements, reupholstering and other repairs to the furniture as normal maintenance to maximize its useful life.

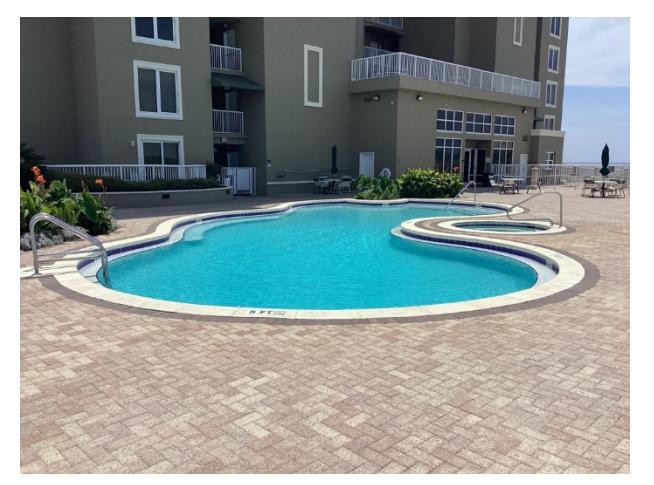
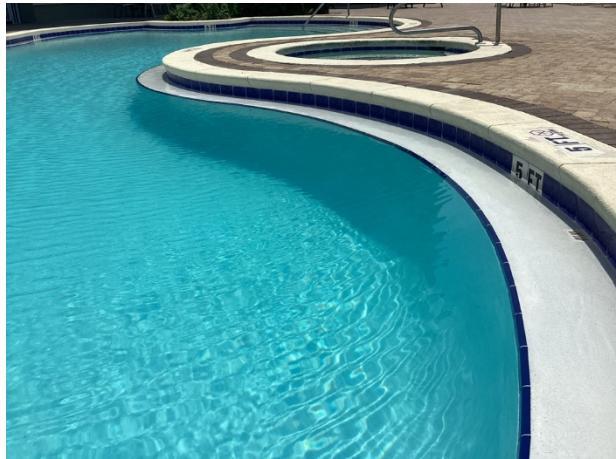
Condition: Good to fair overall

Pool plaster overview

- Semi-annually:
 - o Inspect and patch areas of significant plaster delamination, coping damage and structure cracks
 - o Inspect main drain connection and anti-entrapment covers, pressure test circulation piping and valves
 - Test handrails and safety features for proper operation

- Removal and replacement of the plaster finishes
- Partial replacements of the scuppers and coping as needed
- Replacement of tiles as needed
- Replacement of joint sealants as needed
- Concrete structure repairs as needed

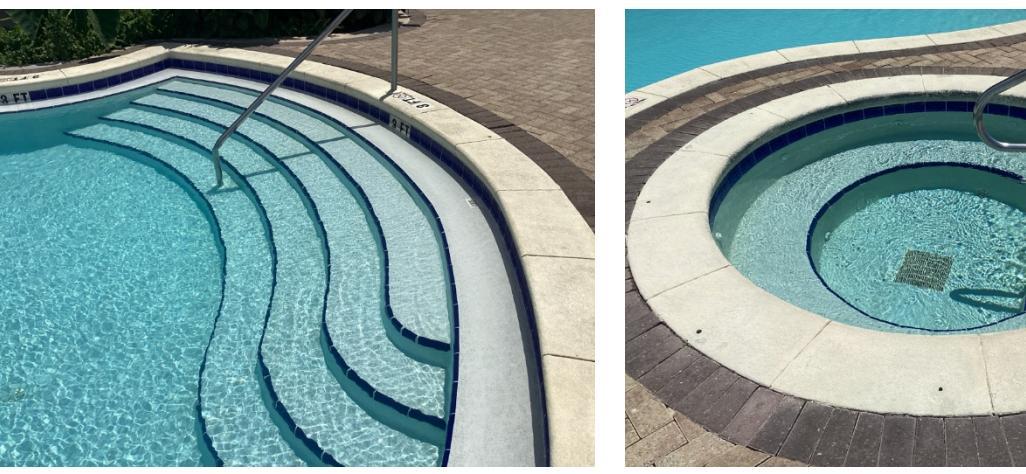
Pool plaster overview

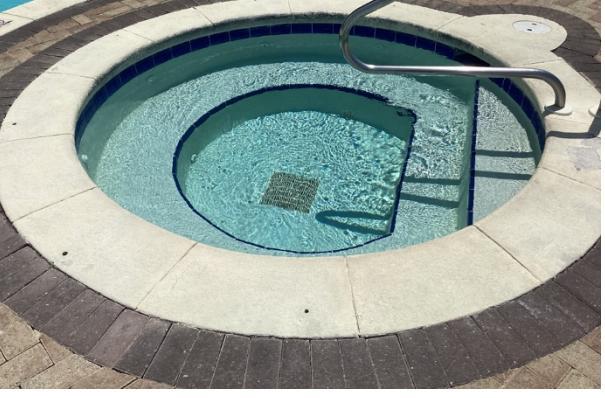
Spa plaster overview

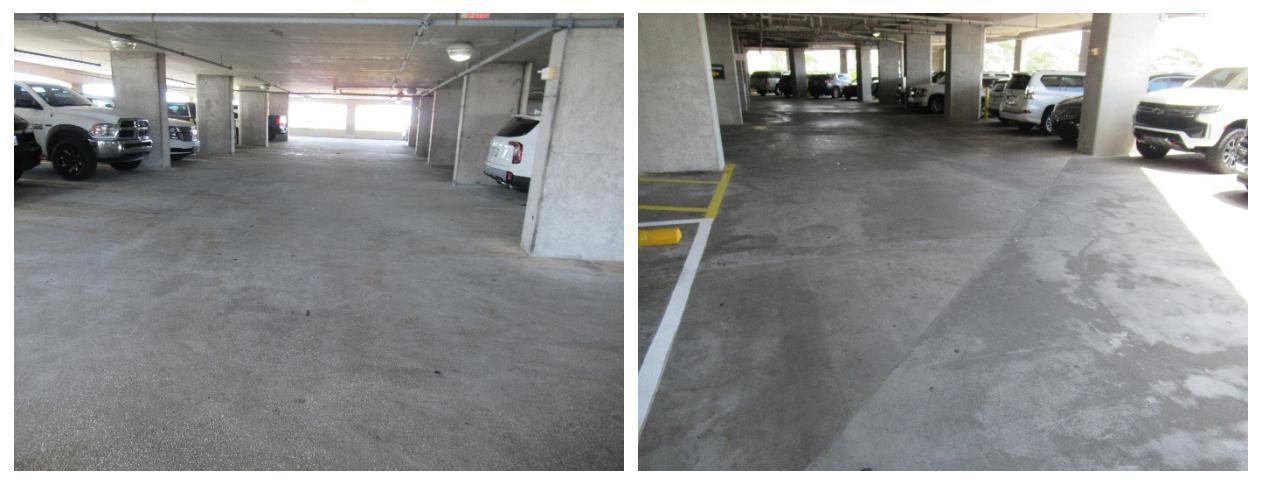
Condition: Good to fair overall with isolated cracks evident. Portions of the elevated structural concrete utilizes a protective traffic coating. We include for this cost on Line Item 7.800.

Elevated garage floor overview at Tower 2

- Partial depth concrete replacement of a limited amount of the surface area of the concrete floors
- Partial depth concrete replacement of a limited amount of the surface area of the elevated structural concrete ceilings
- Remediation of structural concrete columns and beams as needed
- Crack repairs on all surfaces as needed

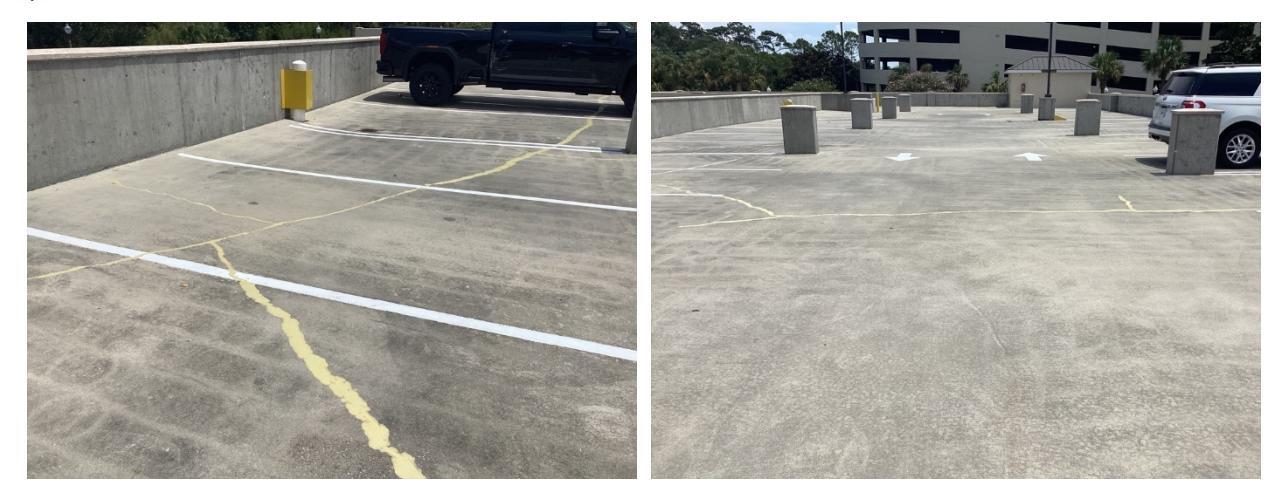
Elevated detached garage floor overview

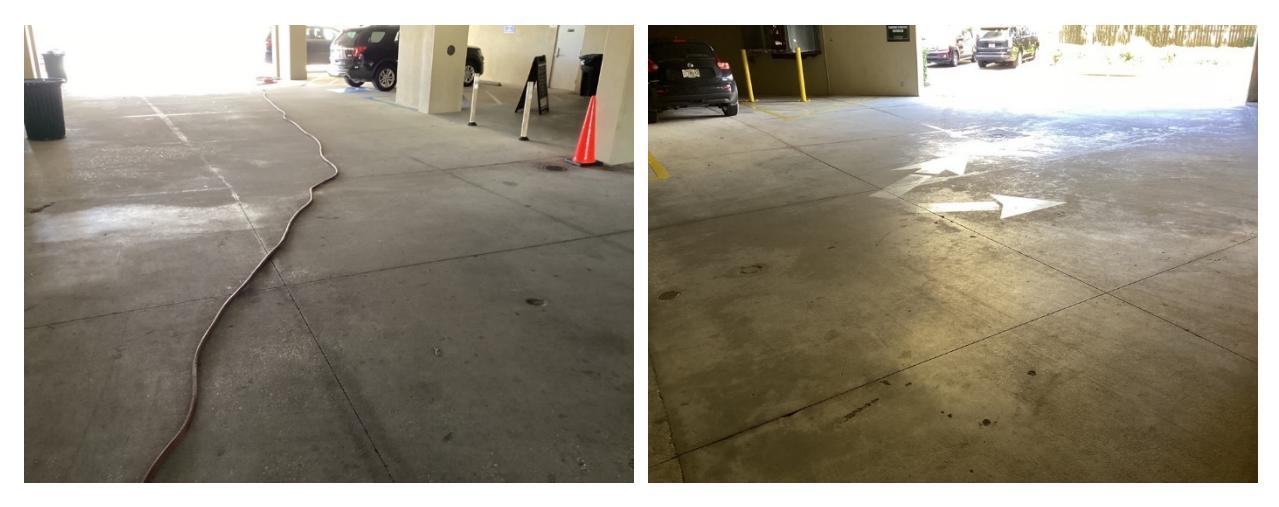
Condition: Good to fair overall with isolated cracks evident.

On-grade garage floor overview at Tower 2

- Selective cut out and replacement of up to three percent (3%), or 600 square feet, of the on-grade concrete
- Crack repairs as needed

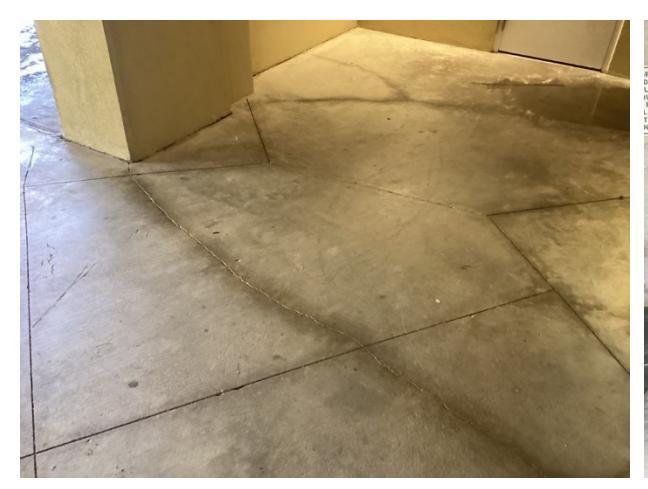
Concrete cracks at Tower 2 on-grade concrete

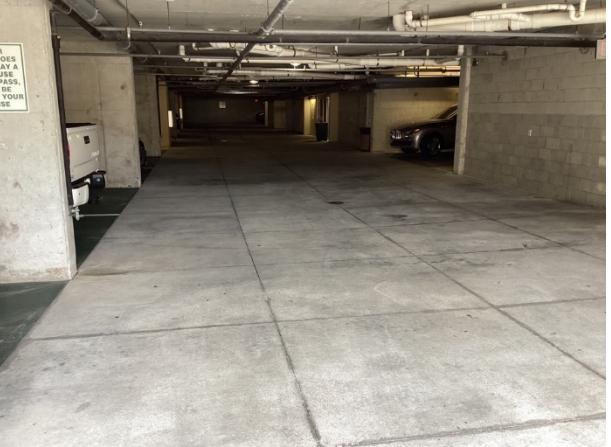
On-grade garage floor overview

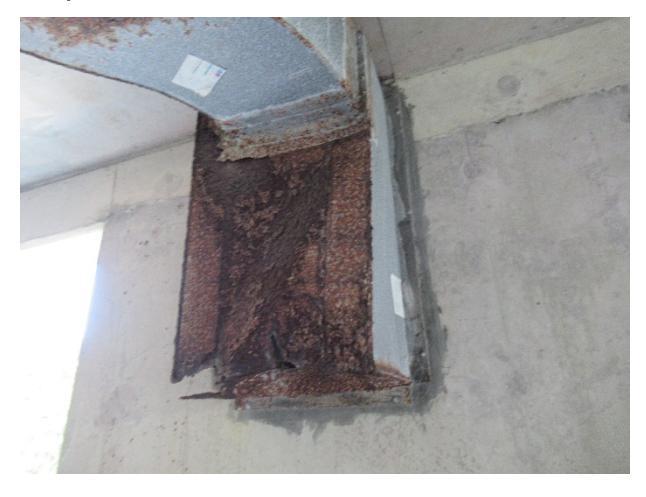
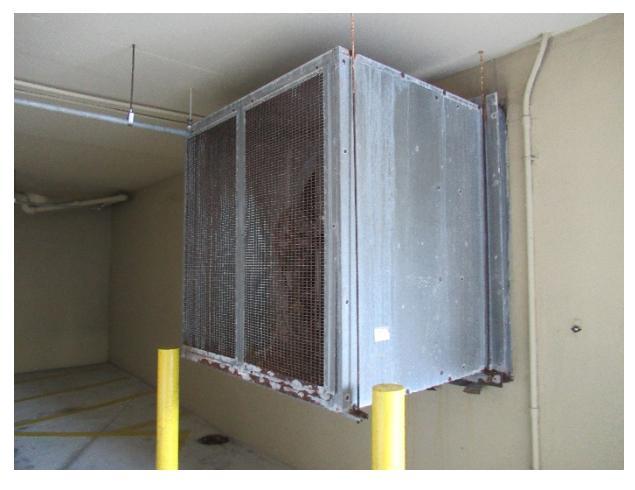
Condition: Reported satisfactory. We noted extensive rust and corrosion at expose components in Tower 2.

Exhaust fan

Expenditure Detail Notes: Expenditure timing and costs are depicted in the **Reserve Expenditures** table in Section 3. We regard interim repairs or partial replacements of components as normal maintenance.

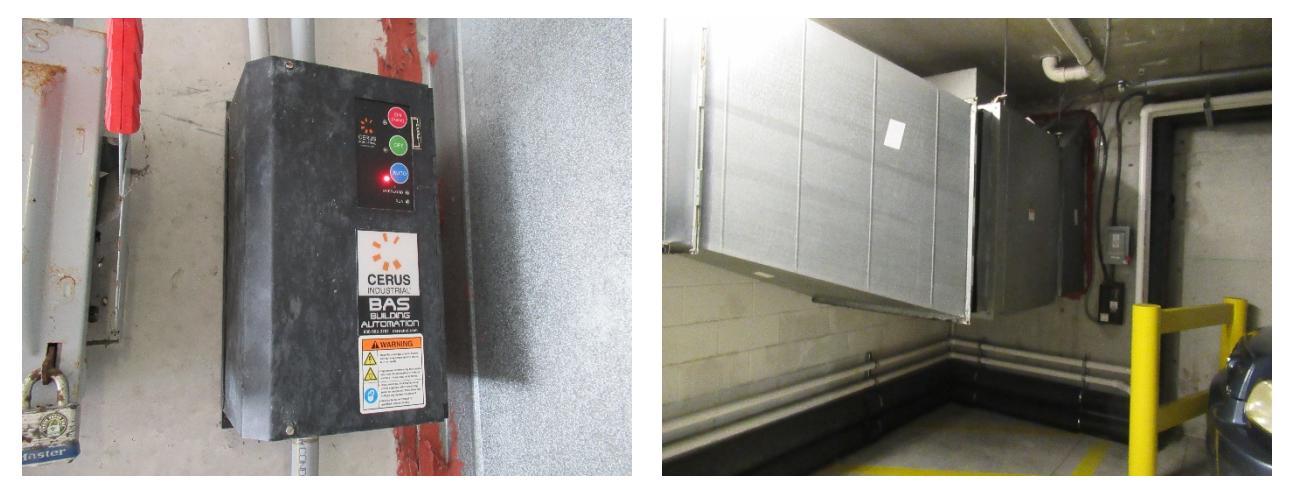
Control panel

Exhaust system

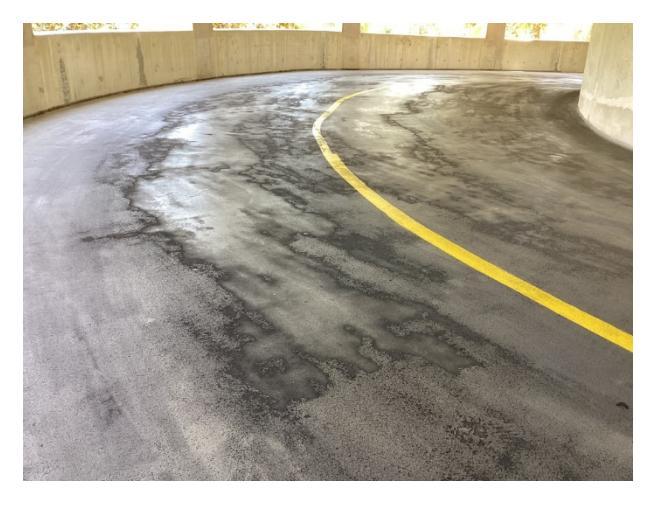
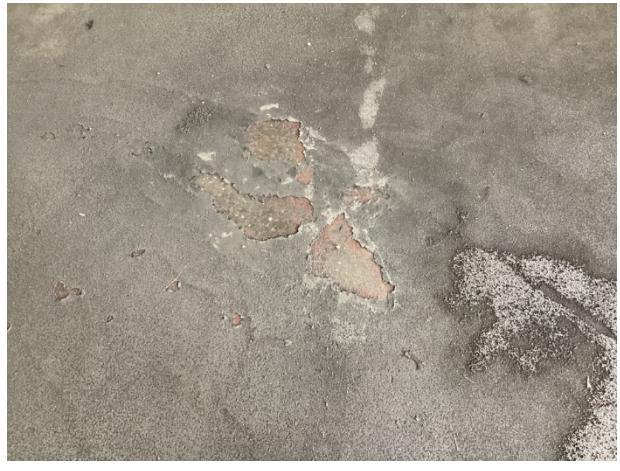
Condition: Fair to poor overall

Traffic coating delamination

Moisture-driven chemical reactions are detrimental to the integrity of an elevated structural concrete garage floor. Once it reaches the steel, moisture causes expansive corrosion, ultimately causing the concrete to expand and "pop" or spall. Left unrepaired, additional moisture will continue to infiltrate the concrete, eventually causing structural failure. This type of deterioration is progressive and costly to repair. The utilization of a traffic coating atop the concrete minimizes the infiltration of moisture into the concrete thereby minimizing future capital repairs.

Component Detail Notes: In our experience, active periodic maintenance and protection with a traffic coating on elevated concrete structures results in a longer useful life, safer operation and a lower overall life cycle costs. Failure to maintain a traffic coating on elevated floors will result in accelerated concrete deterioration at concrete ceilings below the elevated floors and a higher overall capital investment in the parking structure over time. The most recent coating application was overlaid atop an existing coating. This installation does not provide the opportunity for the underlying concrete structure to be inspected. We recommend the Association plan future coating applications to include complete removal of the existing coating(s).
